TECHNICAL REPORT HL-90-19

# A STUDY OF VEGETATION ON REVETMENTS SACRAMENTO RIVER BANK PROTECTION PROJECT

## PHASE 1

### LITERATURE REVIEW AND PILOT STUDY

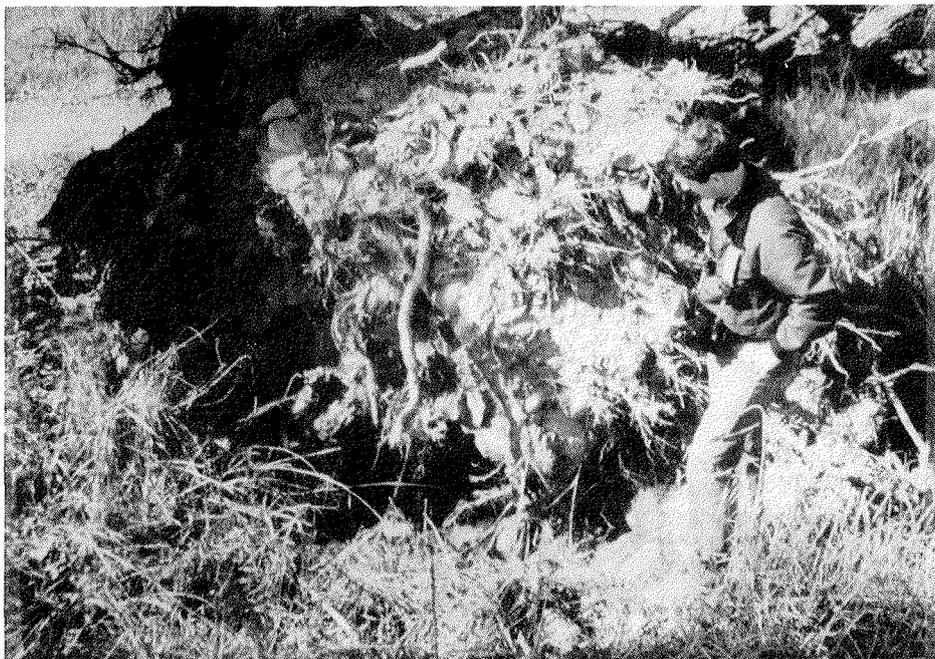
Figure 7. Large cottonwood uprooted from cobble revetment by wind, near Sacramento River, February 1989

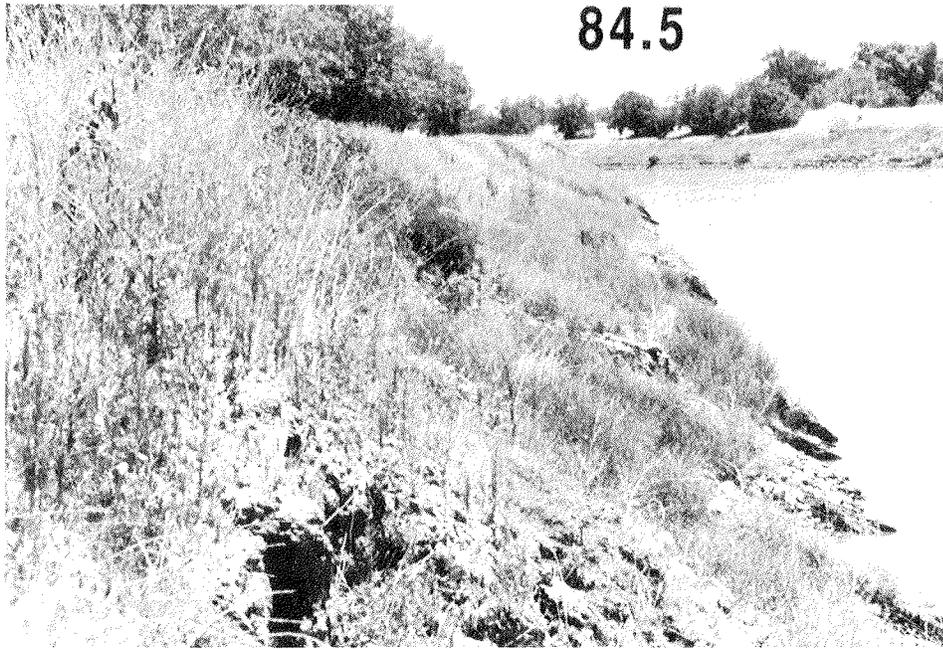
a. RM 84.6 to 85.4L

\* The file described the damage as being "along the entire length of the revetment" from 84.6 to 85.4L. Field inspections in April (Harvey, Watson, and Schumm 1989) and September 1989 found damage limited to 84.7 to 84.9L.

Figure 20. PL-99 damage sites, pilot study reach (Sheet 1 of 3)

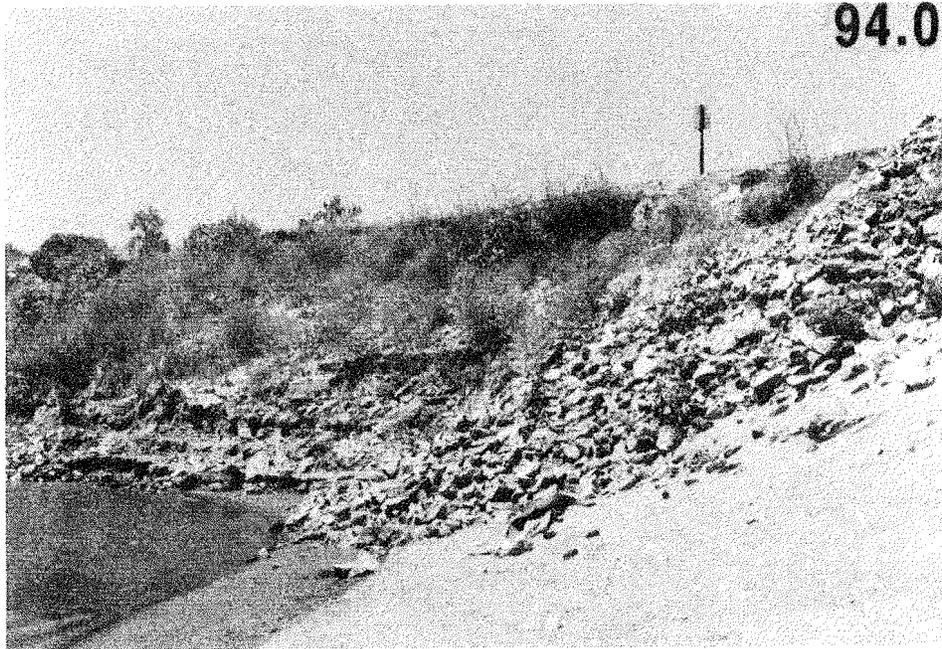
c. RM 94.0L

Figure 20. (Sheet 2 of 3)

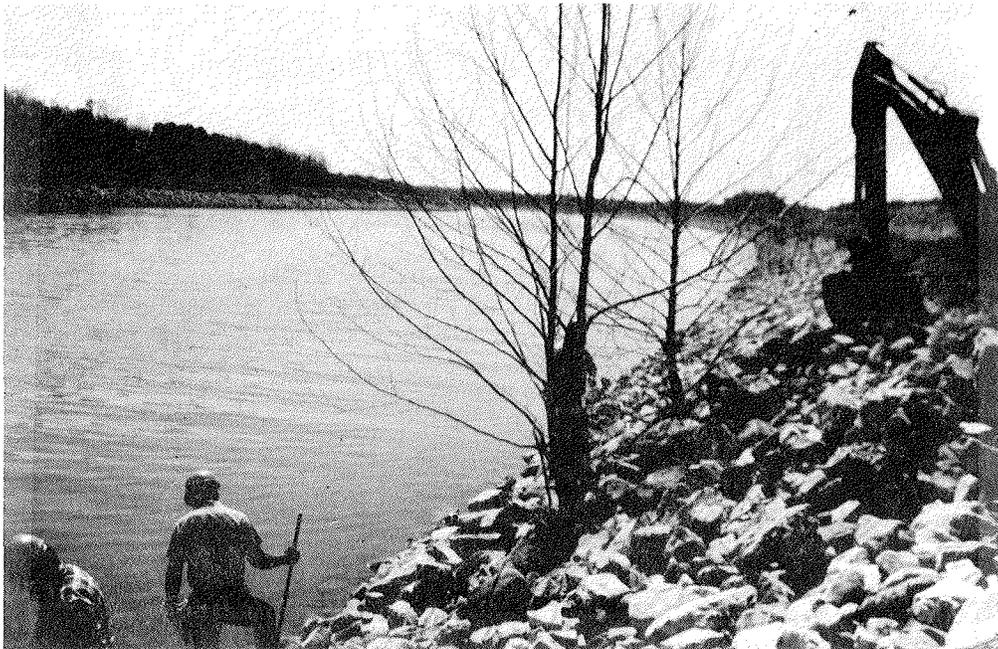
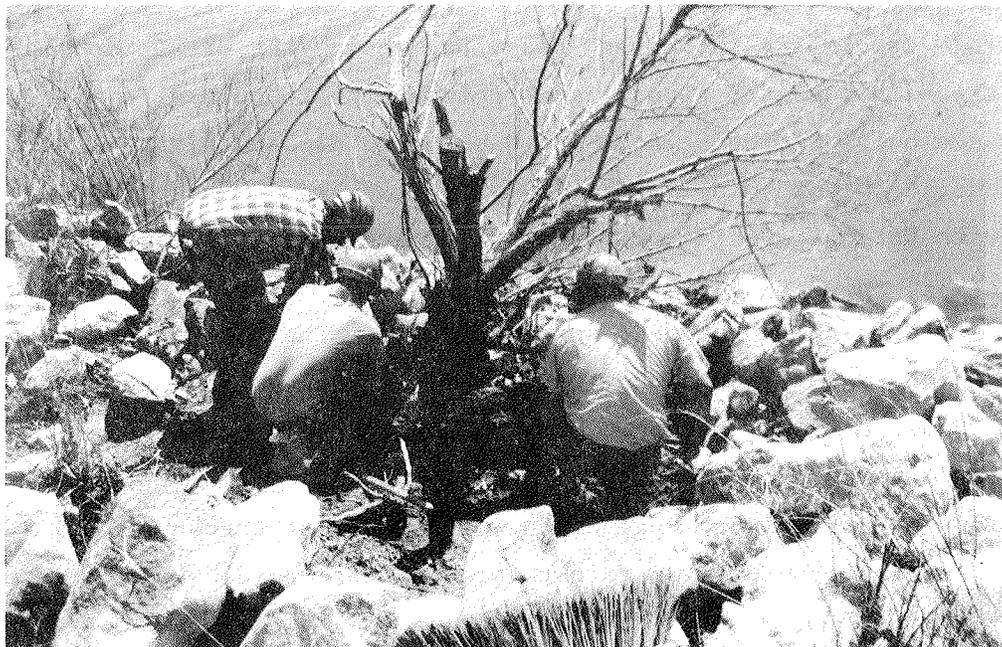
Figure 33. Tree growing in riprap slope protection, Divide Section, Tennessee-Tombigbee Waterway, Mississippi

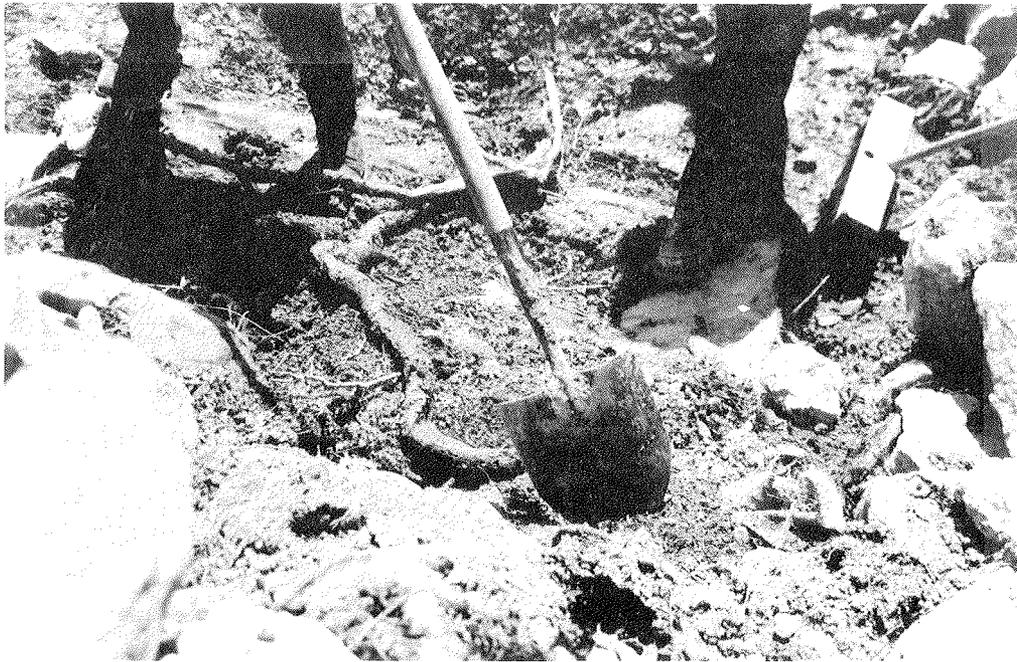
Figure 34. Excavation of riprap from around tree growing in slope protection, Divide Section, Tennessee-Tombigbee Waterway, Mississippi

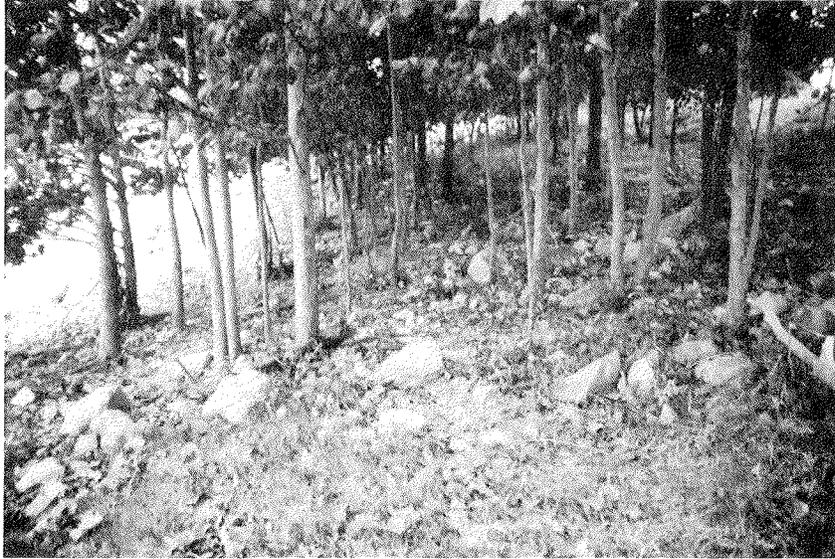
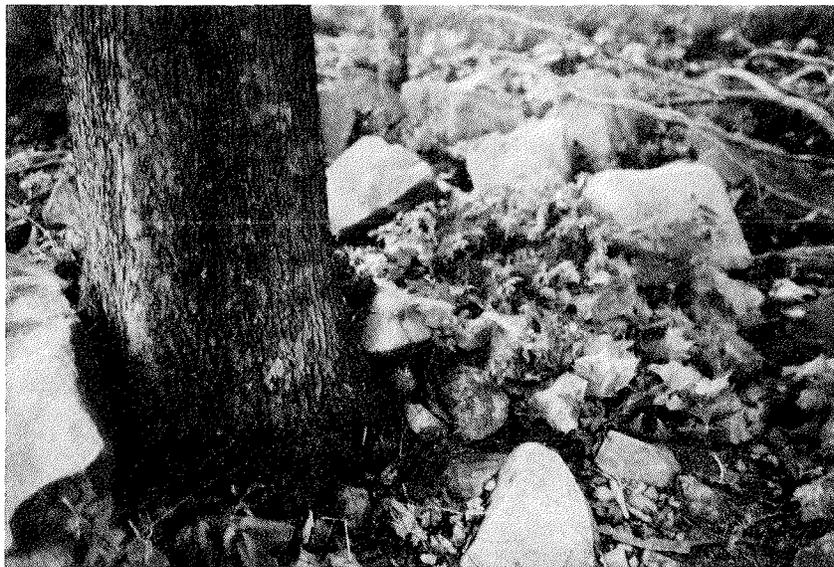
Figure 37. Large vegetation growing in riprap, Morameal  
Revetment, Red River, RM 256.1, October 1989
