Appendix 1 to Attachment 3

HEC-HMS Hydrologic Modeling Analysis of Memorial Park Detention Basin in Peak Flow Reduction

Lower Sorich Creek Culvert Assessment

**GEOTECHNICAL AND GEOLOGIC FEASIBILITY STUDY
LOMA ALTA, LEFTY GOMEZ FIELD, MEMORIAL PARK
AND RED HILL PARK DETENTION BASINS
WATERSHED FLOOD DAMAGE REDUCTION &
CREEK MANAGEMENT STUDY
MARIN COUNTY, CALIFORNIA**

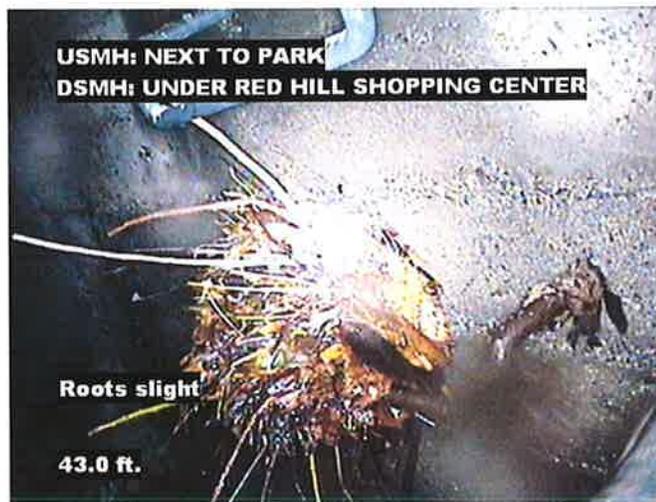
Distance: 43.0 ft. Grade: 1
 Condition: Roots slight
 Remarks: N/A

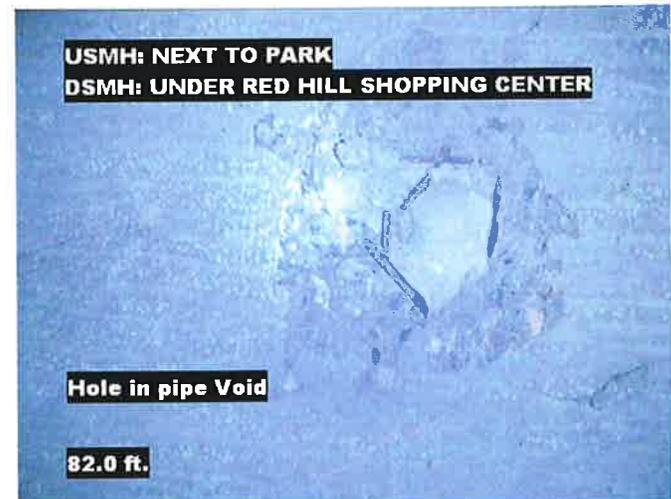
The inspection was done by video on December 17, 2012. Beginning at the manhole on Sunnyhills Drive, the video inspection covered 380 linear feet downstream, through the Redhill Shopping Center parking lot towards Sir Francis Drake Boulevard. The defects found, such as root impingement, a void, and infiltration dripping, were minor and serviceable.

Distance: 82.0 ft. Grade: 4
 Condition: Hole in pipe Void
 Remarks: N/A

4: Constructional damages with nonsufficient static safety, hydraulic or tightness: f.e. axial/radial pipebursts, pipe deformations, visually noticeable infiltration/exfiltration, cavities in pipe-wall, severe protruding, laterals severe root penetrations, severe corrosion of pipe wall etc. Should be fixed or replaced soon.

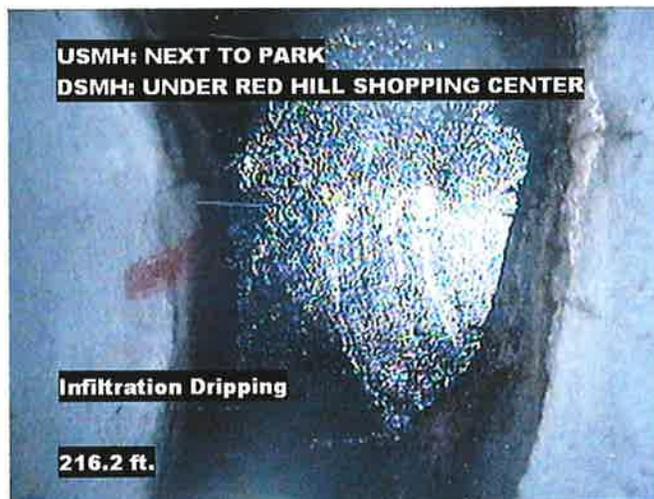
Distance: 216.2 ft. Grade: 2
 Condition: Infiltration Dripping
 Remarks: N/A

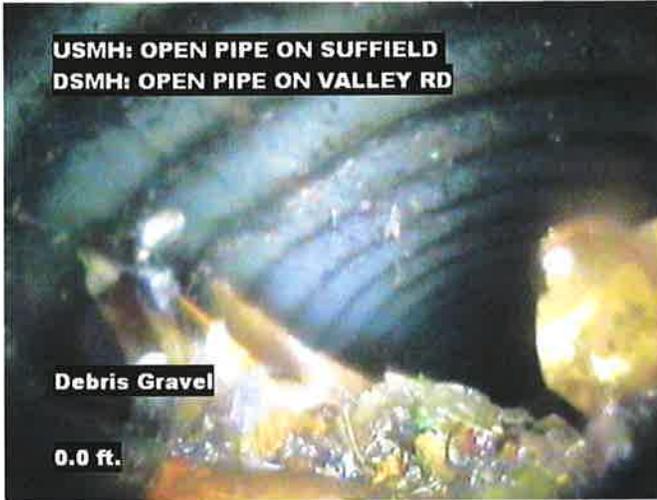
Distance: 0.0 ft. Grade: 2
 Condition: Debris Gravel
 Remarks: N/A

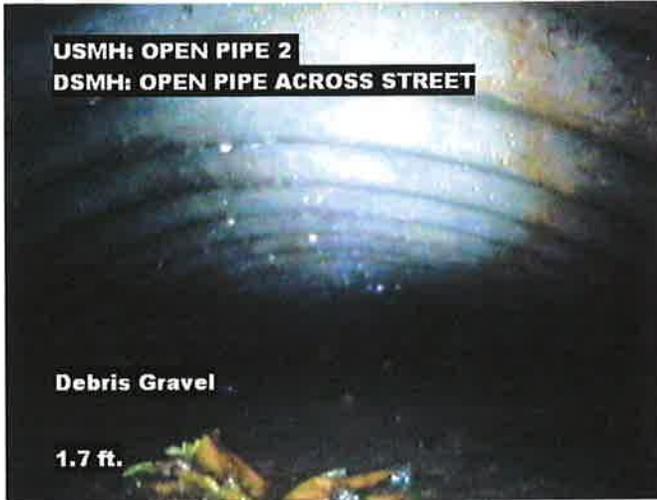
Distance: 1.7 ft. Grade: 2
 Condition: Debris Gravel
 Remarks: N/A

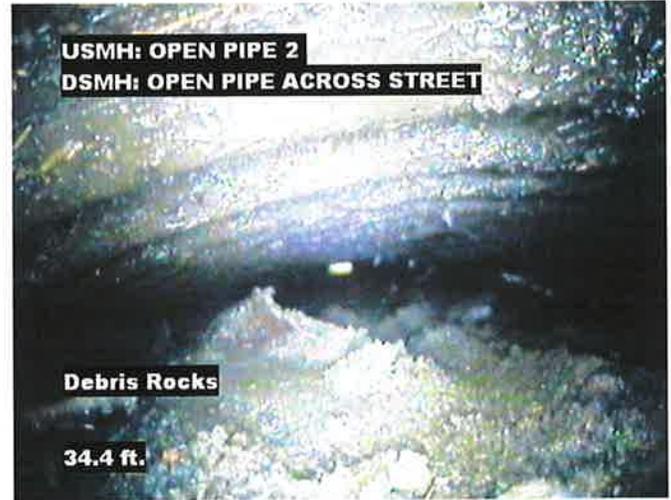
Distance: 34.4 ft. Grade: 2
 Condition: Debris Rocks
 Remarks: N/A
