## Appendix A Site Descriptions

## **Appendix A Site Descriptions**

### **Calaveras River Downstream of Confluence with the Stockton Diverting Canal**

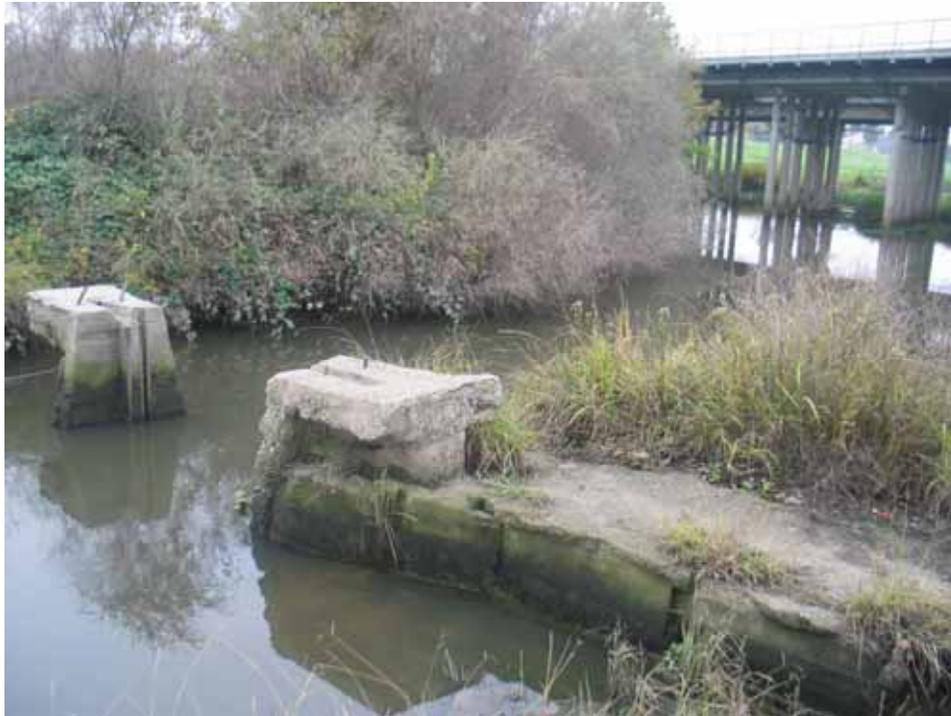
The concrete remnant structure upstream of Pacific Avenue Bridge, near river mile 3.9, appears to have been the foundation and abutments of a flashboard dam. The opening between abutments is 8 feet wide, and the bankfull width is 60 feet. The structure has been washed away near the left bank and is no longer in use. Because the structure is no longer in use, it should be removed.

**Photo A-13. Upstream face of concrete remnant structure**

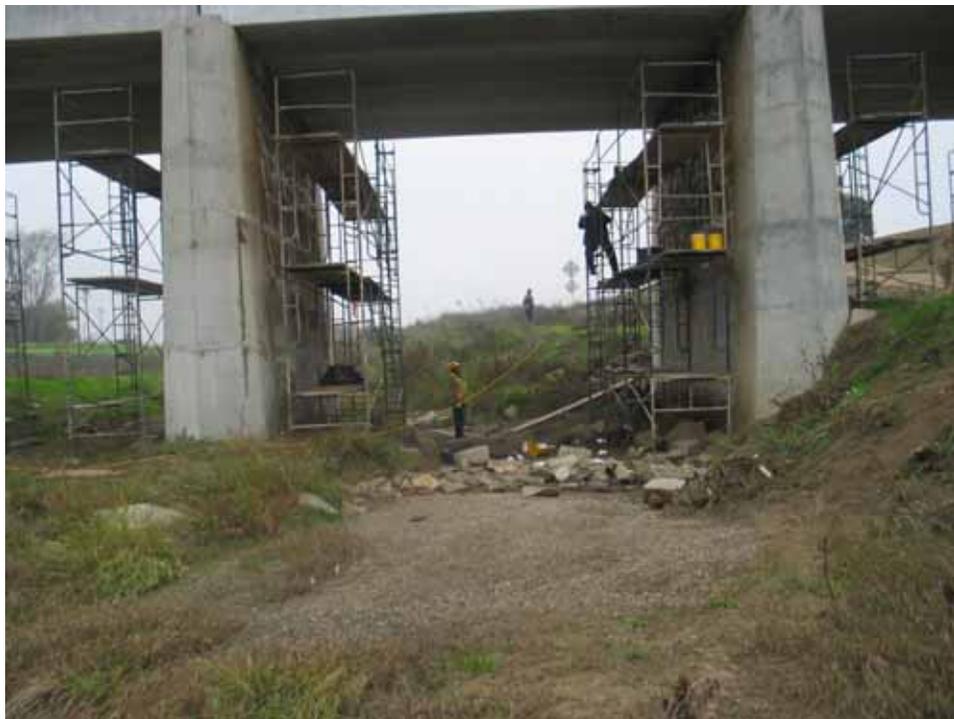
The Railroad Crossing No. 1 spans about 275 feet. The concrete crossing contains 9 piers that are 25 feet apart. The active channel encompasses 2 piers with a width of 60 feet. There is no apron under the bridge, but there is some scattered rubble under the bridge. There is a bike path on the south side of the channel. Structural repairs were made to the crossing in 2004 (Photo A-32).

**Photo A-32. Construction on Railroad Crossing No. 1 in late 2004**

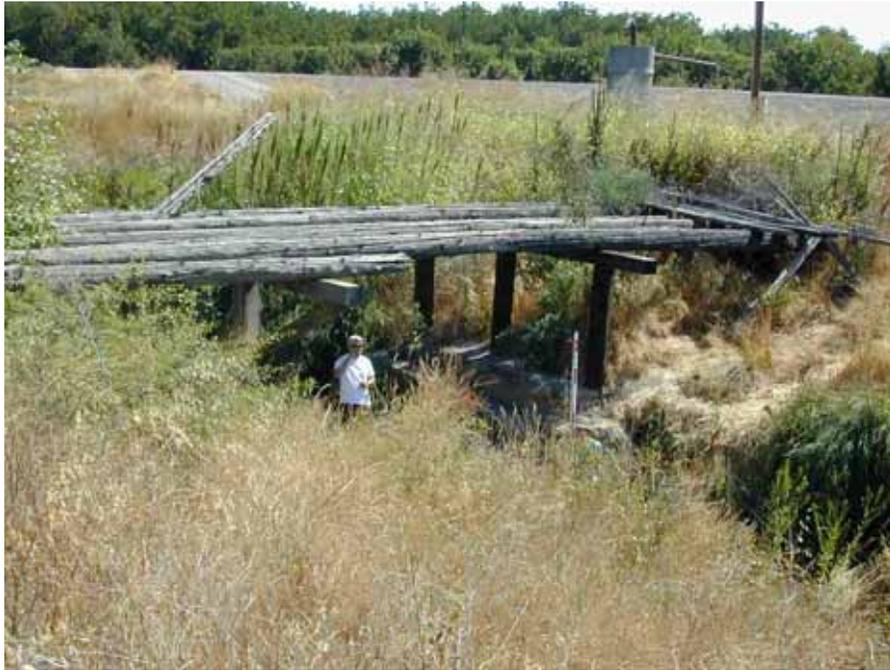
The Old Wooden Bridge is an abandoned wooden bridge on the Calaveras River channel downstream of the Calaveras Headworks near river mile 6. The structure is oriented perpendicular to the flow path and spans approximately 65 feet across the channel. Two sets of wooden support piers made of treated lumber are in the bankfull channel. Most of the small diameter, unfinished logs that rest on the piers spanning the channel remain in place. A few are broken partway or are completely missing. Only a few of the planks that make up the bridge deck still exist at the right bank side (Photo A-35).

**Photo A-35. View from downstream of Old Wooden Bridge**

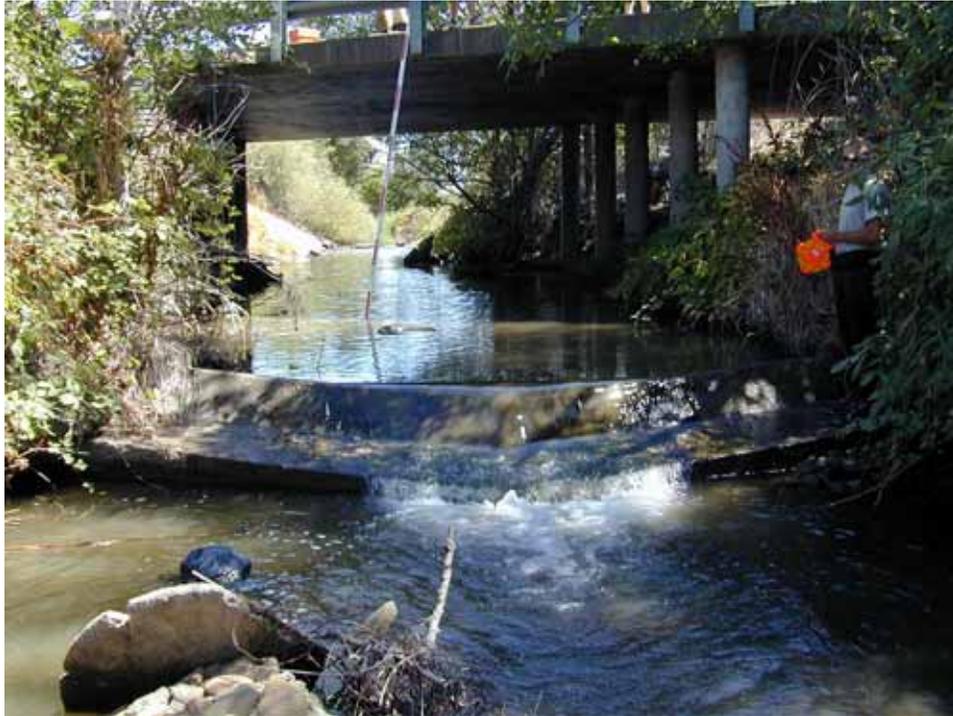
The structure is a potential barrier to upstream fish migration. Until flows are high enough to backwater or submerge the weir, fish leaping onto the flat portion of the weir do not have sufficient water depth to proceed and leap over the rounded crest. Water velocity over the smooth concrete may also cause a fish to fall back after leaping onto the lower weir. Because the weir and gage are no longer in use, the structure should be removed.

**Photo A-78. Looking upstream at the Old DWR Gage Weir**

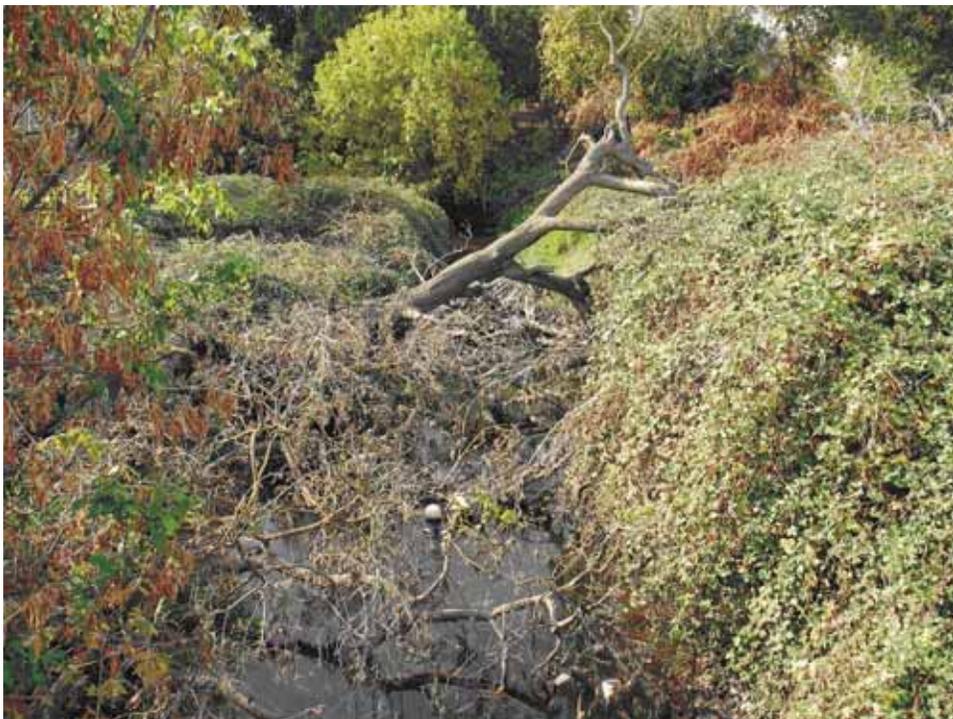
**Photo A-161. Looking downstream from DeMartini Lane Bridge at the logjam**

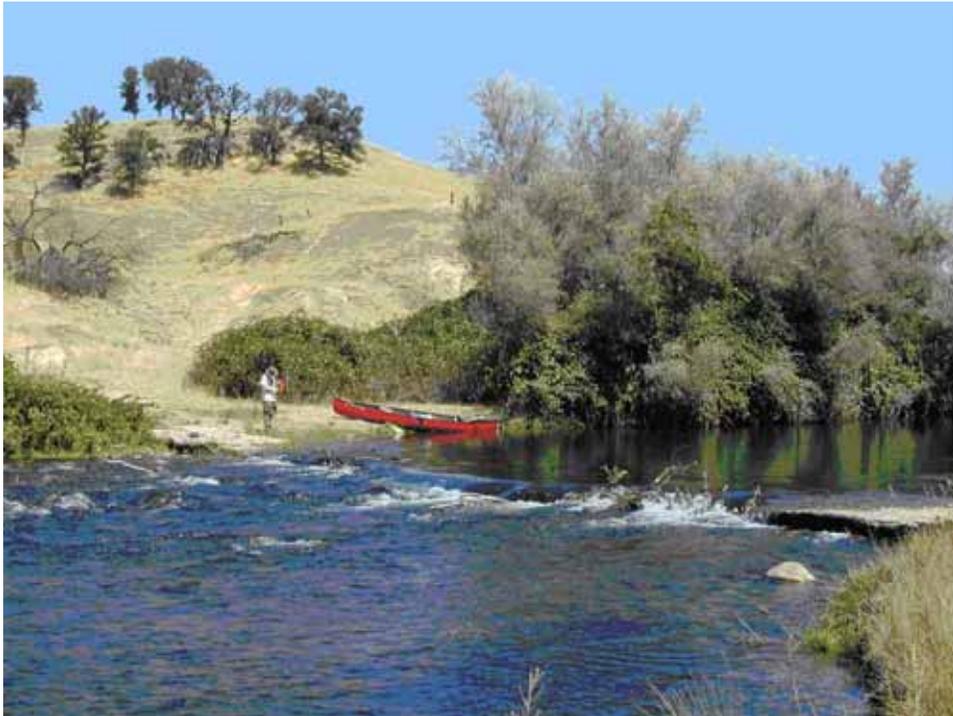
The Deteriorated Low-flow Road Crossing provides vehicular access across the Calaveras River (Photo A-210). The structure is in disrepair and is on the Calaveras River at river mile 34.9, upstream of the Calaveras Headworks. The road crossing has a drop on the downstream end that varies with the river flow. During low flows, this may hinder fish passage. Scattered rubble associated with the crossing is in the river channel.

**Photo A-210. Deteriorated Low-flow Road Crossing**

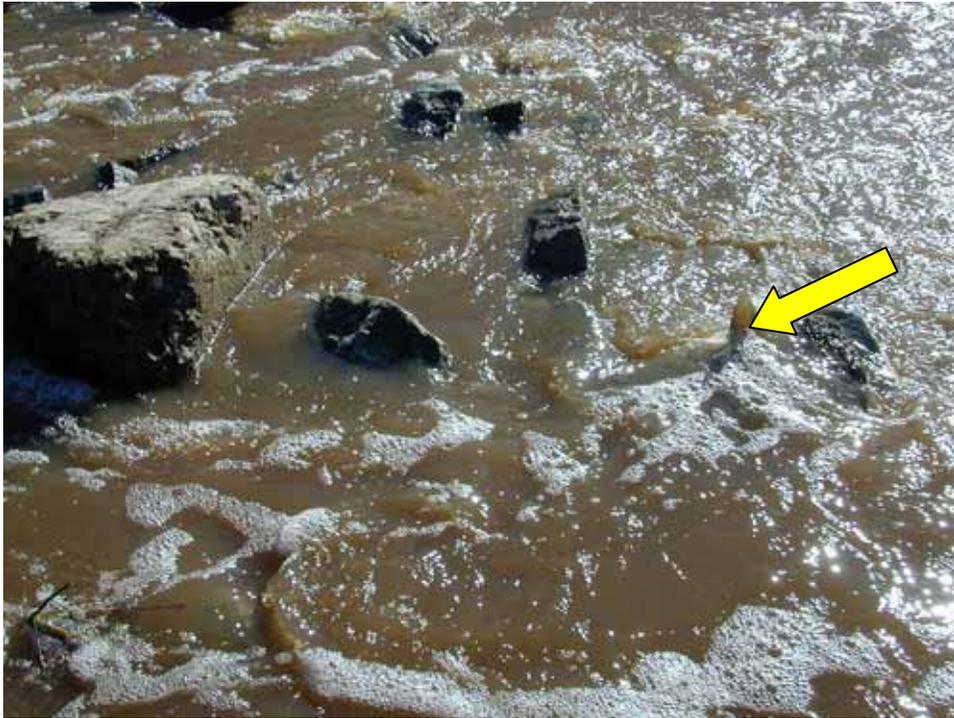
On December 4, 2001, representatives from DWR observed a live female adult Chinook salmon about 30 inches long in the downstream plunge pool (Photo A-269). The fish was observed for about 30 minutes making repeated, unsuccessful attempts to ascend the rock cascade. The primary hindrance appeared to be the lack of a clear migration route over the haphazard placement of rock compounded by the lack of incremental jump pools. Preliminary field measurements at the time showed water depths of about 3 inches with a velocity of 5 feet per second across the outlet apron corresponding to a flow reading of about 15 cfs at the Mormon Slough at Bellota Gage. The actual flow at Caprini LFC was probably higher because of ungaged inflows from storm runoff to Mormon Slough between the gage and the site, particularly from Potter Creek. A dead adult salmon was found at Caprini LFC (Photo A-270).

**Photo A-269. Chinook salmon attempting upstream migration past Caprini LFC**

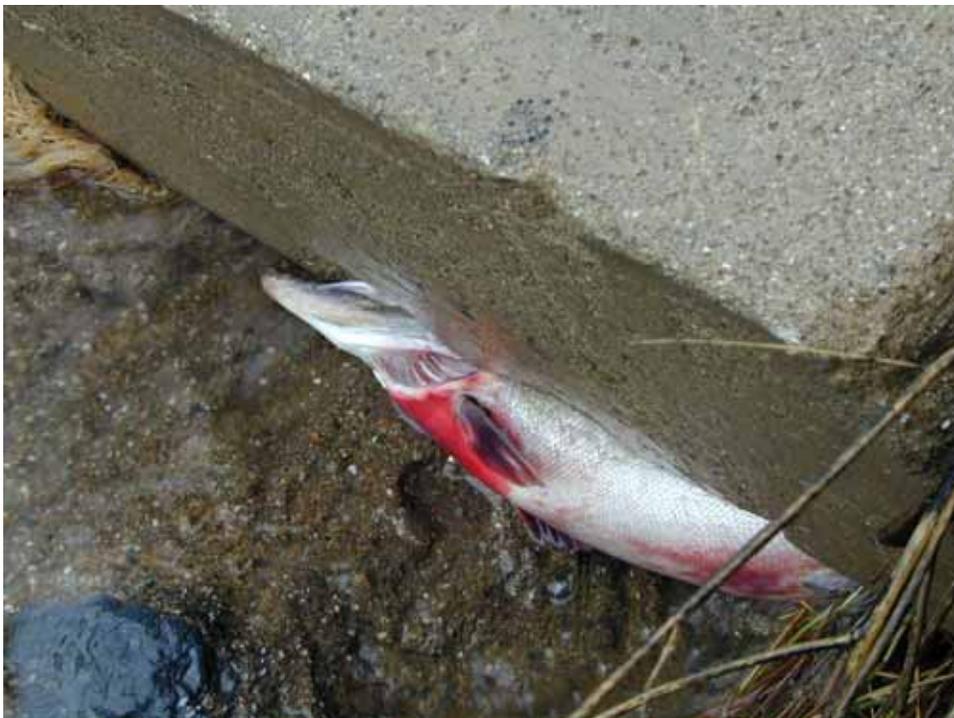
On December 19, 2002, representatives from DWR found a relatively fresh carcass of an adult male salmon at the site (Photo A-270). The carcass was on the right side of the outlet apron wedged under a large boulder. Flows were probably high enough for the fish to ascend the rock cascade and get onto the outlet apron but unable to pass through the culverts.

**Photo A-270. Dead adult salmon at Caprini LFC**

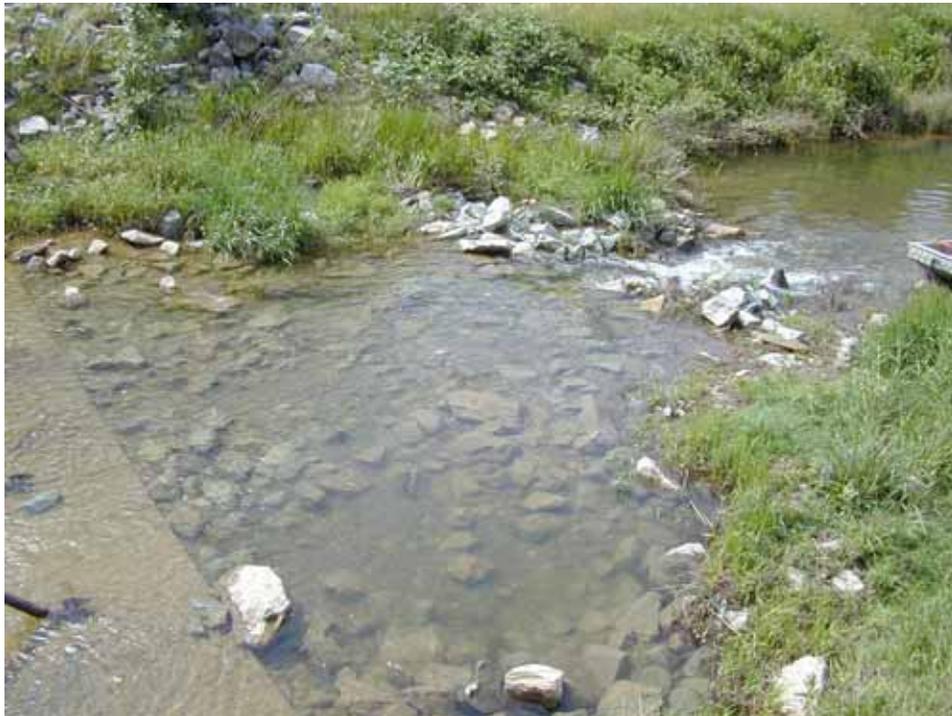
**Photo A-275. Lavaggi Dam with boards shows shallow flow over loose riprap ending in a riprap cascade**

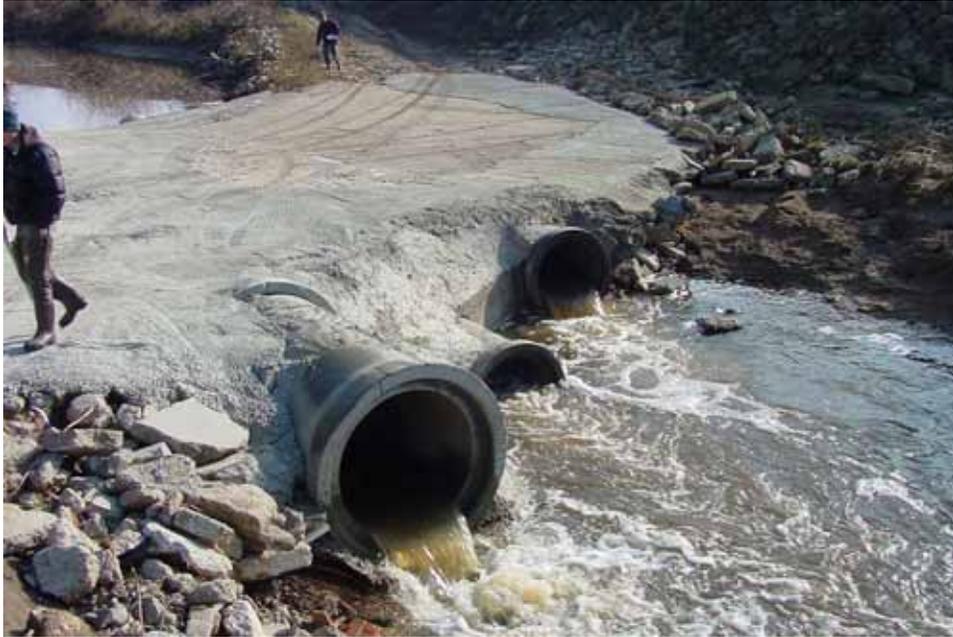
**Photo A-284. Typical culvert outlet condition at Hogan Low-flow Road Crossing during adult migration season**

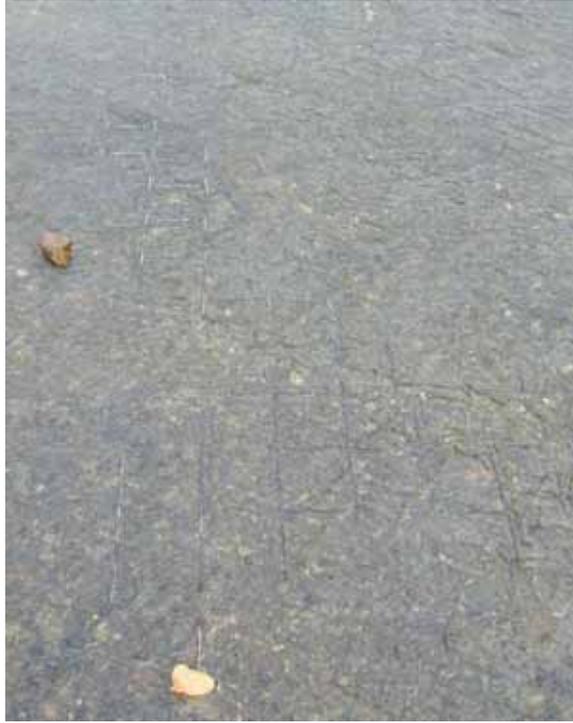
**Photo A-321. Road deterioration and exposed wire mesh of Hosie Low-flow Road Crossing road surface**

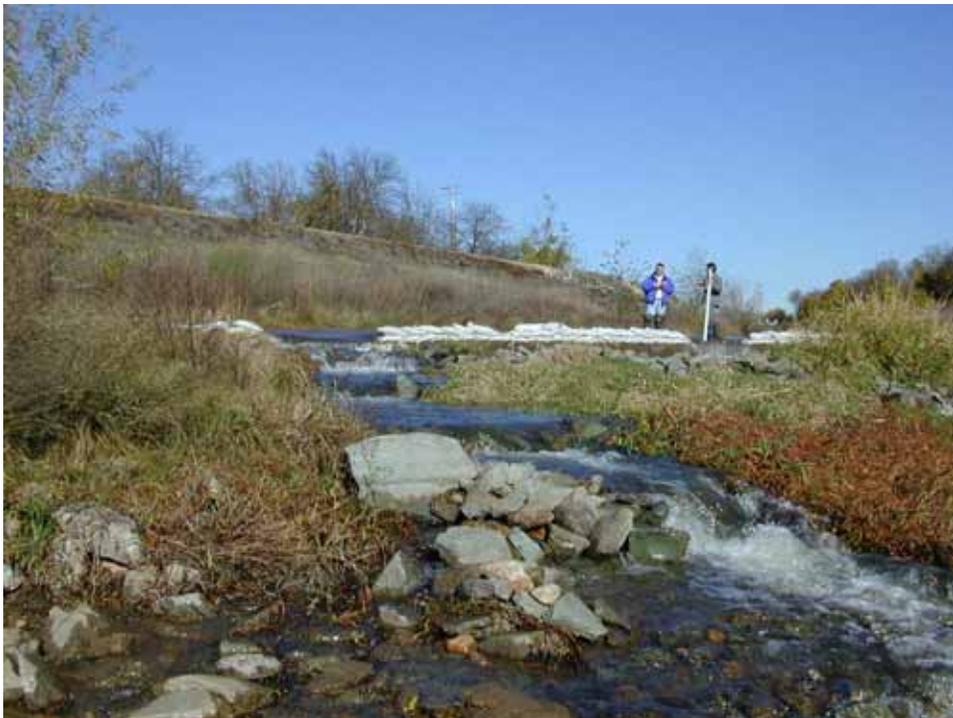
**Photo A-326. Temporary site retrofit at Hosie Low-flow Road Crossing (2001)**

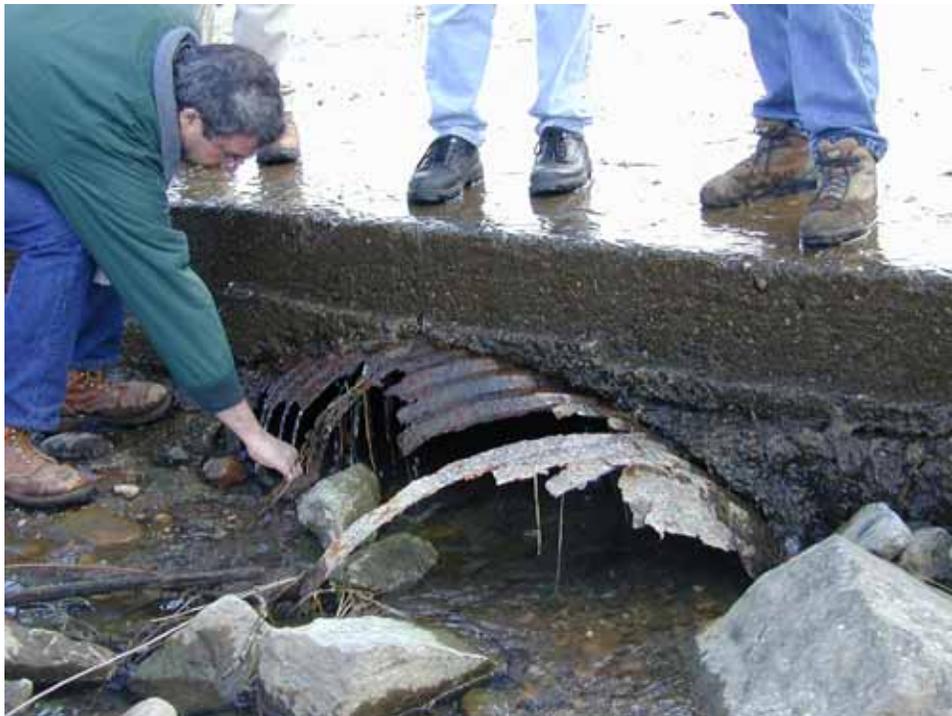
**Photo A-350. Deteriorated, abandoned culvert at Watkins LFC**
