Humboldt Bay Watershed Management Area

206 - Humboldt Bay Municipal Water District, Ranney Collectors 1 & 1A Lateral Replacement

Humboldt Bay Municipal Water District
Prop 84 Application

Collector Wells Inspection Report Recommendations for Collectors 1 & 1A

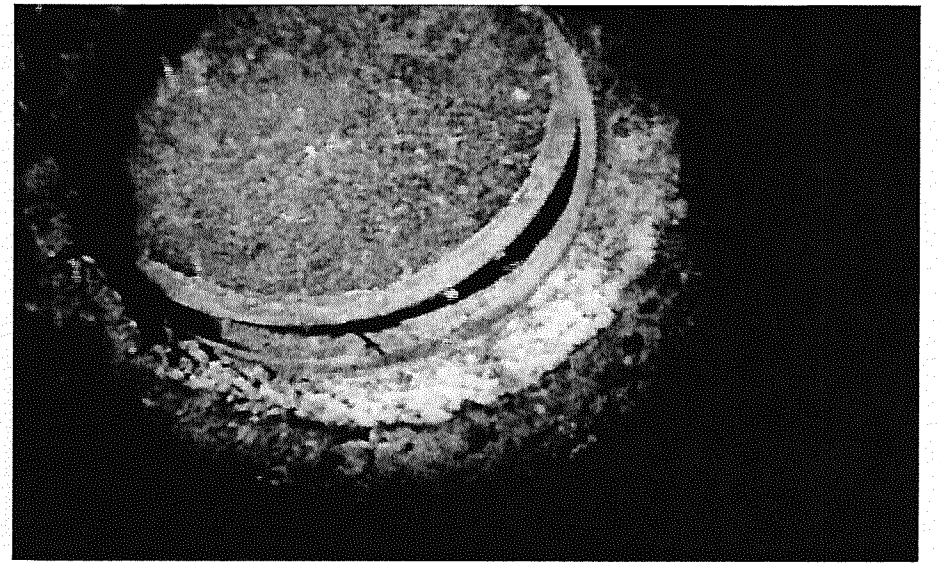
Collector Well 1, Lateral A6 Valve opening

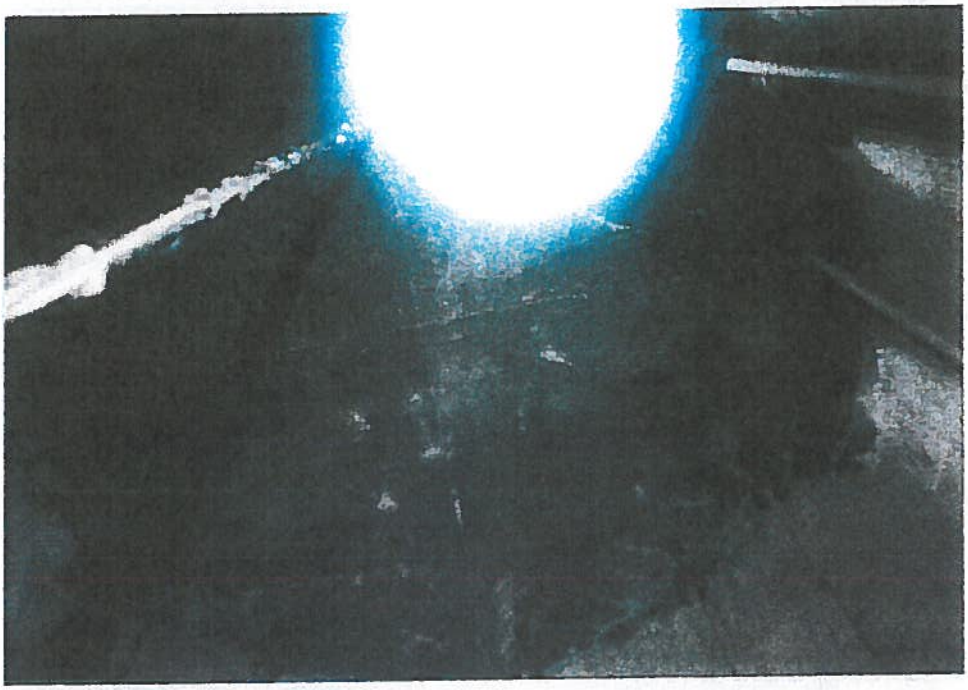
PHOTOGRAPH #8: ROOF STRUCTURE, VALVE LINES

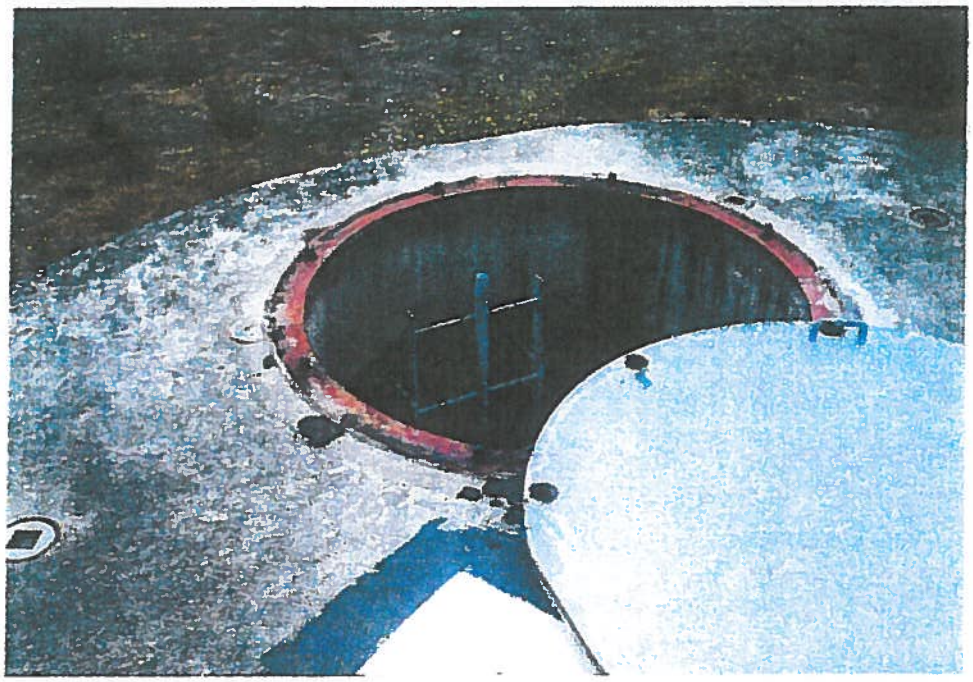
PHOTOGRAPH #10: ACCESS HATCH, INTERIOR LADDER

2.1 **ACCESS HATCH:** The 60" diameter Access Hatch with galvanized steel curb and cover is structurally sound and in good condition. Small amounts of corrosion were observed on the bolts, washers, and nuts. [Photographs #10, 11]

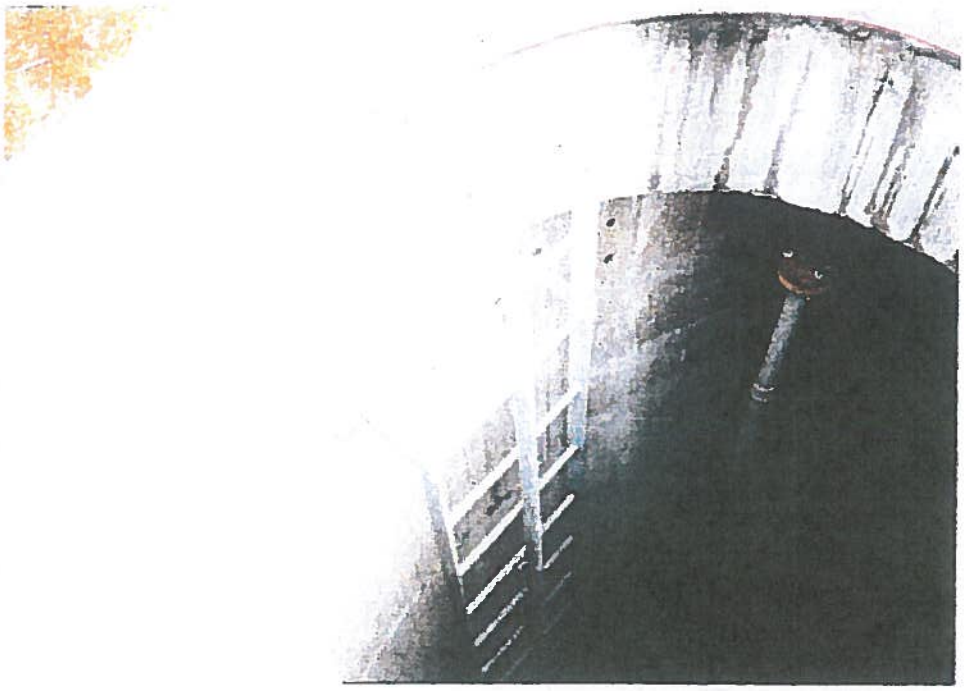
PHOTOGRAPH #11: ACCESS HATCH, INTERIOR LADDER

2.2 **INTERIOR LADDER**: the galvanized steel Interior Ladder is structurally sound and in good condition. It is equipped with a safety climb device. The upper 20% of the ladder was above the normal water line and had a few patches of corrosion, below the water line the ladder was heavily encrusted with corrosion products. The degree of corrosion could not be determined from this visual inspection.
[Photographs #11 through 18]

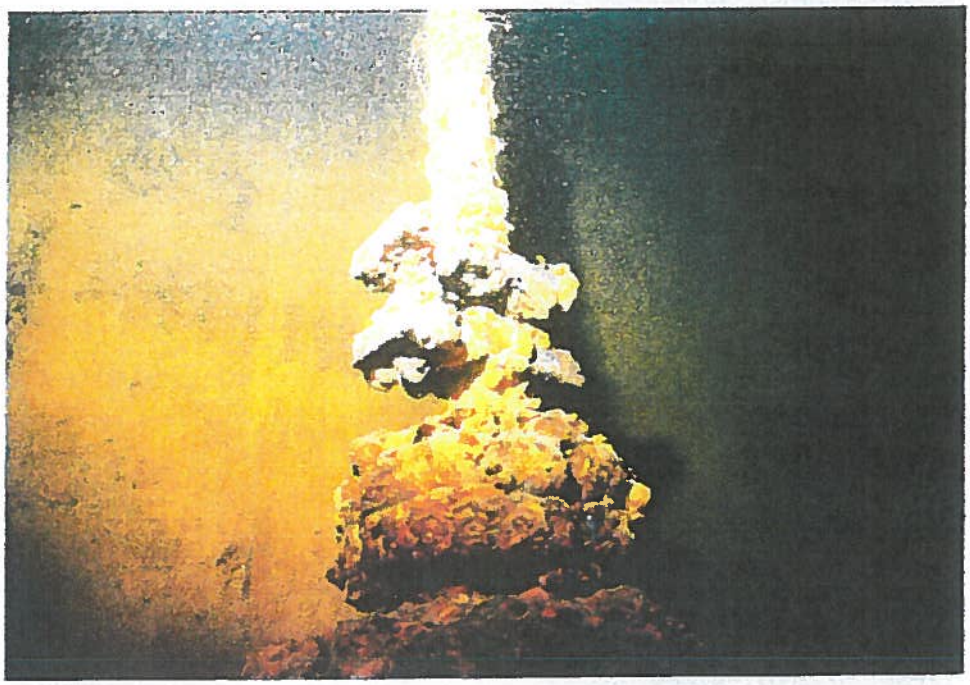
PHOTOGRAPH #19: LATERAL COLLECTOR A - TOP OF VALVE

3.1 **COLLECTOR LATERALS:** The main collector is fitted with 12 collector laterals (identified clockwise from the interior ladder as "A" through "L"). Each lateral is fitted with a gate valve that is operated from the top via valve extension lines attached to the side of the main collector. The valves appeared functional at the time of inspection. The ends of the collectors, the valves, and the metal hydraulic lines were all encrusted with corrosion products and nodules.
[Photographs #4, 19 through 40]

4.2 **METAL COMPONENTS:** The metal components below the water line that have not been recoated are heavily encrusted with corrosion products. The degree of corrosion could not be determined from this visual inspection but it is obvious that there is some metal loss occurring. At this point the structural integrity is not compromised and these features should be monitored if not scheduled to be recoated.

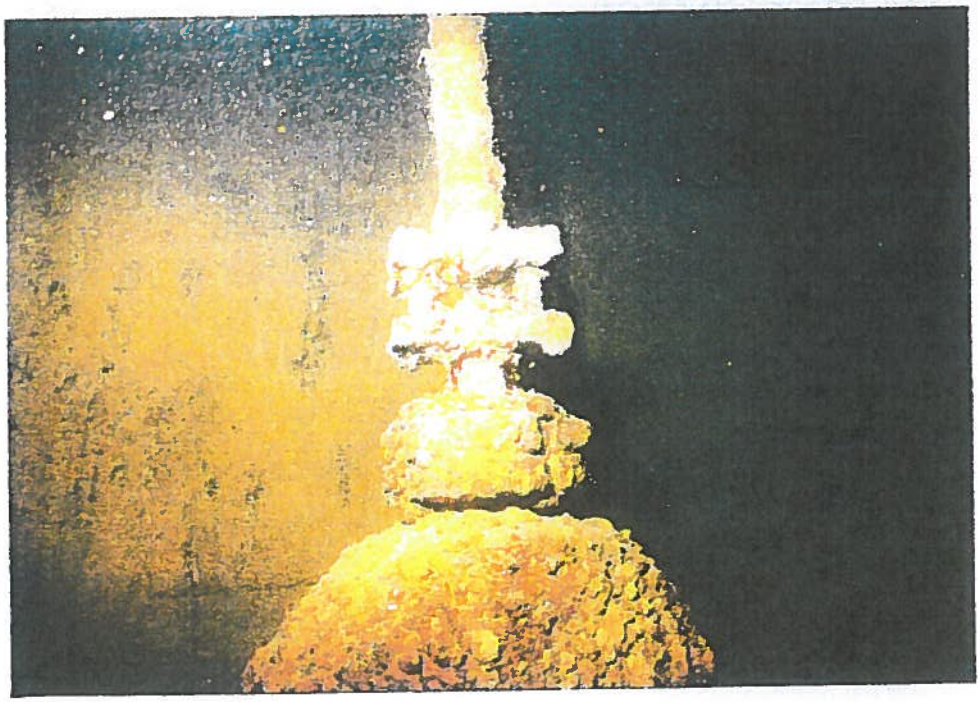
PHOTOGRAPH #40: TOP OF VALVE - TYPICAL CONDITION

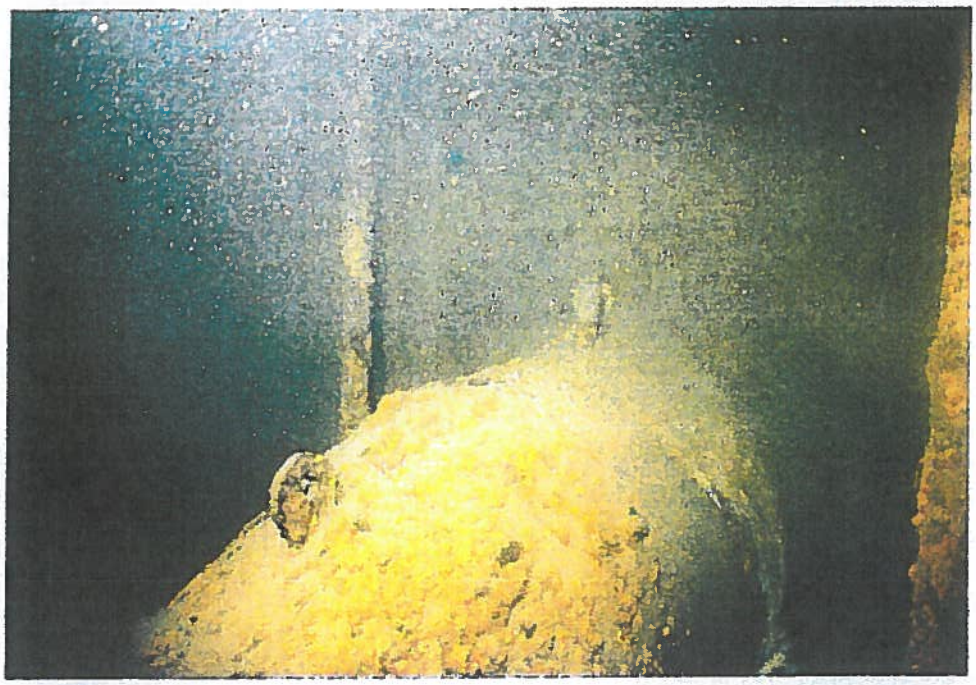
PHOTOGRAPH #43: TOP OF SIPHON PIPE

3.2 **SIPHON:** A 36" diameter siphon pipe sends water to Pump Station #1. It exits through the side wall and elbows down to a flared bell. The coating on the exterior of the pipe and the end of the bell has failed and there are numerous 1" to 2" individual rust nodules on the pipe and bell. As far as it could be observed, the coating on the interior of the pipe is in good condition with a few small (1/4" diameter) corrosion cells observed at holidays and other coating imperfections. [Photographs #41 through 46]
