TECHNICAL REPORT HL-90-19

# A STUDY OF VEGETATION ON REVETMENTS SACRAMENTO RIVER BANK PROTECTION PROJECT

## PHASE 1

### LITERATURE REVIEW AND PILOT STUDY

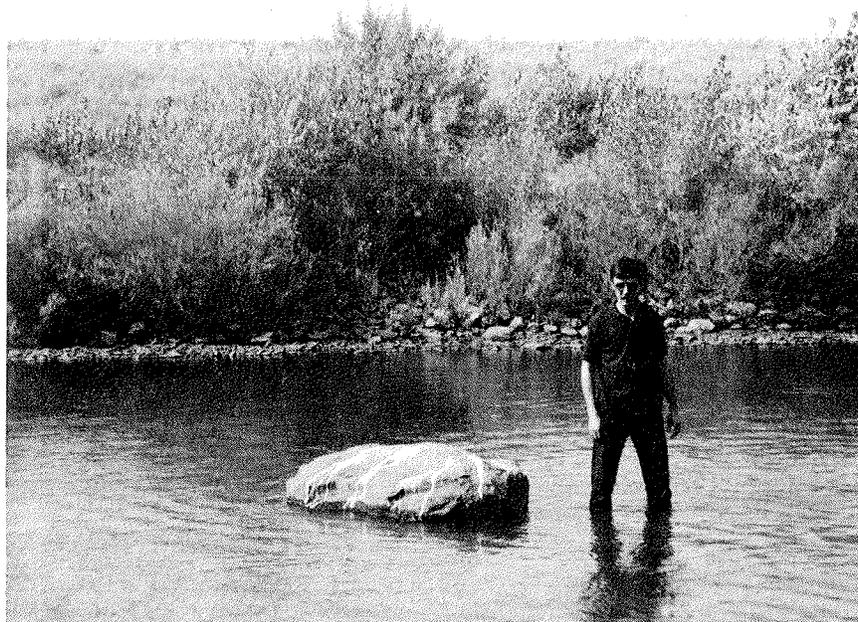
bank protection materials or underlying soils (Figure 6). If vegetation is not removed by maintenance activities, a community of large trees may eventually develop, and biological effects of revetment construction will be reduced. Bank line habitat value for birds and other small wildlife species can be substantially improved by allowing vegetation to establish and remain on riprap. Dennis, Ellis, and Arnold (1981) pointed out the habitat value of brushy riprap in the Sacramento delta relative to unvegetated riprap. Brushy plant communities (blackberries, shrubby alders, stinging nettles, willows, wild radish, and smartweed) developed on riprapped banks not disturbed by maintenance for several years. Forbes et al. (1976) observed 2.6 times as many birds and 1.4 times as many bird species on revegetated revetments along the Willamette River as on recently cleared revetments. Jones and Stokes Associates, Inc. (1987) reported that adverse impacts of SRBPP revetment construction on juvenile salmon habitat could be partially addressed by planting woody vegetation in revetments.

Figure 6. Volunteer vegetation in riprap revetment, South Platte River below Chatfield Reservoir, near Denver, CO, September 1989

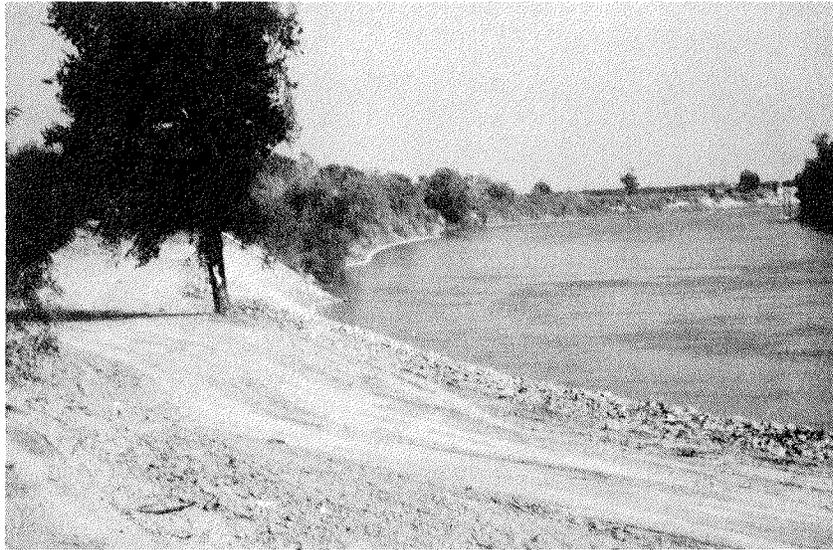
a. Looking upstream from Sacramento River, RM 72.5R, August 1987. Recently constructed revetment in foreground, overgrown revetment in background

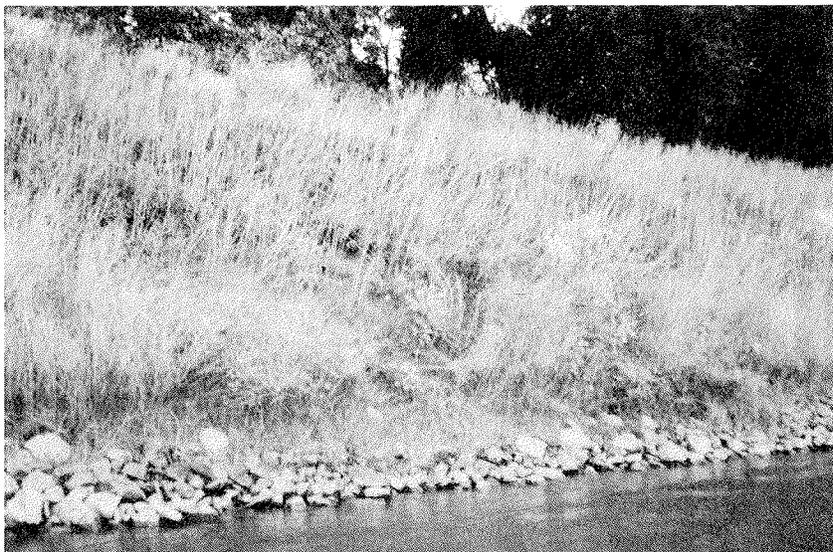
b. Sacramento River, RM 91.2R, September 1989. Rock riprap revetment overgrown by grasses and forbs (referred to as Type 1 vegetation in Part IV of text)

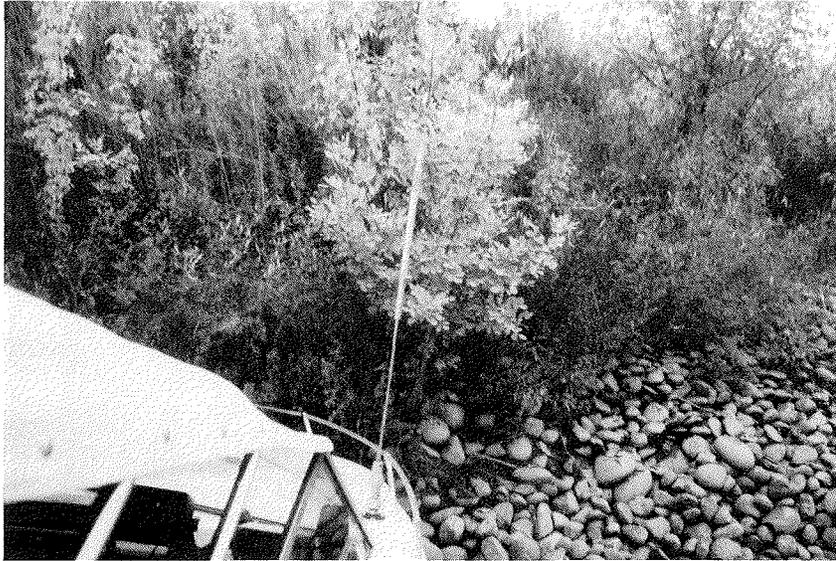
c. Cobble revetment, Sacramento River, RM 104.6R,  
September 1989. Type 2 vegetation (see Part IV)

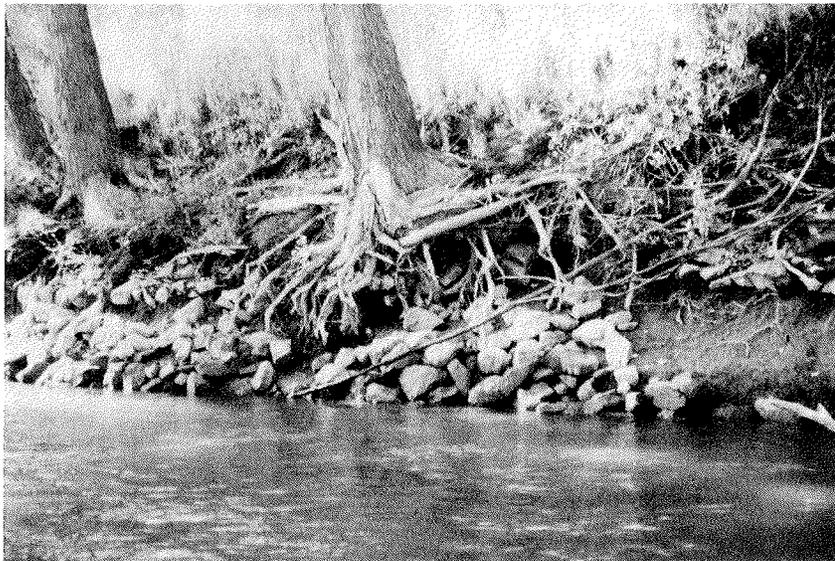
d. Riprap revetment, Sacramento River, RM 141.5R,  
September 1989. Type 3 vegetation (see Part IV)

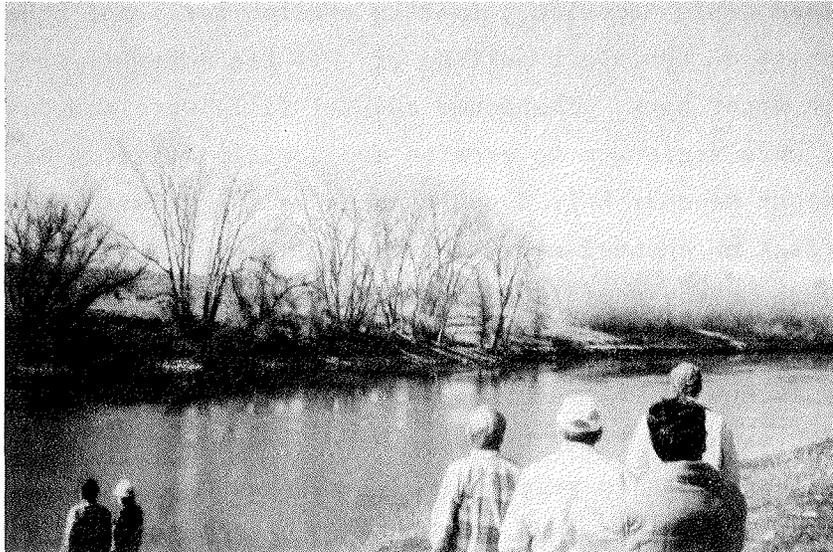
Longitudinal berms of silt and clay sediments occurred on many of the revetted banks in the pilot reach, as shown in Figures 14 and 15. These wedge-shaped (in cross section) deposits were also found on unprotected banks and were extensive enough to represent a significant sediment storage location. The deposits generally had well-defined upper and lower boundaries, the elevations of which may be related to stages with specific durations. Harvey, Watson, and Schumm (1989) stated that specific gage, area, and velocity analyses suggested that these sediment deposits were gradually reducing low-flow channel conveyance. A similar effect on high-flow conveyance was not observed.

Figure 14. Longitudinal sediment berm on revetment, Sacramento River, February 1989. Trees on opposite bank are growing on a sediment deposit on a revetment

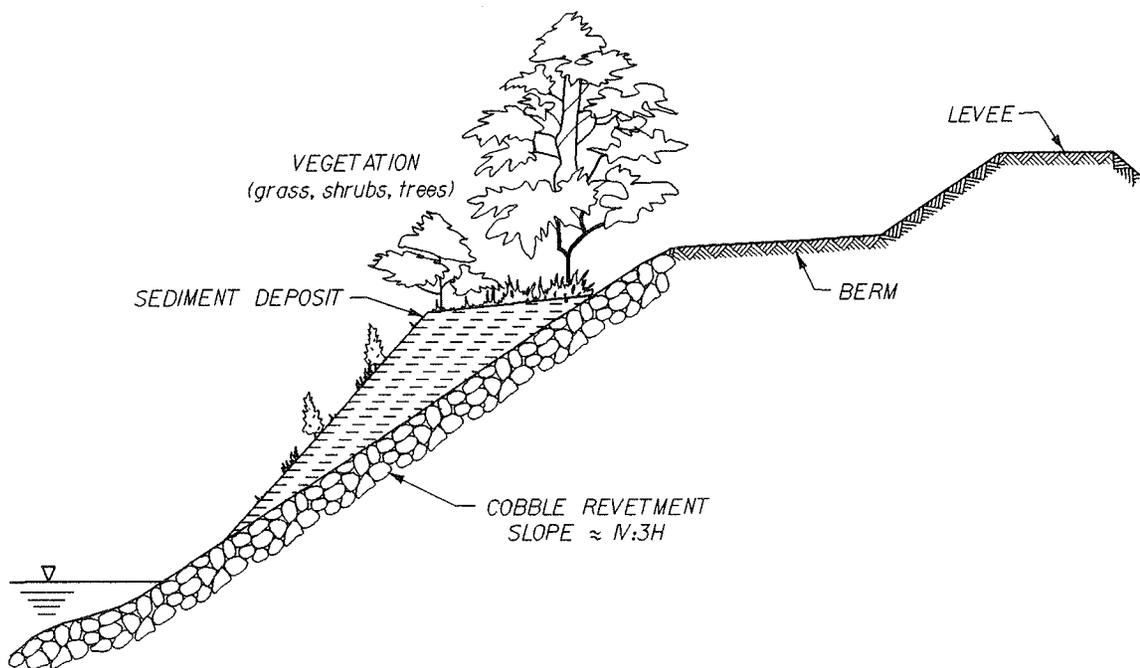
Figure 15. Cross section through a typical vegetated sediment deposit on a cobble revetment

Most of the cobble revetments were covered with wedge-shaped sediment deposits as shown in Figure 15. The faces of the wedges extended from near

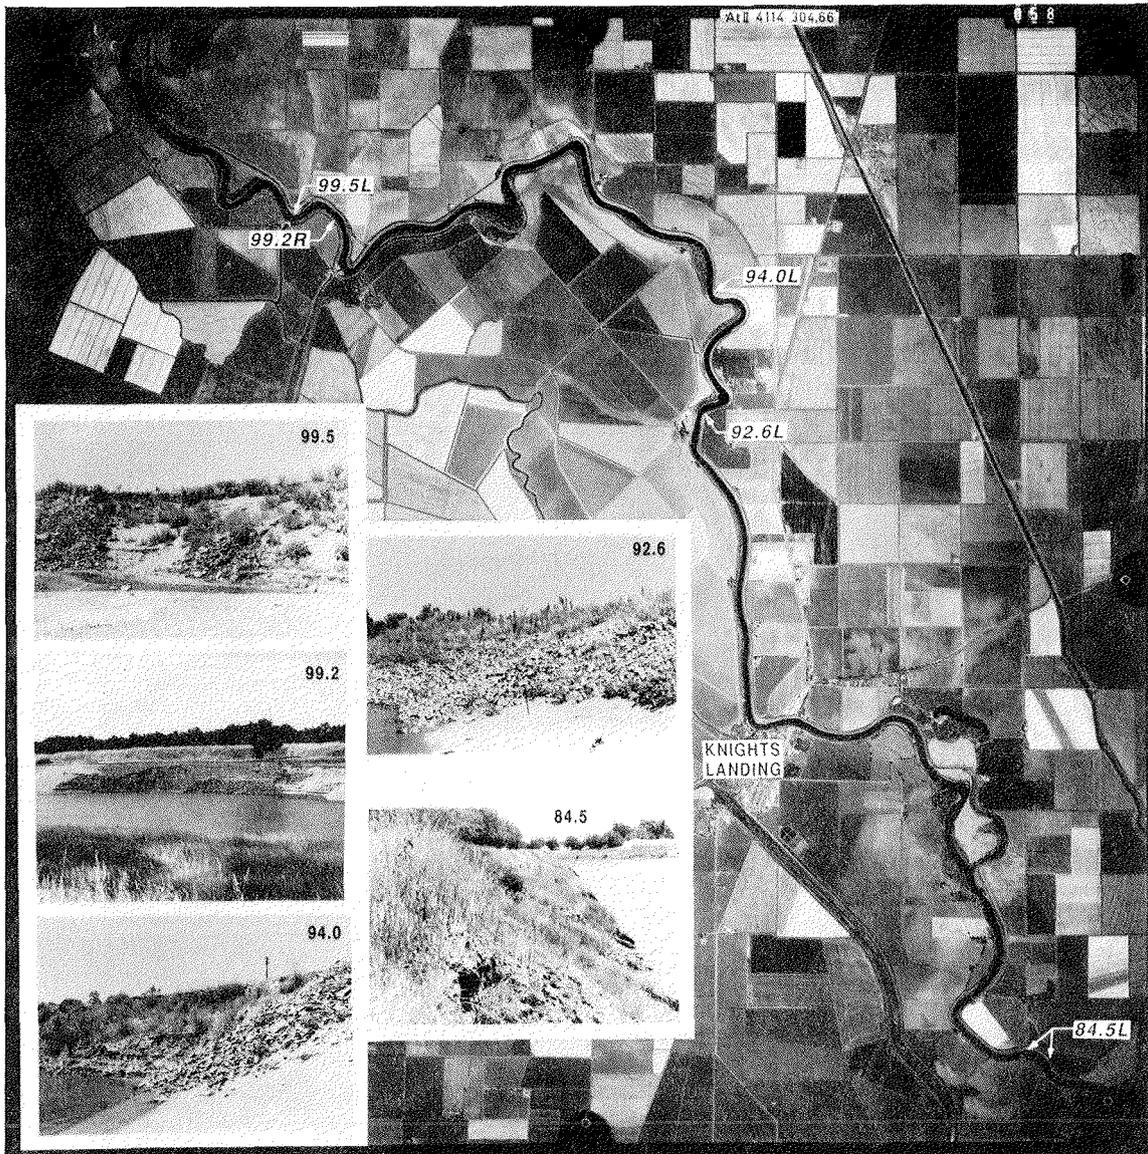
The five PL-99 1986 flood damage sites in the pilot study reach were inspected. The relative locations of these sites are shown in Figure 19. Photographs of each site from 1986 are shown as Figures 20a-e. Construction data and information from the PL-99 files are given in Tables 4 and 6. Of the five sites in the pilot study reach, only 94.0L was repaired after the 1986 flood. None of the sites supported large vegetation.

Figure 19. Location of 1986 flood PL-99 damage sites, pilot study reach, Sacramento River

requests, the observed damage tended to be short segments of toe damage grouped closely together. However, these groups of damaged areas tended to be isolated from each other. A cohesive toe was present at most of the damage sites. None of the toe damage that was observed appeared to be an immediate threat to the overall integrity of the revetment, the upper bank, or the levee. Almost all of the damaged sites not described in the PL-99 requests occurred on older, cobble revetments.

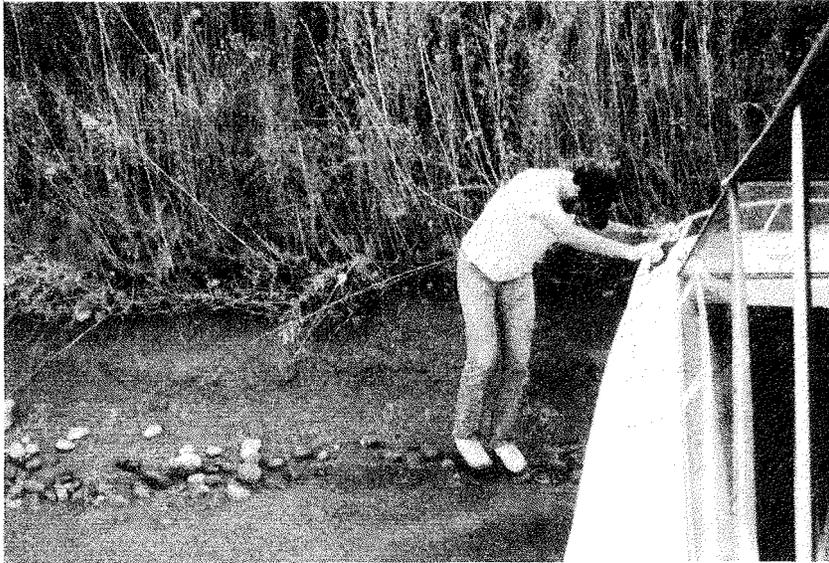
a. RM 108.2R

Nearly all of the cobble revetment damage appeared to be related to toe failure. These sites were characterized by an unprotected vertical channel bank surface that rose from the water, as shown in Figure 21a. The toe material at these locations was cohesive. Cobble was generally present at the top of the vertical surface, as shown in Figure 20b, and was generally found on the channel bottom adjacent to the vertical surface. (This was verified by probing with a boathook.) No upper bank problems were present at most of the sites. Usually the sediment berm above these failures was either undisturbed or had a failure plane at the location of the vertical clay face. The length and height of the damaged areas varied widely, but they were generally less than 50 ft long and 4 ft high. Other toe failures occurred as underlying bank material was removed and rock was launched along irregular failure surfaces.

Figure 21. Typical cobble revetment damage observed in pilot study reach

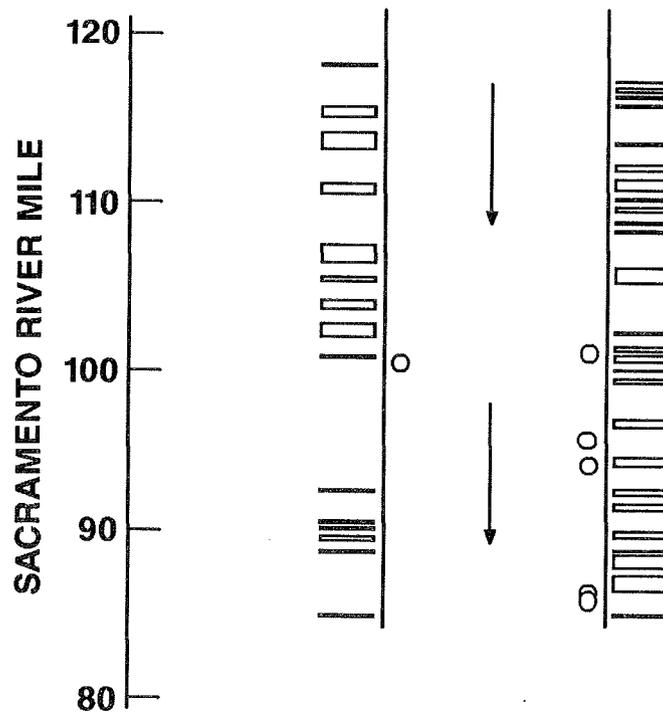
Not counting 84.6 to 85.4L, 92 percent of the damaged segments were riprap revetments located on convex banks. Aside from 84.6 to 85.4L, 96 percent of the damaged segments were constructed subsequent to 1970. All of the damaged sites were located below mile 100, and 50 of the 54 damaged segments were on the left bank (Figure 25).

Figure 25. Schematic of pilot study reach, Sacramento River, showing PL-99 damage sites and preflood revetment vegetation from aerial photographs

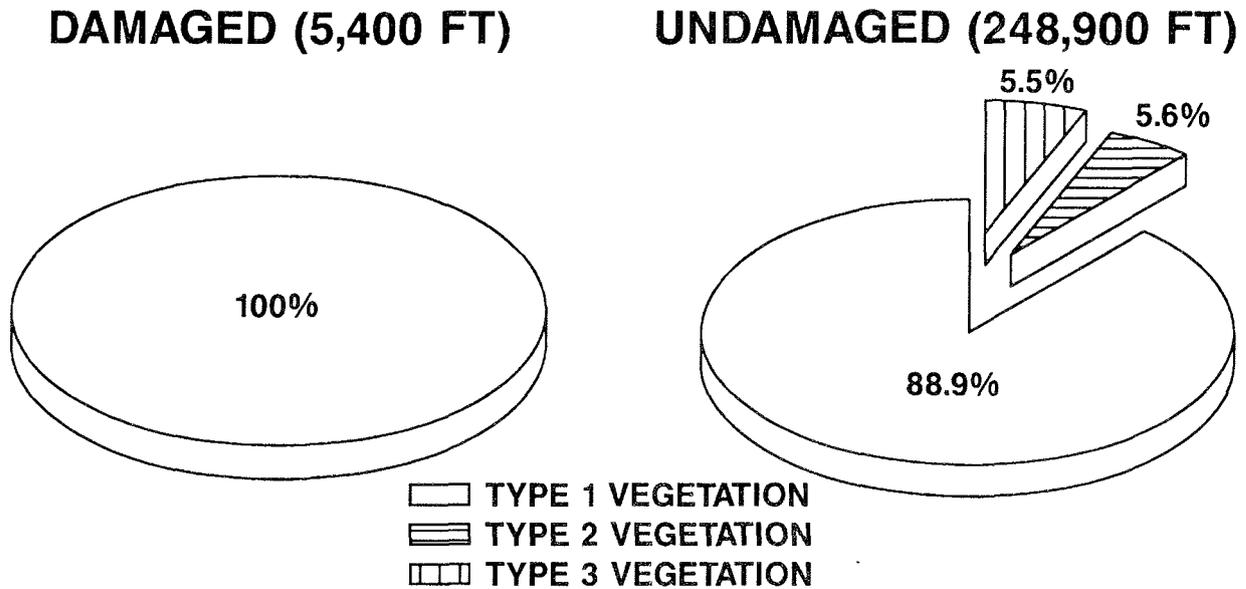
Vegetation types for undamaged and damaged revetments are compared in Figure 26. None of the four sources of information about revetment vegetation indicated any woody vegetation on any of the damaged segments before or after the 1986 flood. Accordingly, damage rates for unvegetated sites were higher than for vegetated ones. Damage rates for various revetment categories are presented in Table 15.

Figure 26. Distribution of vegetation types on damaged and undamaged revetments

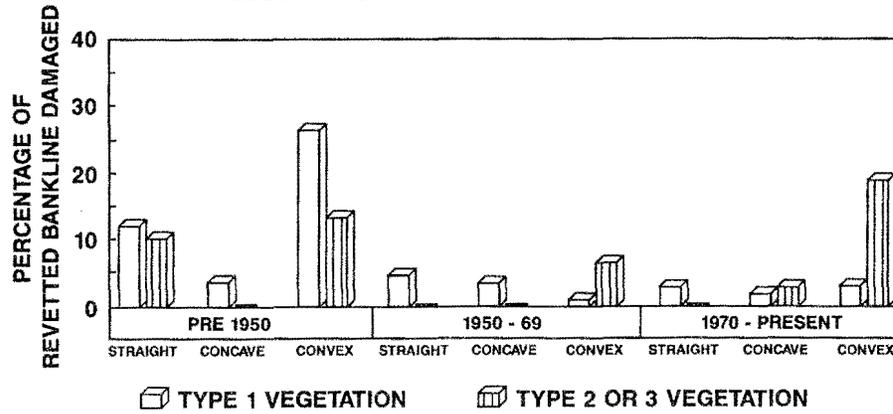
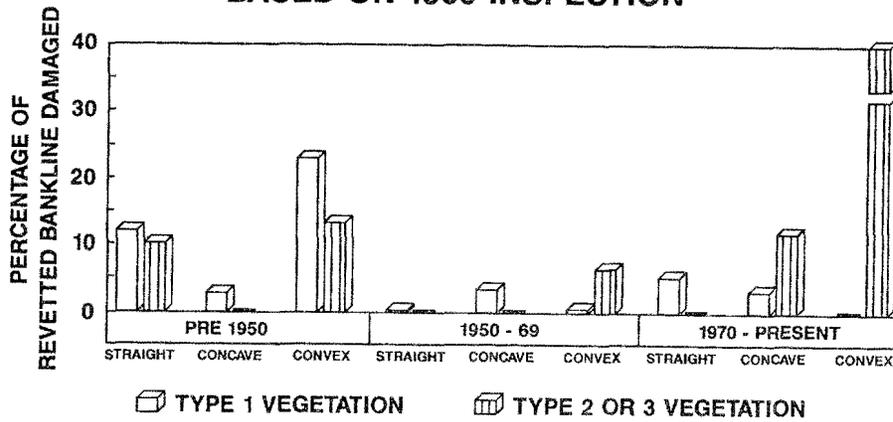
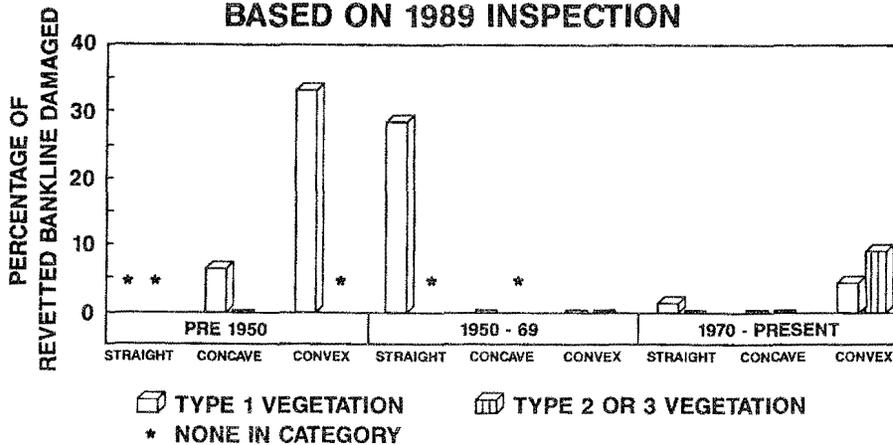
Figure 27. 1989 revetment damage rates for vegetated and unvegetated revetments

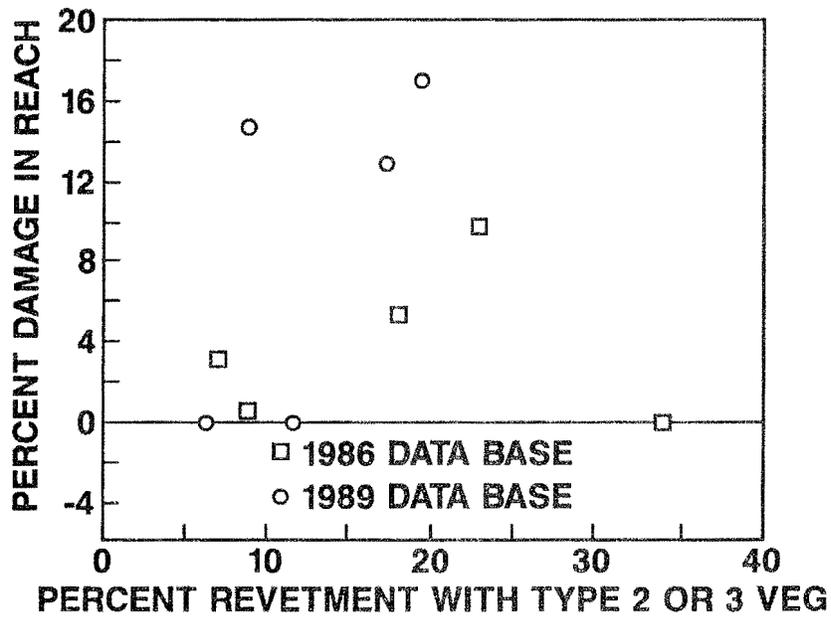
Results obtained from cross-tabulation analyses of the two data bases are compared in Table 18. The 1989 data base includes more damage and more types of damage situations, although it does not provide any information about structure performance under a given set of hydraulic conditions. Aside from 84.6 to 85.4L, the PL-99 data base emphasizes damage to relatively new rock riprap sites on convex bank. The 1989 data base records damage to old cobble sites that was not recorded in PL-99 files. Many of these sites are located on concave bend exits or convex bend entrances. Both data bases revealed that older revetments were more likely to support woody vegetation (Figure 28). Both also indicated no relationship between the amount of vegetation and the amount of damage in a WET subreach (Figure 29).

Figure 29. Damage and vegetation rates by WET subreach

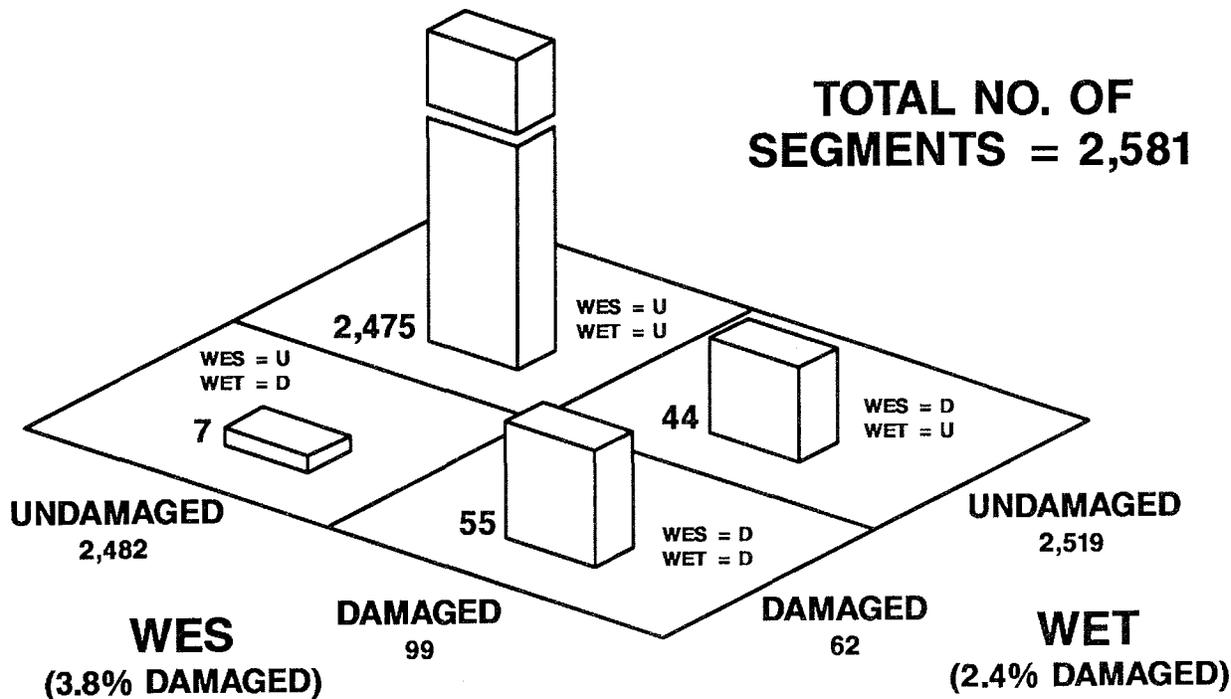
on the WET field notes from April 1989. Comparison of the two damage tallies is provided in Figure 30. Essentially all of the WET damage was included in the WES September inspection results, and 44 additional 100-ft segments were also identified as damaged. The seven segments classified as damaged by WET but undamaged by WES were due primarily to subjective differences.

Figure 30. Comparison of WES and WET revetment damage tallies for pilot study reach, Sacramento River. Of the 99 100-ft segments classified as damaged by WES investigators in September 1989, 55 were also classified as damaged on WET field notes from April 1989. The remaining 44 were not shown as damaged on WET notes

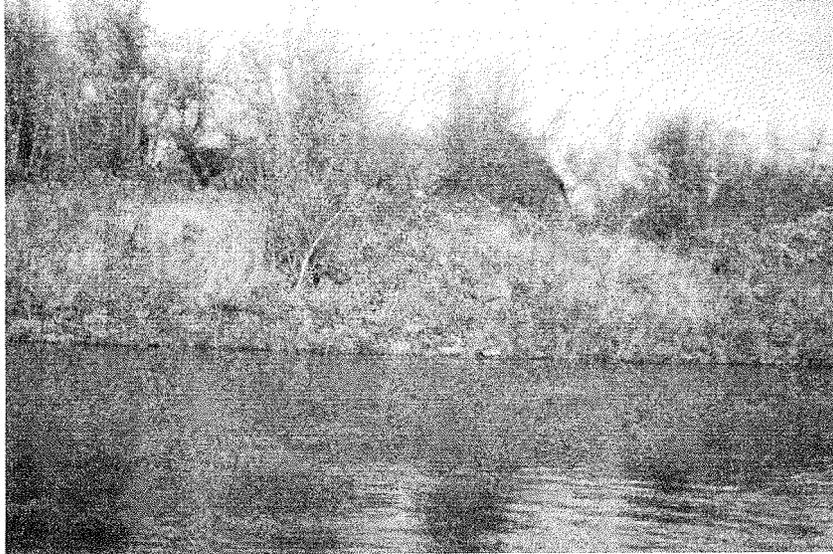
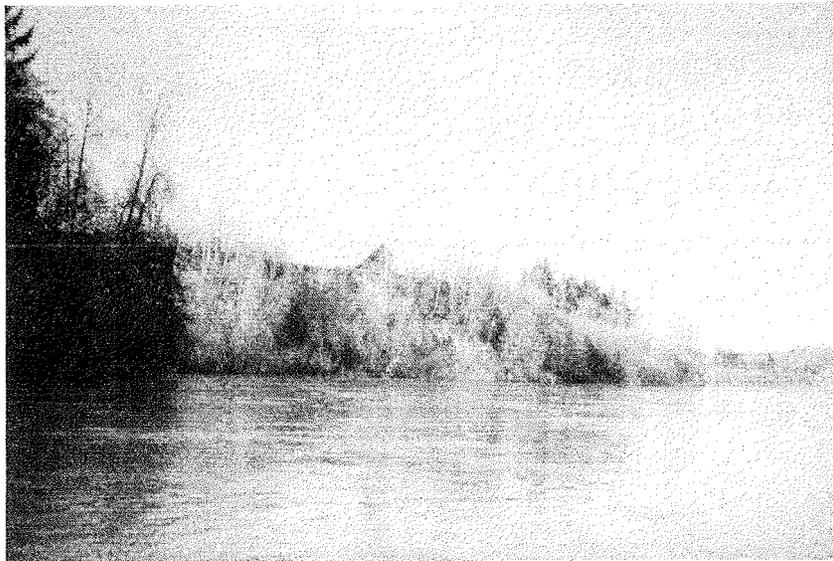
The Willamette River Basin encompasses 11,200 square miles in northwestern Oregon. The Willamette River is basically a high-energy gravel-bed stream in which bank erosion has been common. About 490,000 ft of riprap revetment has been constructed by the CE under special authorities. Revetment maintenance typically includes periodic removal of vegetation using manual tools (Fletcher and Davidson 1988, Forbes et al. 1976). Existing revetment vegetation species composition, density, and size vary with (a) vertical location on the riverbank, (b) maintenance history, and (c) the amount of sediment deposition within the rock (Bierly and Associates, Inc. 1980; Forbes et al. 1976). Revetments support stands of vegetation ranging from grasses and forbs to blackberry vine thickets to dense stands of mature trees (Figure 31).

Figure 31. Vegetation observed on Willamette River revetments, November 1981

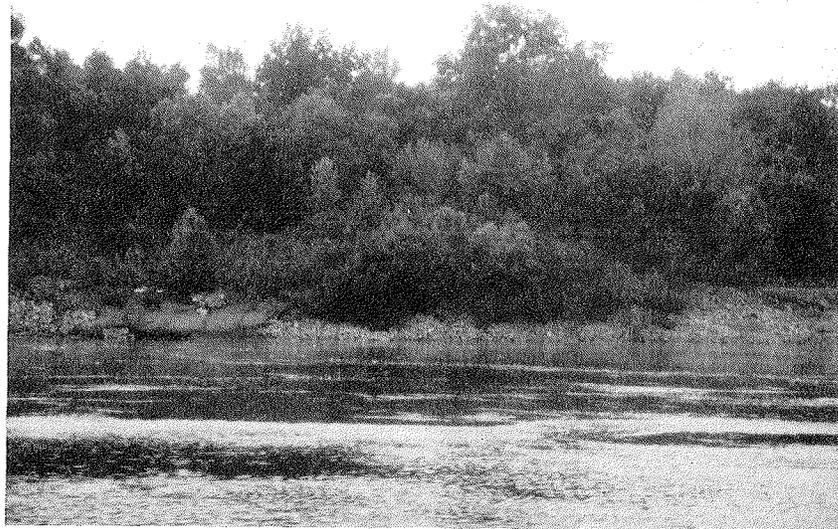
The Lower Mississippi River has 700 to 800 miles of revetments. Rock riprap is used primarily for upper bank protection, while articulated concrete mattress (ACM) is used primarily for lower bank protection. Navigation and flood control are project objectives. Flood control levees are typically several hundred feet to several miles distant from the main channel. Vegetation on the revetments and along the top bank reduces overbank scour during high water.\* Vegetation is not removed from revetments by maintenance. A typical Lower Mississippi River revetment supporting vegetation is shown in Figure 35.

Figure 35. Catfish Point Revetment, Mississippi River, RM 574, October 1989
