## Appendix A Site Descriptions

## **Appendix A Site Descriptions**

### **Calaveras River Downstream of Confluence with the Stockton Diverting Canal**

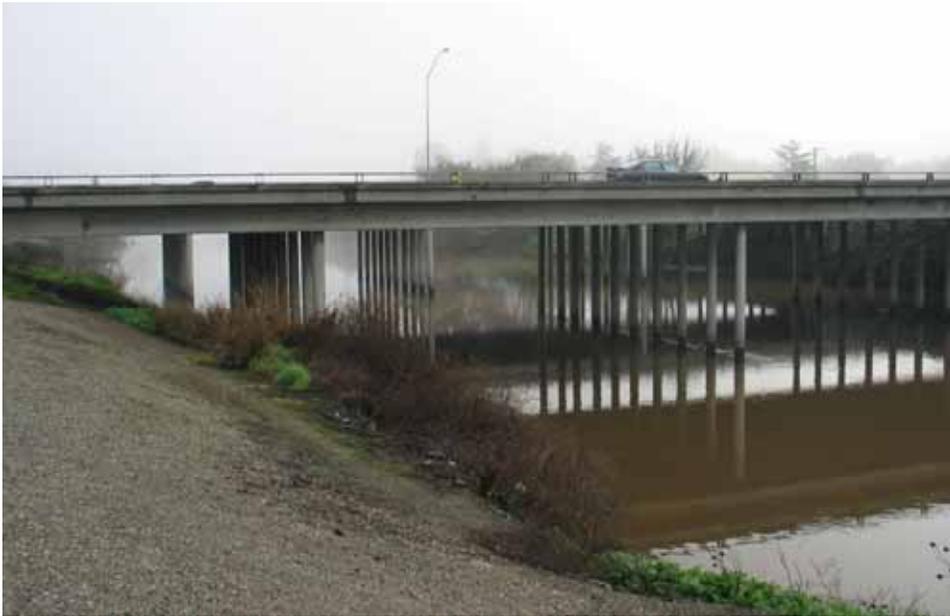
The presence of water is constant, and we were unable to determine channel bottom characteristics. The Interstate 5 bridges have no visible water surface difference between one side of the structure and the other and do not appear to be barriers to fish migration. We will confirm this by modeling fish passage at the McAllen Road Bridge.

**Photo A-1. Looking upstream at Interstate 5 bridges on the Calaveras River**

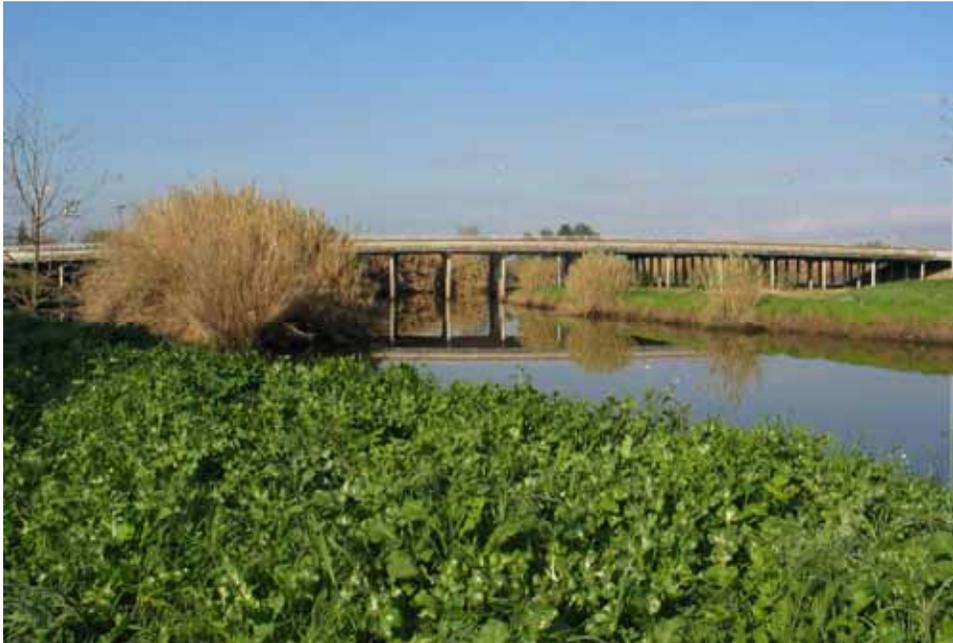
Because of a constant presence of water, we were unable to determine channel bottom characteristics. Pershing Avenue Bridge has no visible water surface difference between one side of the structure and the other so it does not appear to be a barrier to fish migration. We will be confirming this by modeling fish passage at the McAllen Road Bridge.

**Photo A-5. Looking downstream at Pershing Avenue bridge**

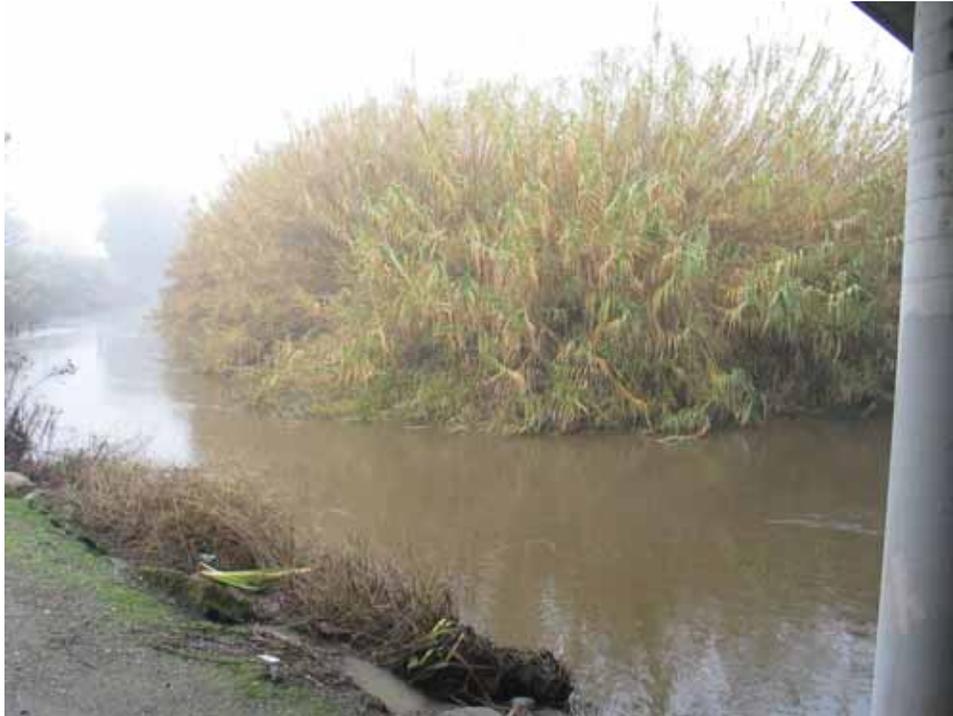
**Photo A-7. Below Pershing Avenue bridge looking downstream. Also looking at island inundated with giant reed or *Arundo donax*.**

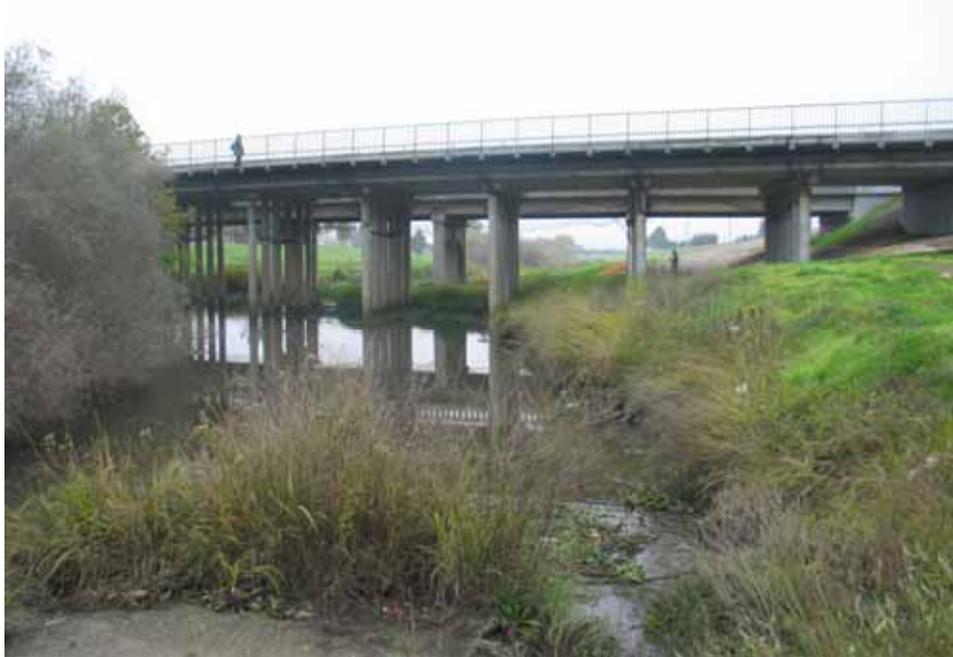
Because the structure has no apron or riprap scour protection and there is no visible water surface difference between one side of the structure and the other, it is not a barrier to fish migration. We will be confirming this by modeling fish passage at the McAllen Road Bridge.

**Photo A-8. Looking downstream at Pacific Avenue Bridge, northbound on the Calaveras**

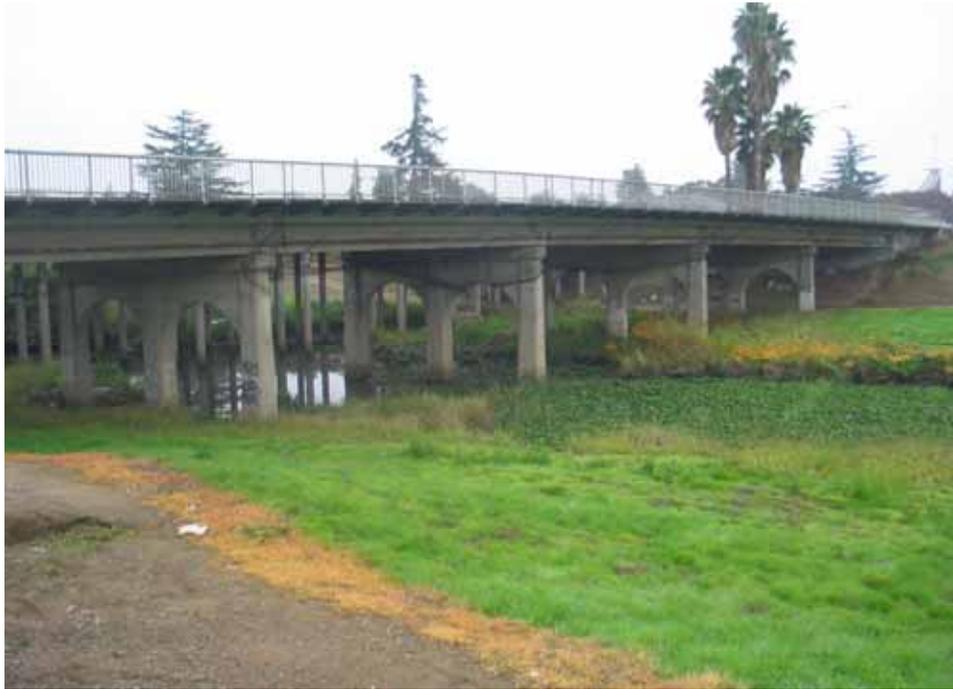
Because the structure has no apron or riprap scour protection and there is no visible water surface difference between one side of the structure and the other, it is not a barrier to fish migration. We will be confirming this by modeling fish passage at the McAllen Road Bridge.

**Photo A-10 Looking upstream at Pacific Avenue Bridge, southbound**

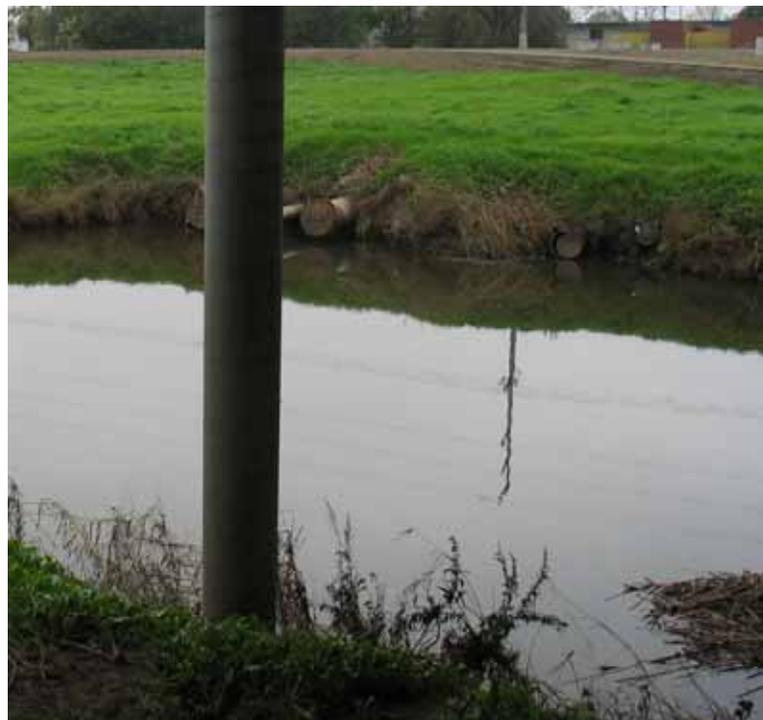
**Photo A-17. Drainpipes downstream of El Dorado Street Bridge**

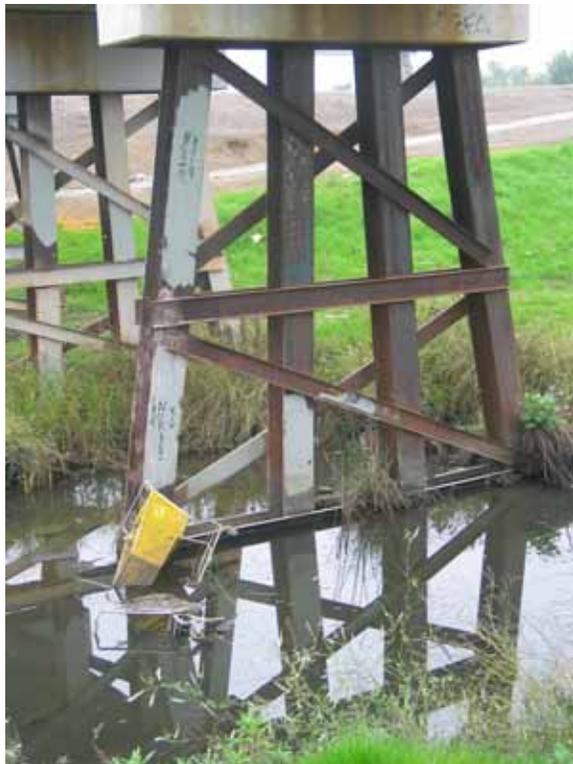
**Photo A-19. Trash under Railroad Crossing No. 2**

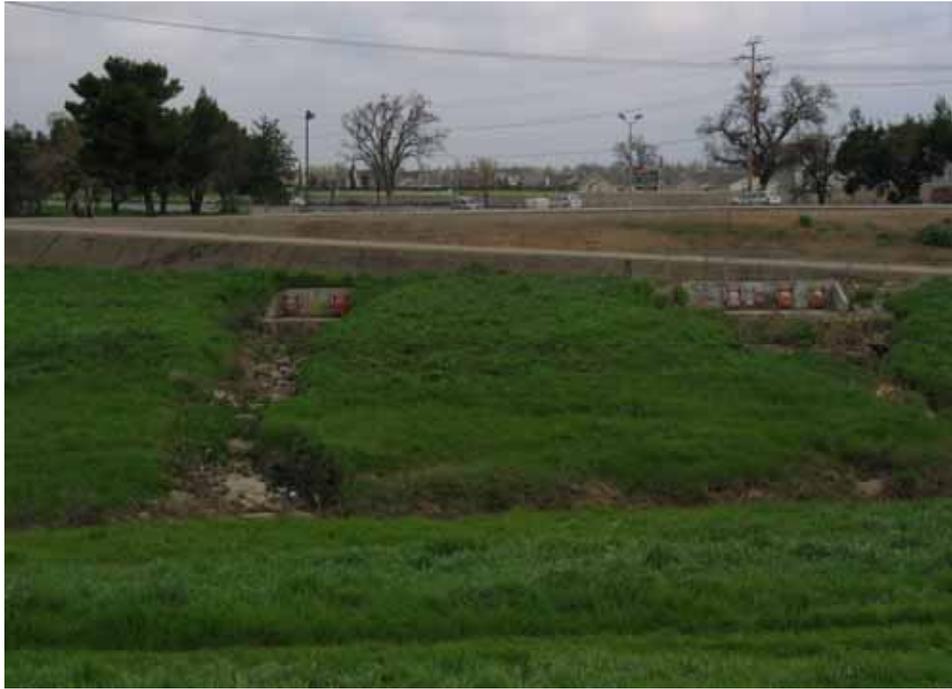
**Photo A-20. Drain outlets upstream of Railroad Crossing No. 2**

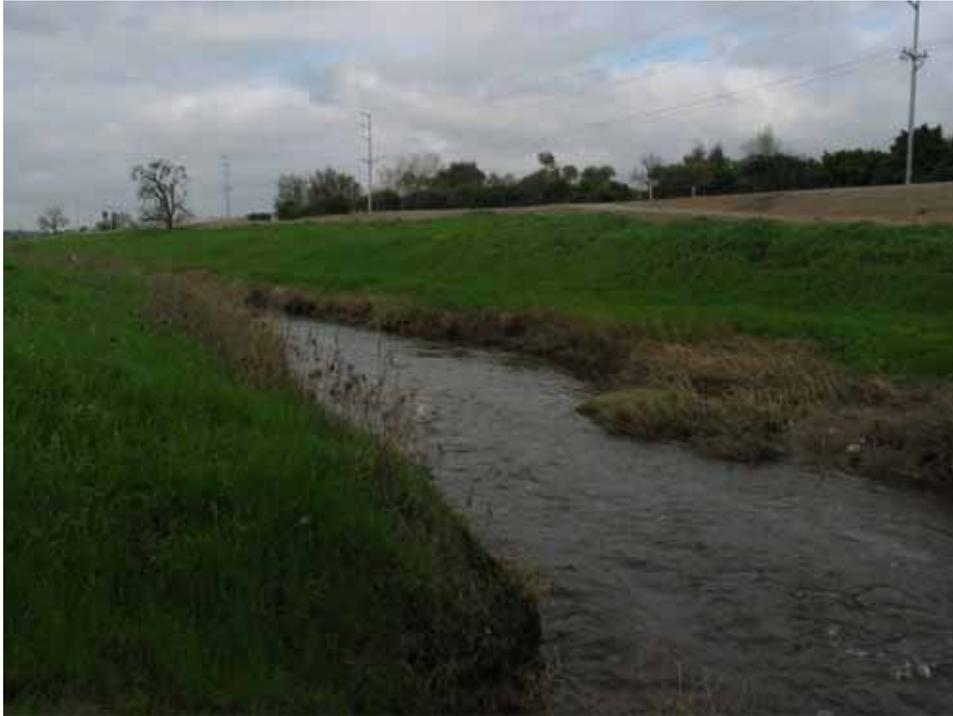
Downstream of the crossing, the river channel is relatively straight and the channel bottom is composed of bare earth with some scattered rubble (Photo A-22). The downstream banks are relatively flat until you reach the river channel, which is steeply incised. The banks are well vegetated with weeds and grasses. There are few riparian trees downstream of Railroad Crossing No. 1 that provide limited shade to the river channel. Modeling results from Mormon Slough Railroad Crossing will be used to assess fish passage at Railroad Crossing No. 2.

**Photo A-22. Looking downstream of Railroad Crossing No. 2**

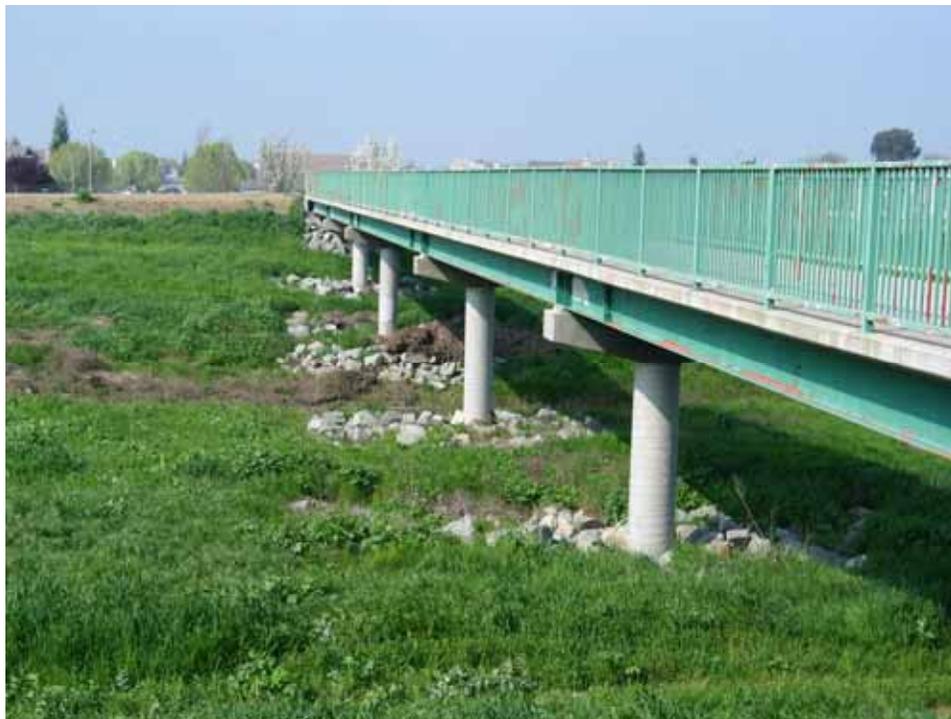
**Photo A-28. Looking at riprap around piers at Pedestrian Bridge**

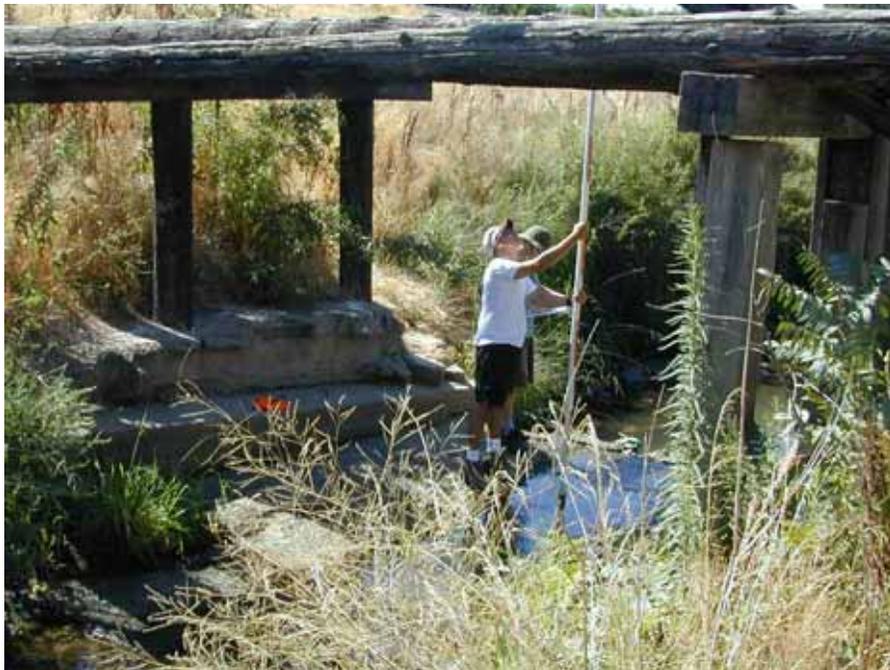
The bridge piers are spaced approximately 20 feet apart; the footings are protected by a full-span concrete apron (Photo A-36). The apron is the width of the bridge at approximately 16 feet. The apron appears to be in fair condition and has a rough concrete pour at the downstream end to attempt to reduce scour (Photo A-37).

**Photo A-36. Footings and apron of Old Wooden Bridge**

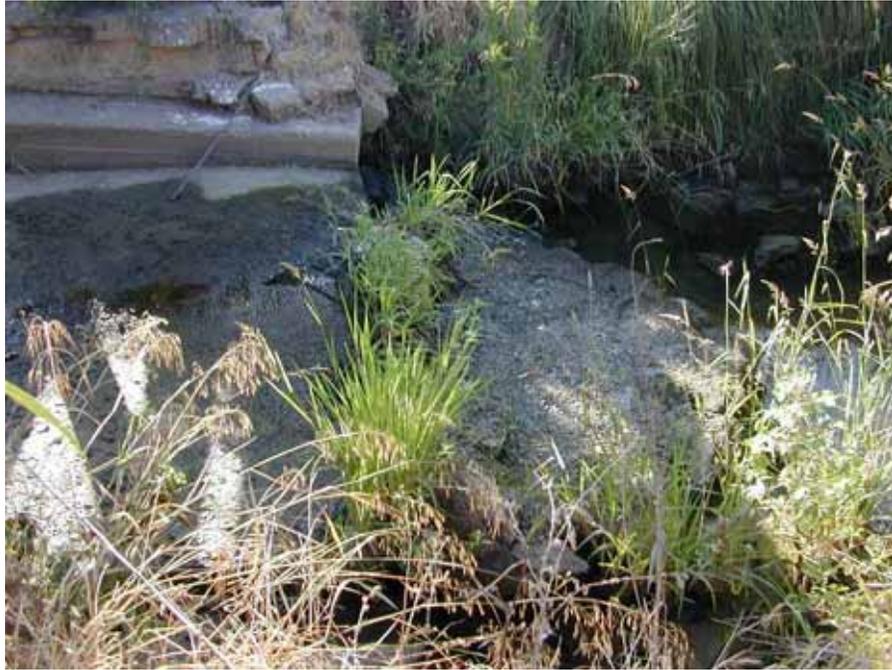
**Photo A-37. Rough concrete pour at downstream edge of apron at Old Wooden Bridge**

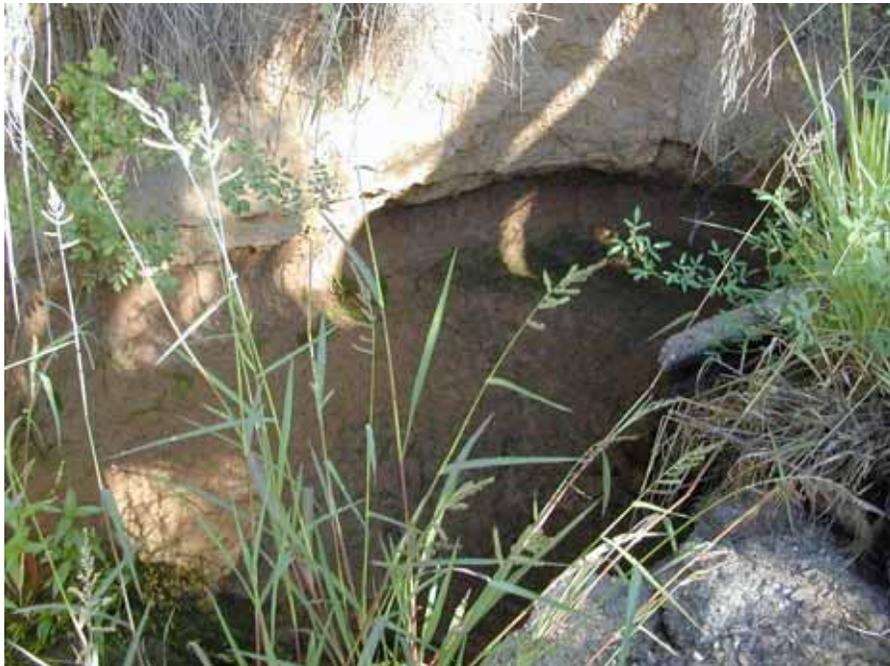
The structure appears to be creating some localized downstream scour at the right bank (Photo A-40). This scour is likely due to velocity increased by constriction of flow between the bridge piers and by the concrete apron that is smoother than the natural channel bottom. Because the structure is no longer in use and the bridge is unsafe, the bridge should be removed. Removal of the structure should eliminate future scour problems and unsafe conditions.

**Photo A-40. Scour hole at right bank downstream of Old Wooden Bridge**

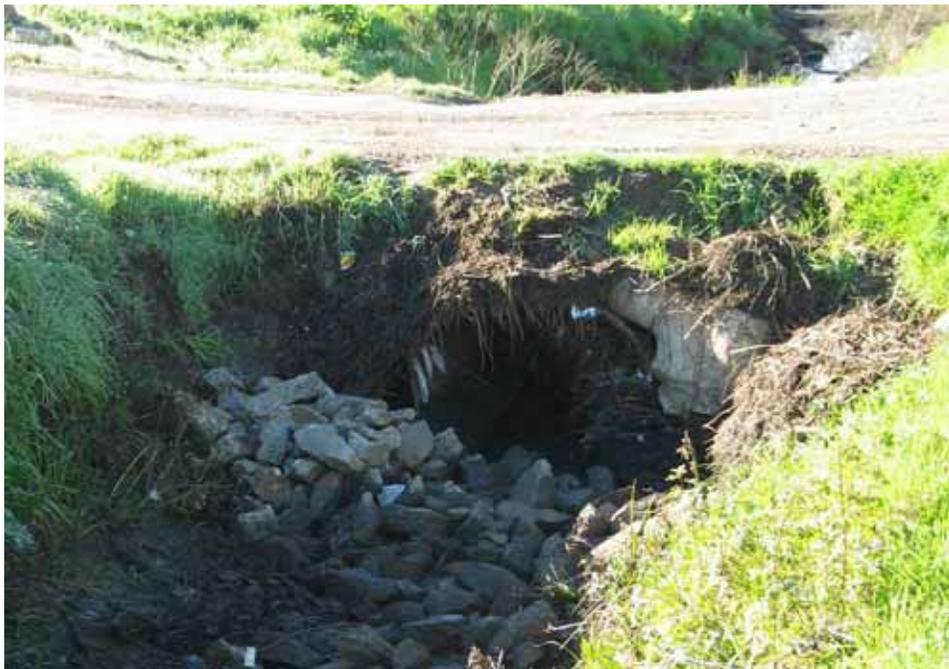
The Gotelli Crossing is a culvert that provides vehicular access across the Calaveras River (Photo A-41). The structure is on the Calaveras River at river mile 6.2, downstream of the Calaveras Headworks. The crossing consists of a circular corrugated metal culvert overlain by an earthen fill road prism situated perpendicular to the channel alignment. The road crossing is unpaved and about 17 feet wide and 40 feet long. The culvert has a diameter of 3.5 feet and a length of 20 feet and is laid on a 2% slope. The inlet and outlet inverts of the culvert are flush with the channel thalweg. The pipe is in poor condition.

**Photo A- 41. Gotelli Low-flow Road Crossing (River Mile 6.2), view of outlet**

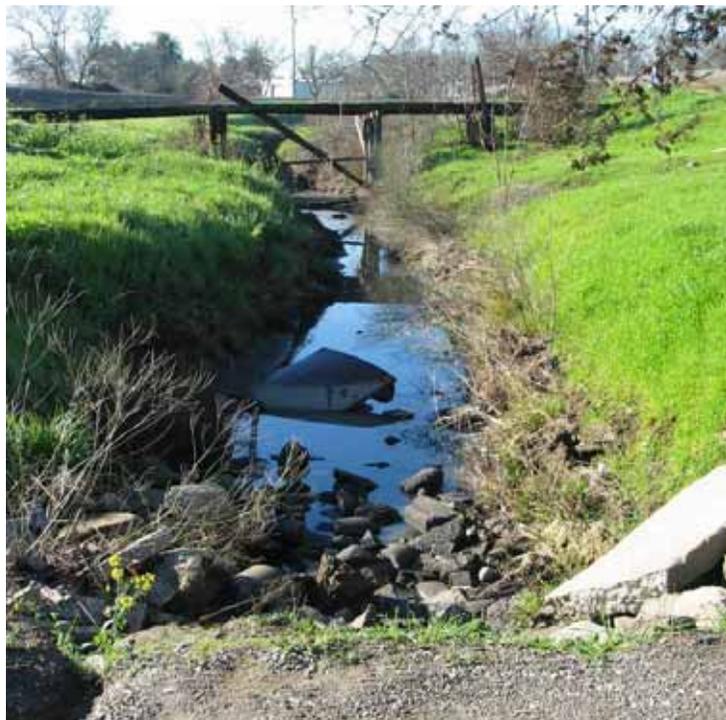
The downstream channel has properties similar to the upstream channel (Photo A-43). The channel bottom is lined with broken concrete and various household refuse items within 16 feet of the outlet. Further downstream, the bottom of the channel was relatively clean, and the banks were overgrown with grassy vegetation. An old road crossing downstream of the site was causing a backwater condition during the site visit.

**Photo A- 43. Calaveras downstream of Gotelli Low-flow Road Crossing (River Mile 6.2)**

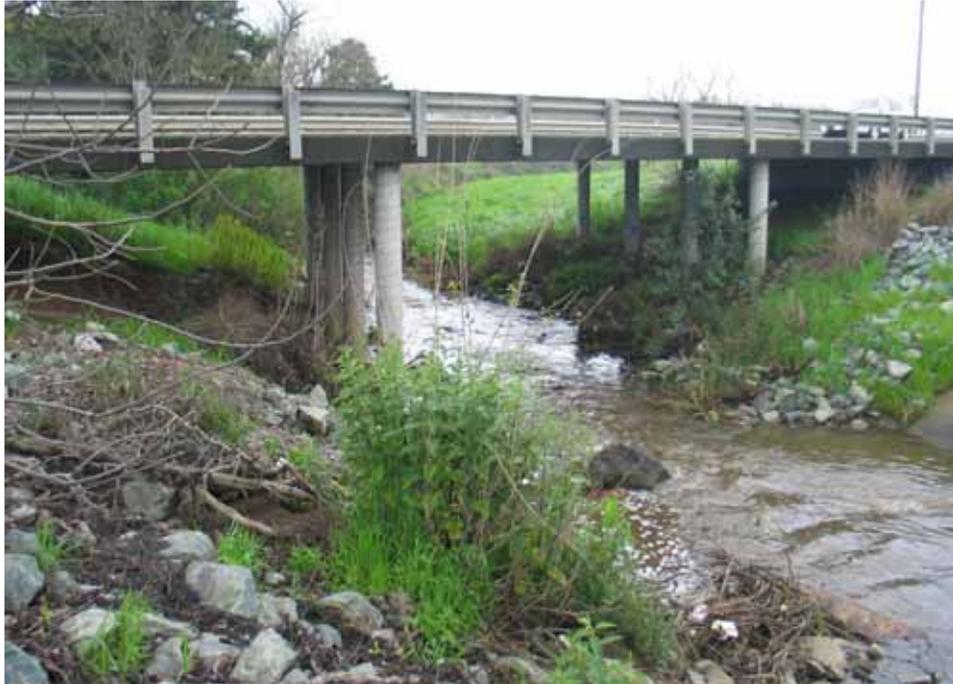
**Photo A-44. Looking downstream at McAllen Road Bridge**

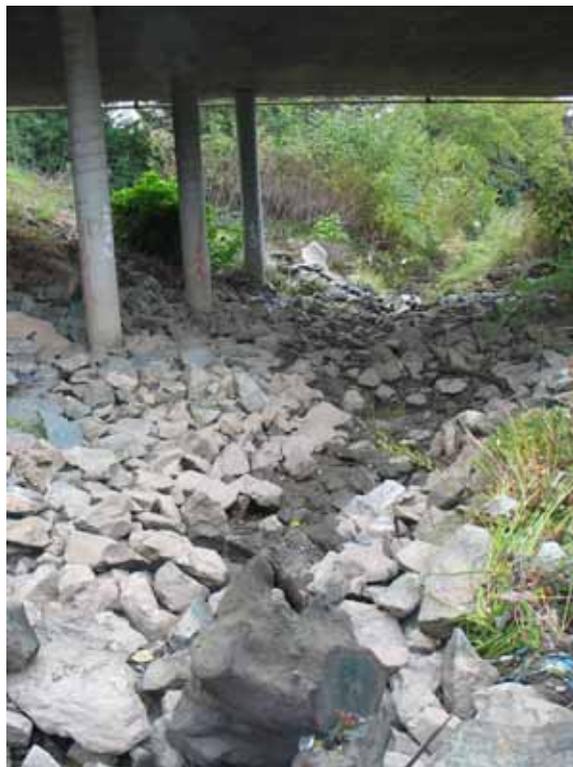
**Photo A-45. Riprap below McAllen Road Bridge**

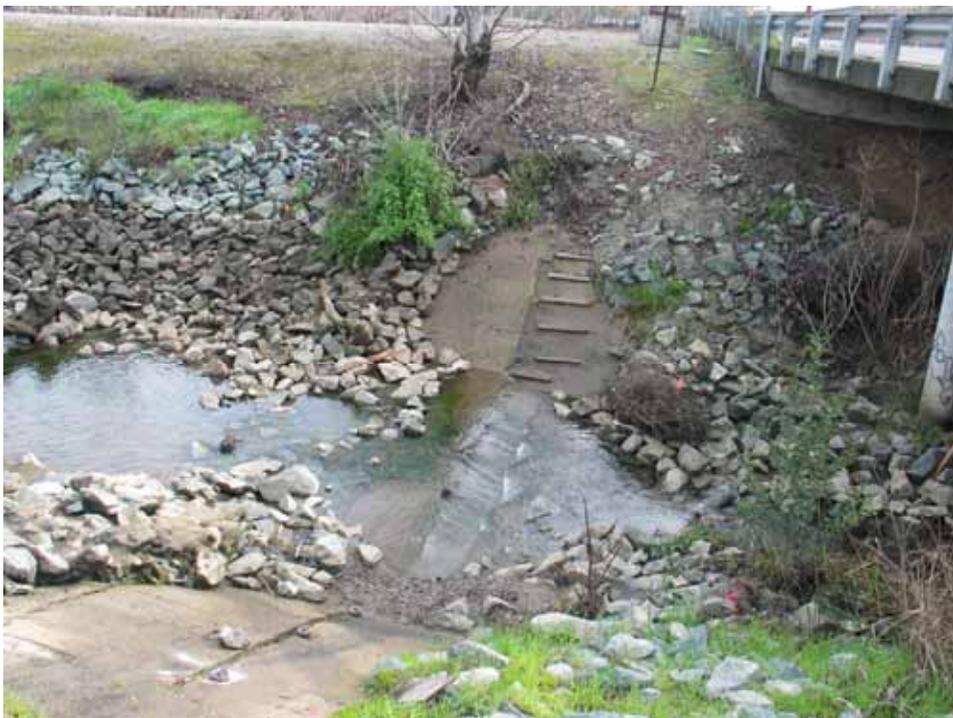
**Photo A-47. McAllen Flashboard Dam upstream of McAllen Road Bridge**

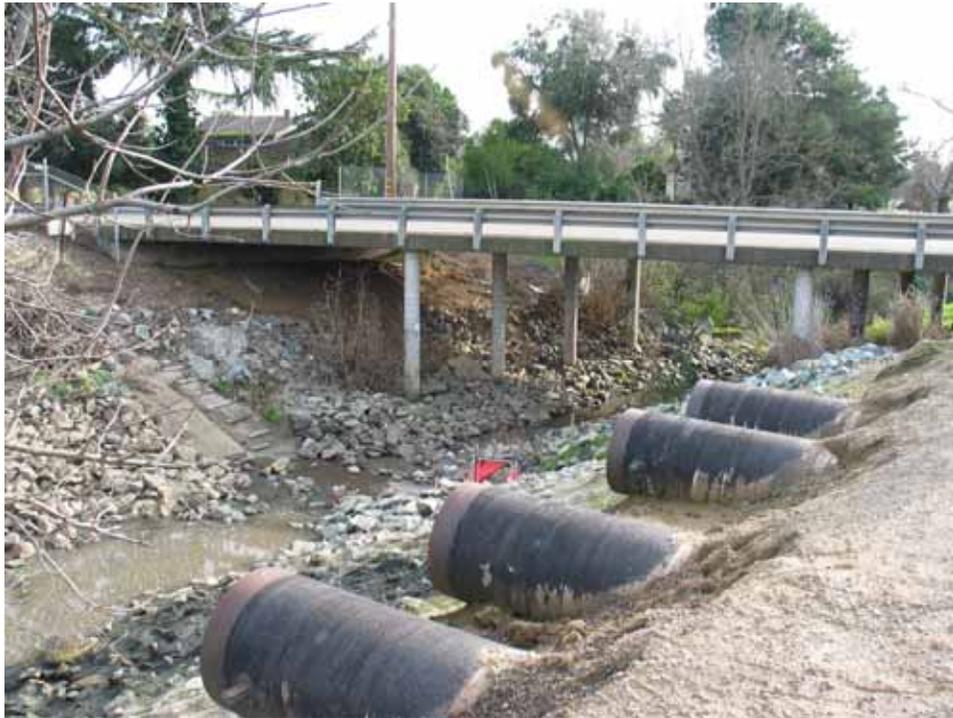
**Photo A-48. Drainpipes upstream of McAllen Road Bridge**

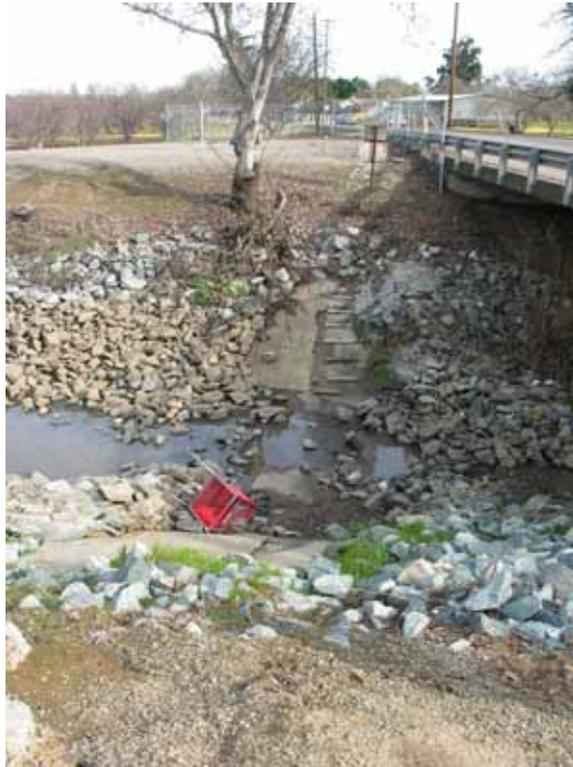
McAllen Flashboard Dam base is near river mile 6.9, immediately upstream of McAllen Road Bridge (Photo A-50). Flashboards are used during irrigation season. When the flashboards are removed, the channel typically receives minimal flows.

The minimum plunge pool depth of 2 feet for juvenile salmonids is met at McAllen Flashboard Dam. This structure was modeled to evaluate depth and velocity at the dam against fish passage criteria. The modeling results are in this report. The model results from this structure also represent fish passage at other flashboard dam bases on the Calaveras River listed in Table 5-11 of the main report.

**Photo A-50. The McAllen Flashboard Dam base**

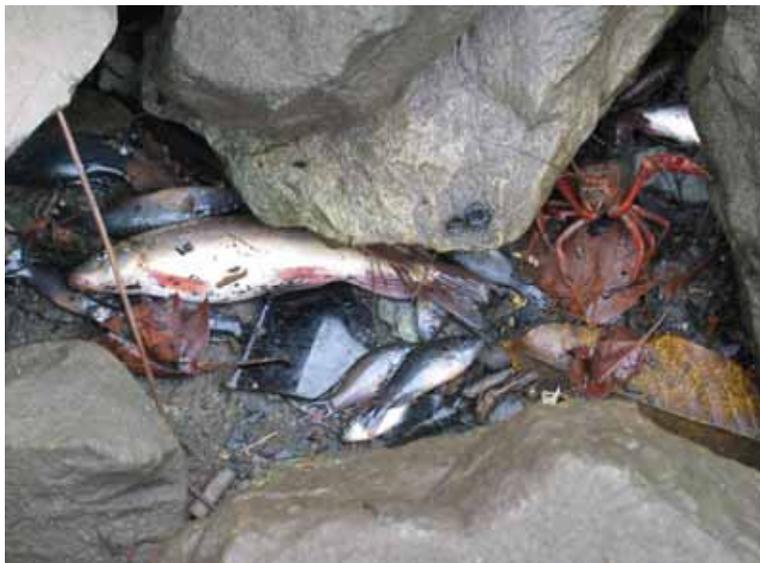
**Photo A-51. Stranded fish and crayfish at McAllen Flashboard Dam base**

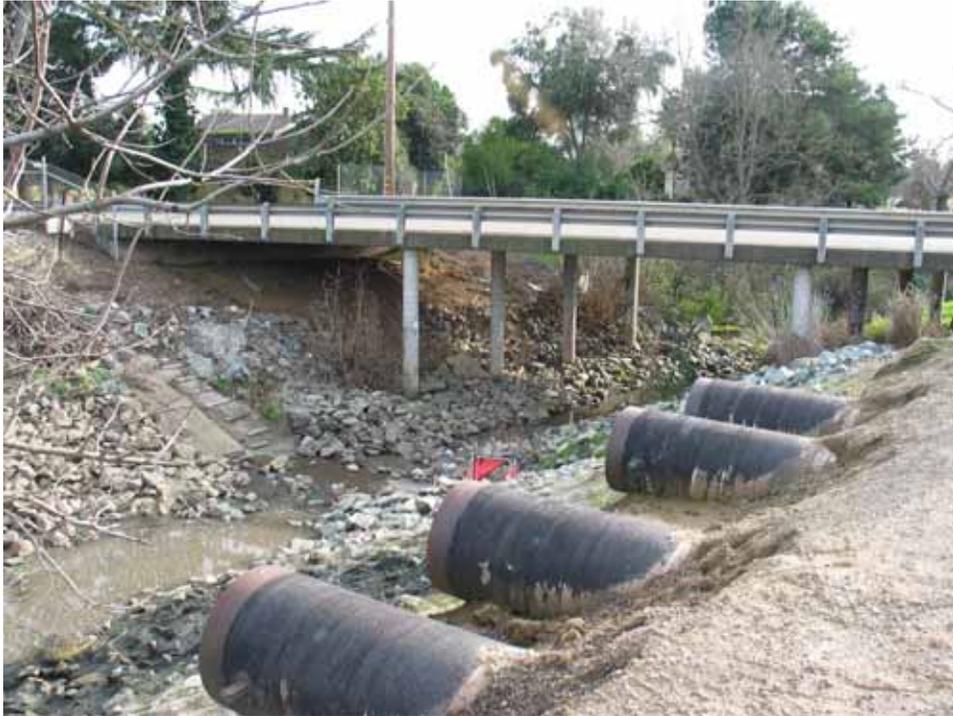
**Photo A-52. Outfall pipes upstream of McAllen Flashboard Dam base**

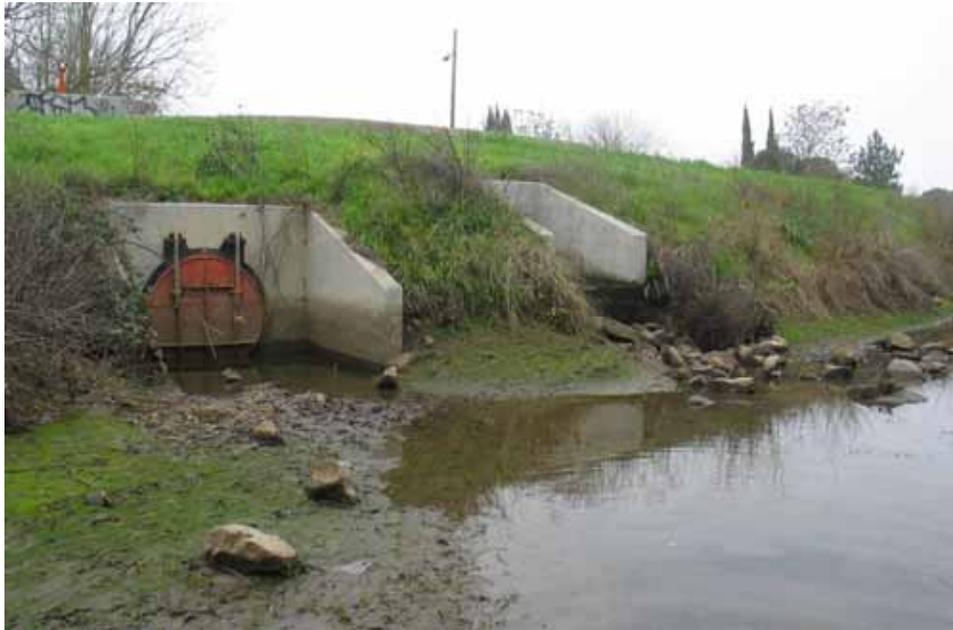
**Photo A-61. Upstream of Highway 99 Bridge, northbound, at the drain outlets**

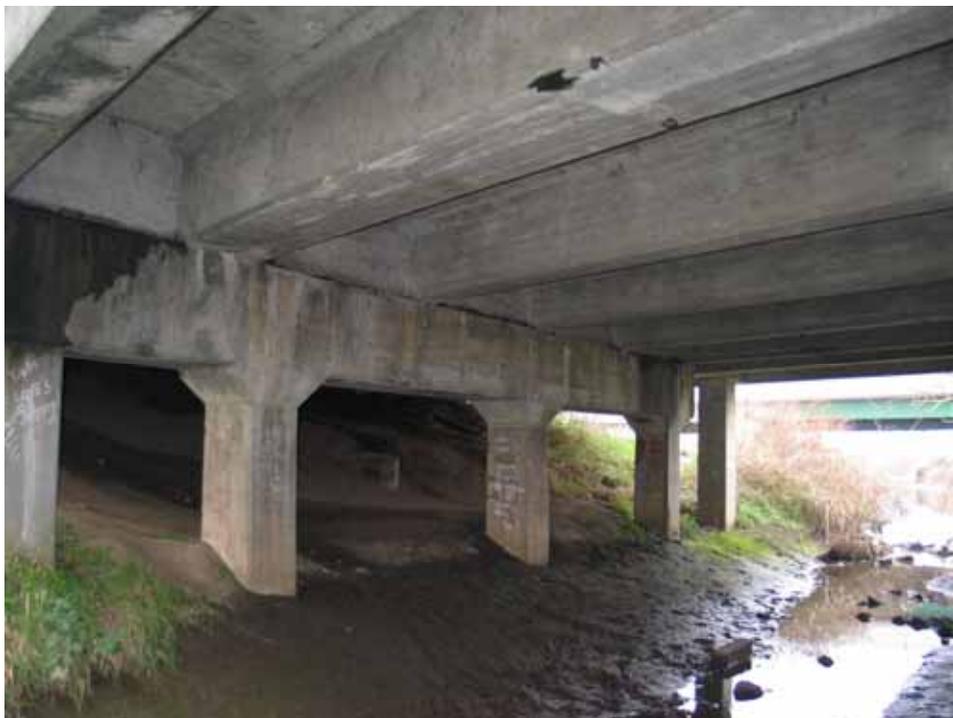
**Photo A-64. Looking at piers under Highway 99 Bridge, southbound**

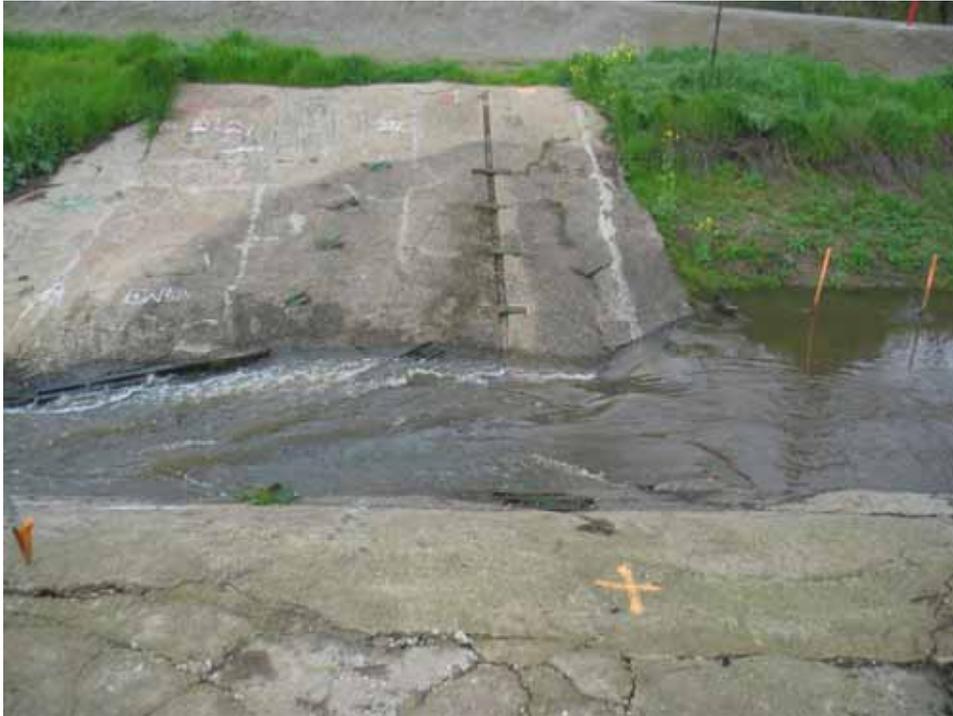
Cherryland Flashboard Dam is at river mile 7.9, downstream from the Calaveras Headworks (Photo A-67). The structure supports flashboards during irrigation season. Flashboards are removed during non-irrigation season, and the Calaveras River receives only minimal flows that are released from the Calaveras Headworks.

The minimum plunge pool depth of 2 feet for juvenile salmonids is not met at Cherryland Dam. This structure was modeled to evaluate depth and velocity at the dam against fish passage criteria. The modeling results are in this report.

**Photo A-67. Cherryland Flashboard Dam base**

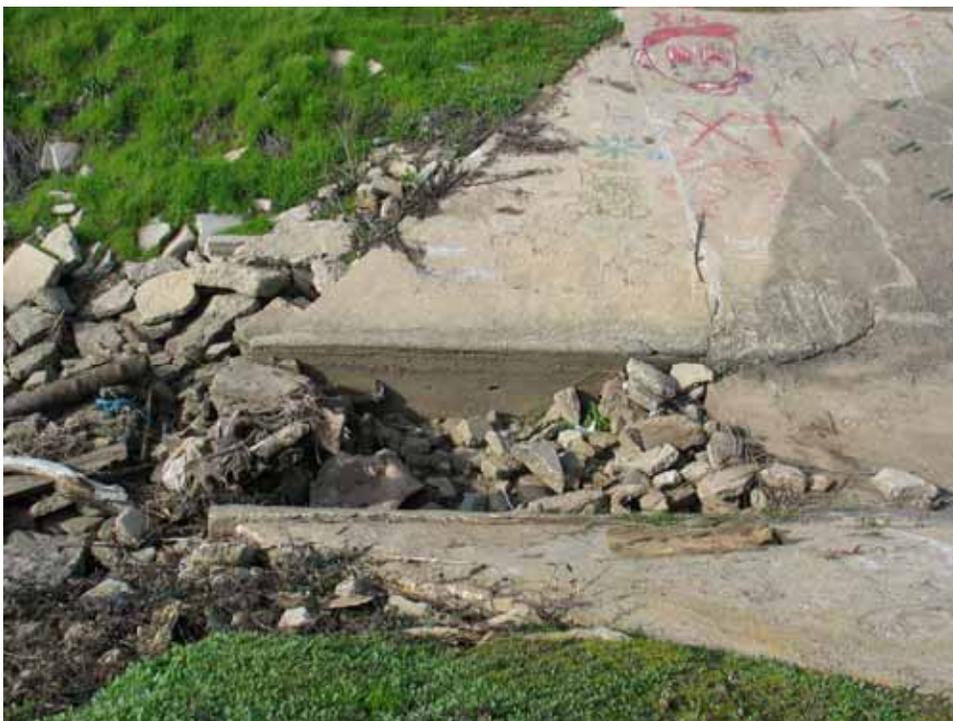
**Photo A-68. The drop from dam base to river channel with no flow**

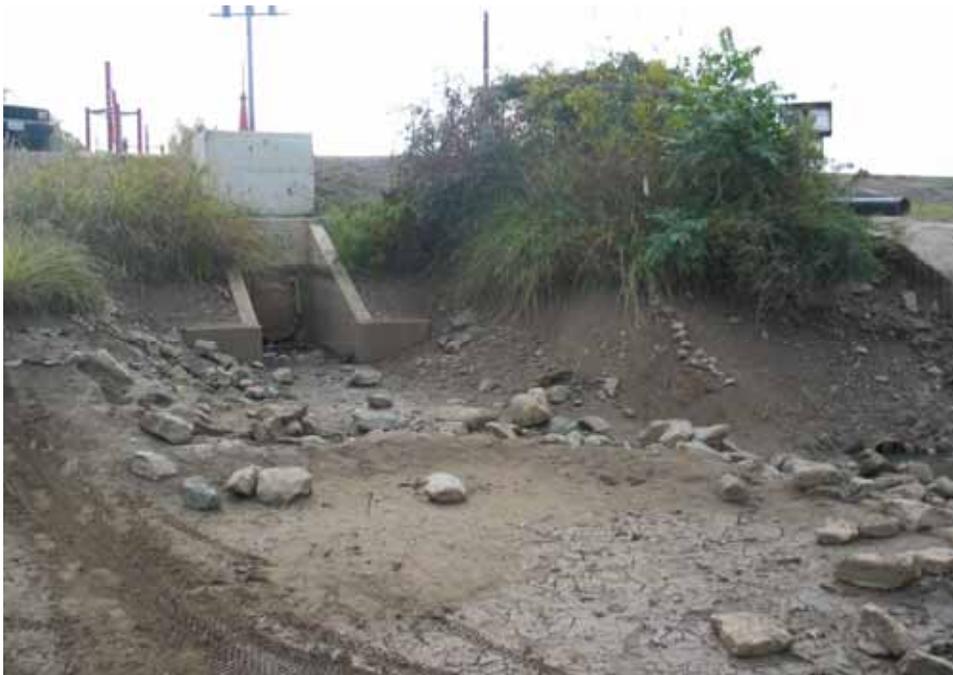
**Photo A-72. The outlet of drainage canal upstream of Cherryland Flashboard Dam**

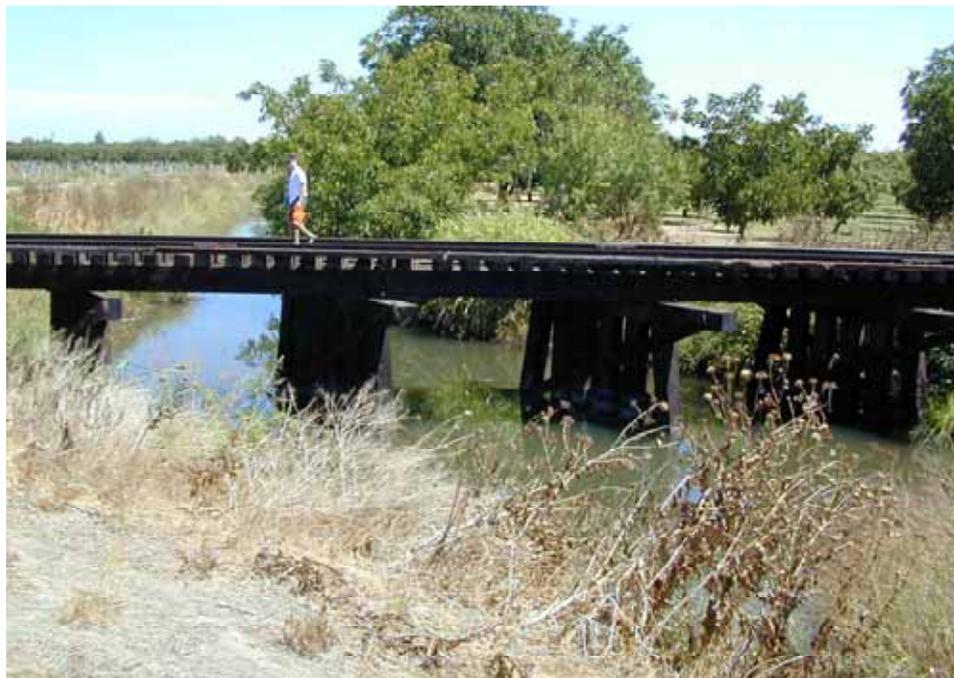
The Railroad Crossing near Leonardini Road crosses perpendicular to the Calaveras River at river mile 8.6, downstream of the Calaveras Headworks (Photo A-75). The Railroad Crossing near Leonardini is upstream of Cherryland Flashboard Dam.

**Photo A-75. Railroad Crossing near Leonardini Road on the Calaveras River**

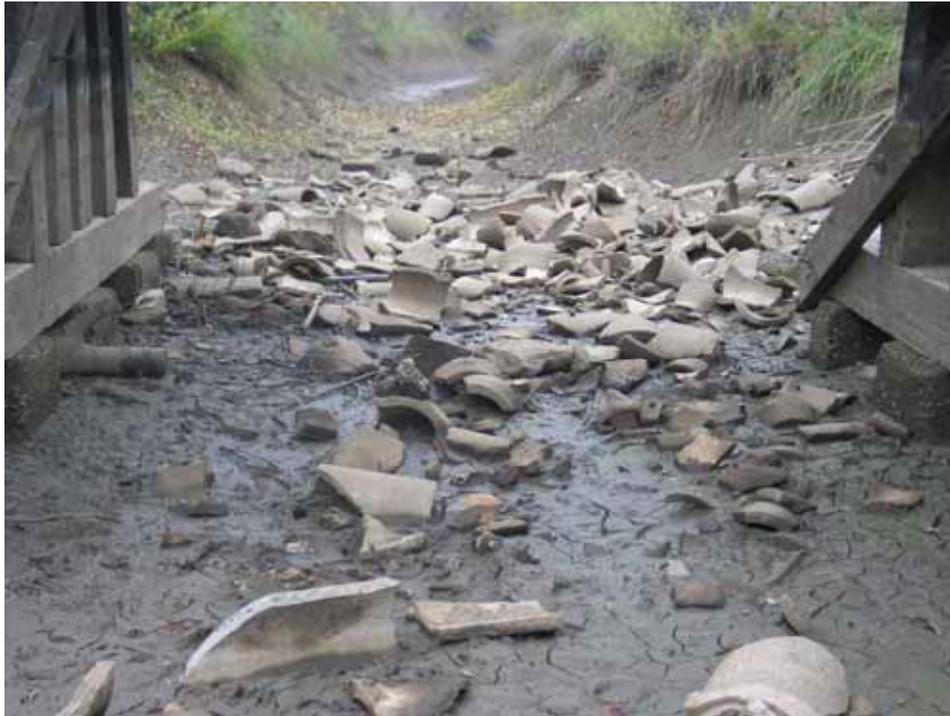
The Railroad Crossing near Leonardini Road spans 85 feet. The crossing is a wooden bridge supporting a single set of tracks. The active channel is 30 feet wide. The active channel widens under the crossing and encompasses four piers. The crossing contains four wooden piers that are subdivided into six supporting wooden beams. There are many pieces of broken concrete under the crossing (Photo A-76). There is no apron under the bridge.

**Photo A-76. Concrete debris under Railroad Crossing near Leonardini Road on the Calaveras River**

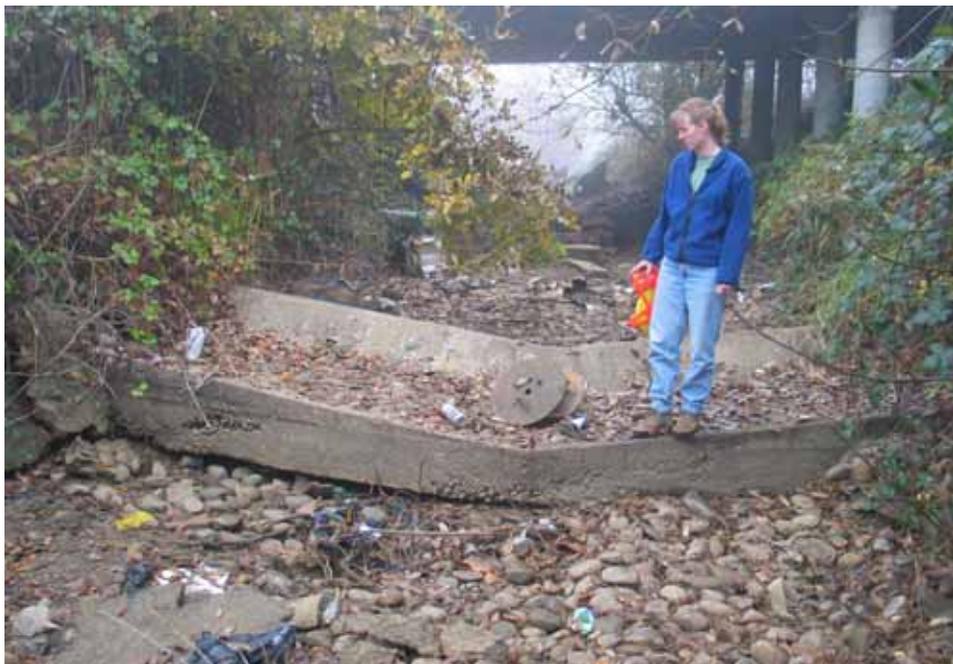
**Photo A-81. Stream gage weir downstream of Solari Ranch Road Bridge**

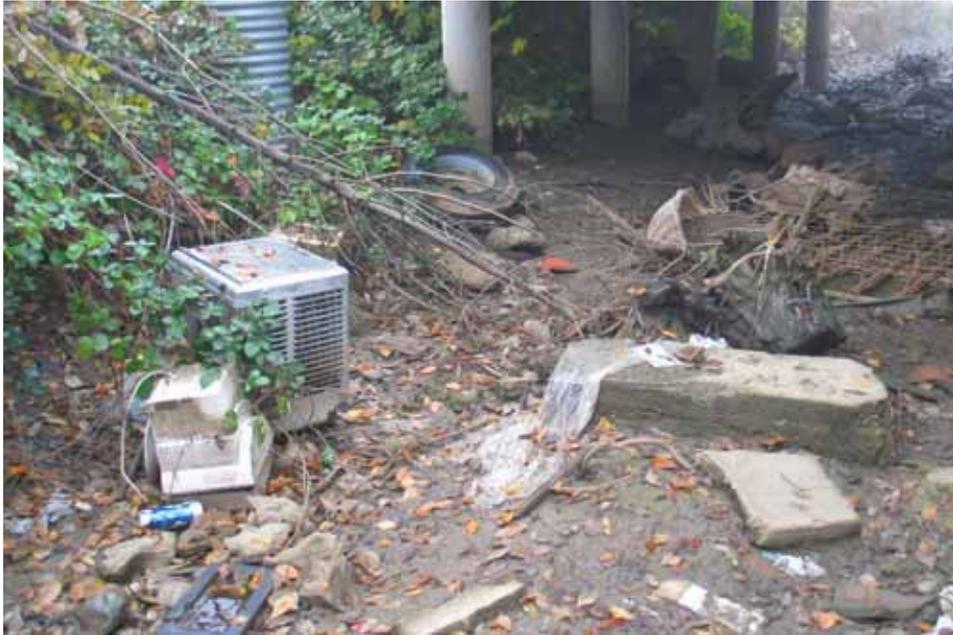
**Photo A-82. Trash below Solari Ranch Road Bridge**

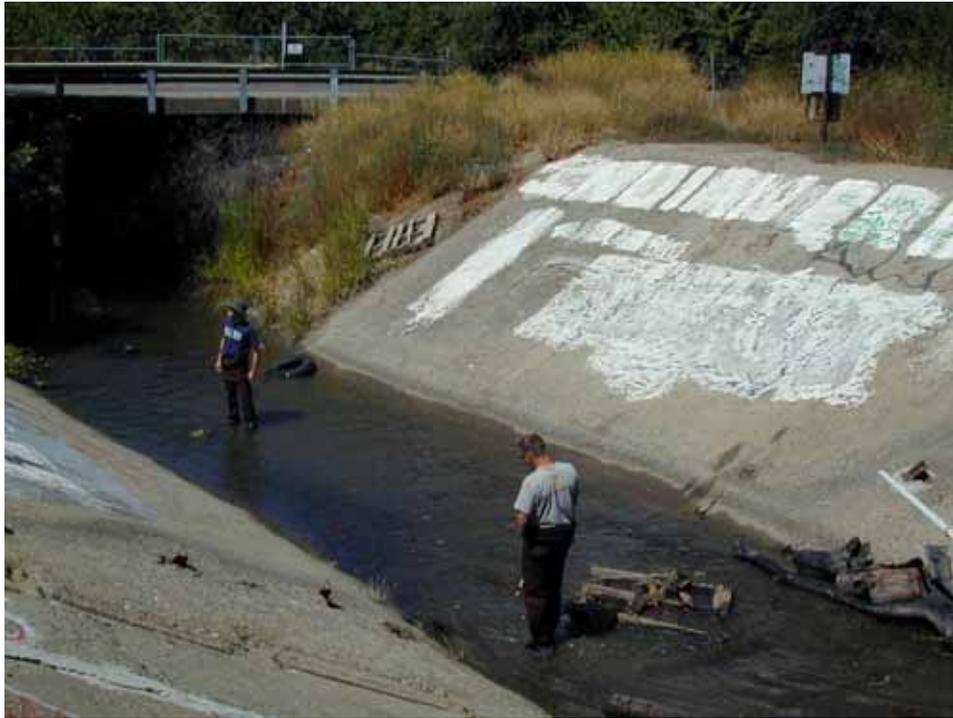
**Photo A-85. Solari Ranch Flashboard Dam base**

Immediately downstream from the dam base there is a narrow band of riprap that crosses the whole channel. Downstream of this row of riprap there is scattered rubble, and excessive trash and debris (Photo A-87). This continues downstream past the old DWR stream gage. Where there is not rubble, debris, or trash the channel substrate is comprised of silty-clay soil. Compared to the upstream banks, the downstream banks are steeper. Both banks are well vegetated with weeds, bushes, and grasses (except for under the bridge). Downstream, there are riparian trees, and they provide some shade to the river channel. Fish passage at Solari Ranch flashboard dam is represented by the modeling results from Murphy Dam.

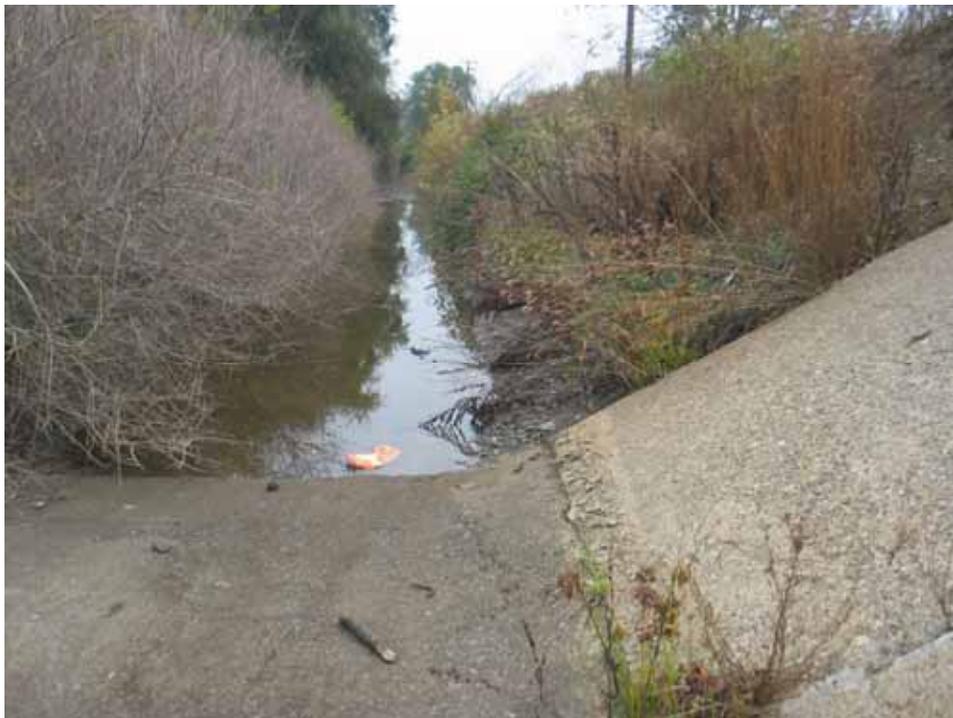
**Photo A-86. Upstream from Solari Ranch Flashboard Dam**
