## Appendix A Site Descriptions

## **Appendix A Site Descriptions**

### **Calaveras River Downstream of Confluence with the Stockton Diverting Canal**

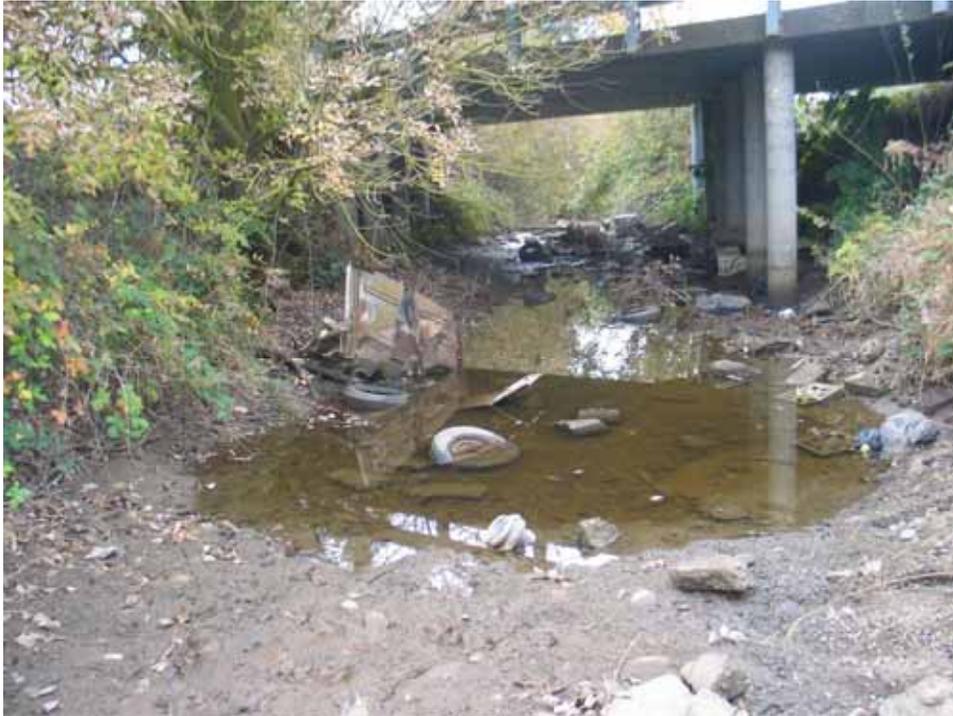
Immediately downstream from the dam base there is a narrow band of riprap that crosses the whole channel. Downstream of this row of riprap there is scattered rubble, and excessive trash and debris (Photo A-87). This continues downstream past the old DWR stream gage. Where there is not rubble, debris, or trash the channel substrate is comprised of silty-clay soil. Compared to the upstream banks, the downstream banks are steeper. Both banks are well vegetated with weeds, bushes, and grasses (except for under the bridge). Downstream, there are riparian trees, and they provide some shade to the river channel. Fish passage at Solari Ranch flashboard dam is represented by the modeling results from Murphy Dam.

**Photo A-87. Downstream from Solari Ranch Flashboard Dam base**

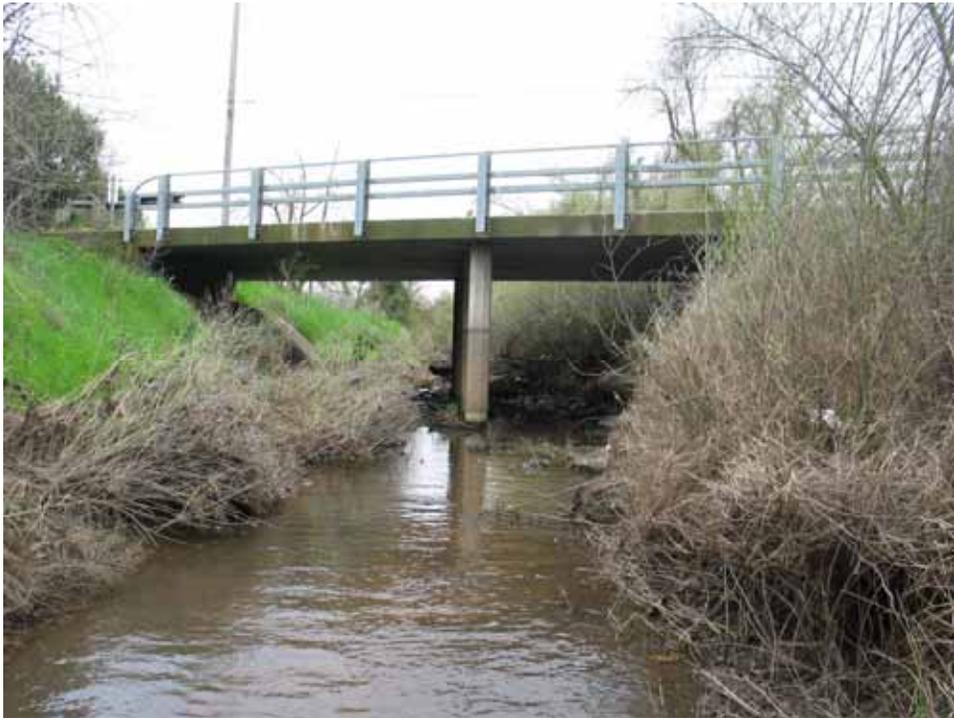
Because the structure has no apron or riprap scour protection and there is no visible water surface difference between one side of the structure and the other, it is not a barrier to fish migration. We will be confirming this by modeling fish passage at the McAllen Road Bridge.

**Photo A-88. Ashley Lane Bridge**

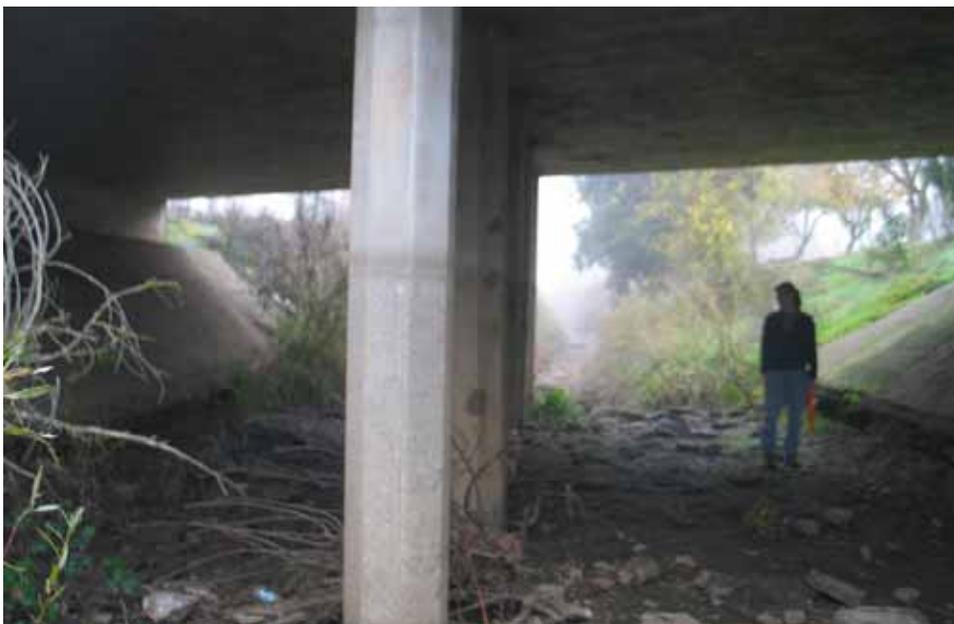
**Photo A-89. Concrete abutments under Ashley Lane Bridge**

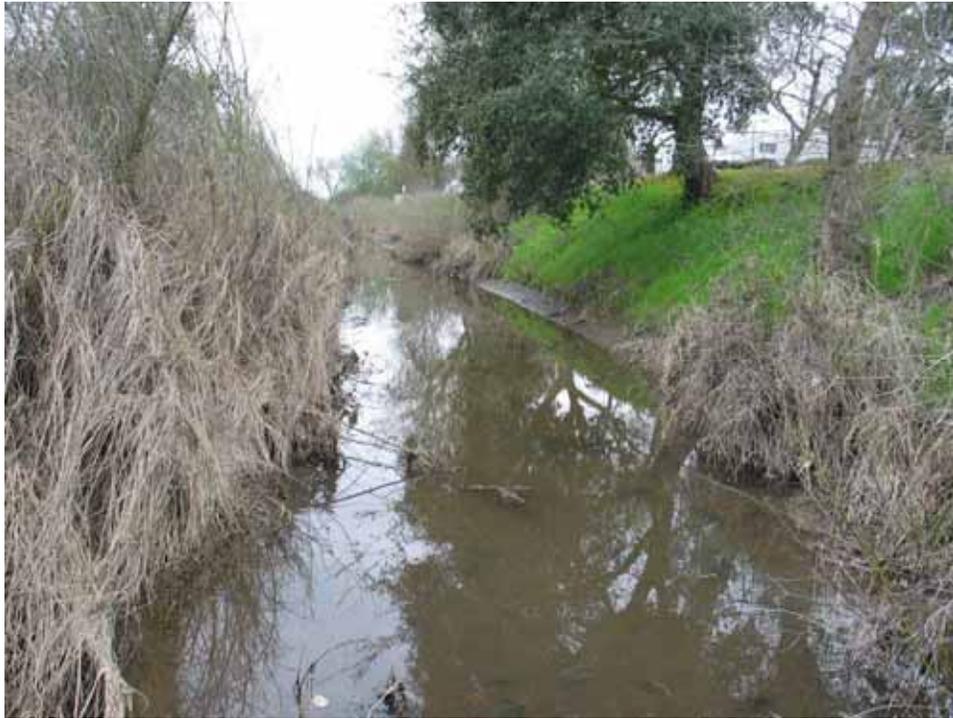
The river channel upstream is bare comprised of silty-clay soil with some scattered rubble. The channel is trapezoid and has little meander. The upstream banks are steep to moderate (with the right bank being steeper) until you near the tops of the levee where the slope becomes more gradual. The right bank is heavily vegetated with bushy weeds that constrict the river channel. Weeds, bushes, and grasses cover the left bank. Riparian trees provide little shade to the river channel (Photo A-90). Downstream conditions are the same (Photo A-91).

**Photo A-90. Upstream from Ashley Lane Bridge**

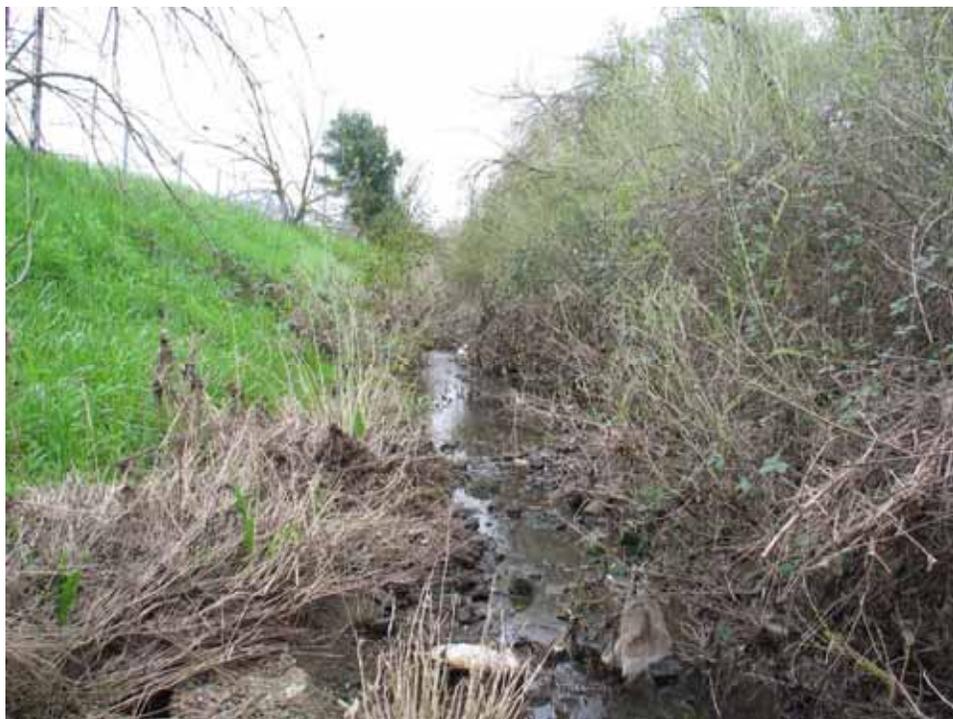
**Photo A-91. Downstream from Ashley Lane Bridge**

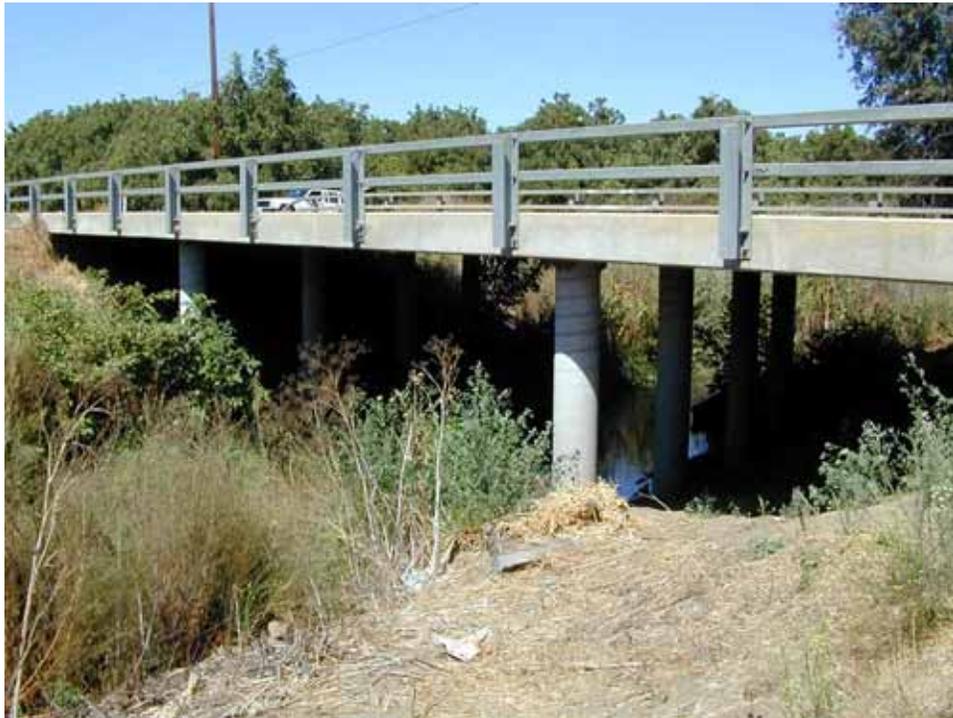
Because the structure has no apron or riprap scour protection and there is no visible water surface difference between one side of the structure and the other, it is not a barrier to fish migration. We will be confirming this by modeling fish passage at the McAllen Road Bridge.

**Photo A-92. Alpine Road Bridge**

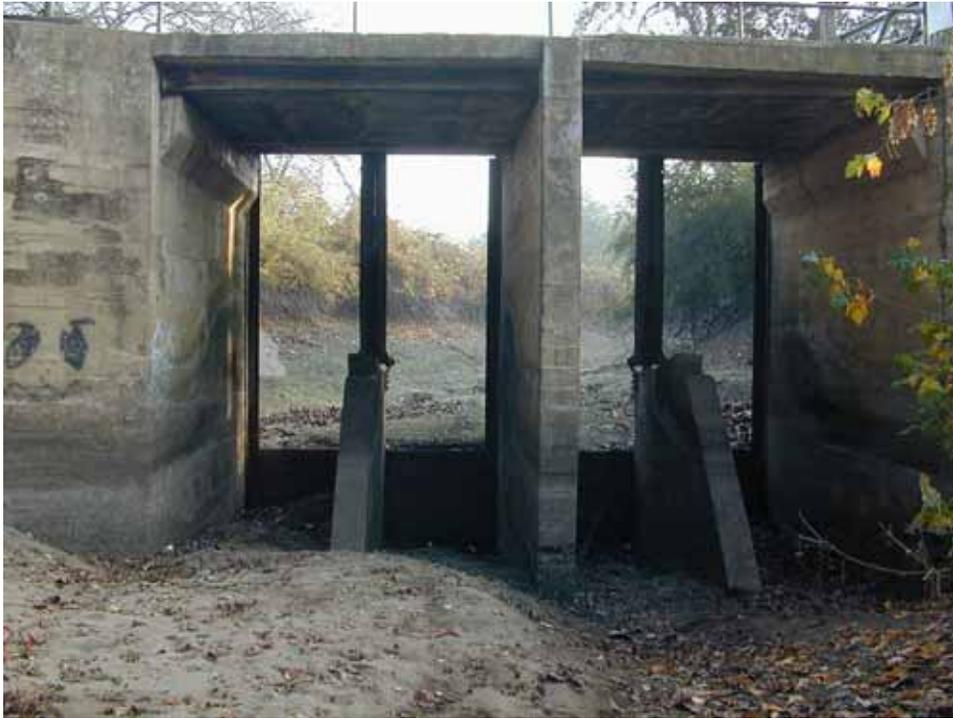
Pezzi Flashboard Dam is near river mile 12, downstream from the Calaveras Headworks. The structure is a concrete box culvert with two bays oriented perpendicular to the river (Photo A-95). The structure supports flashboards during the irrigation season and is topped with a 20-foot-wide bridge.

**Photo A-95. Looking upstream at Pezzi Flashboard Dam**

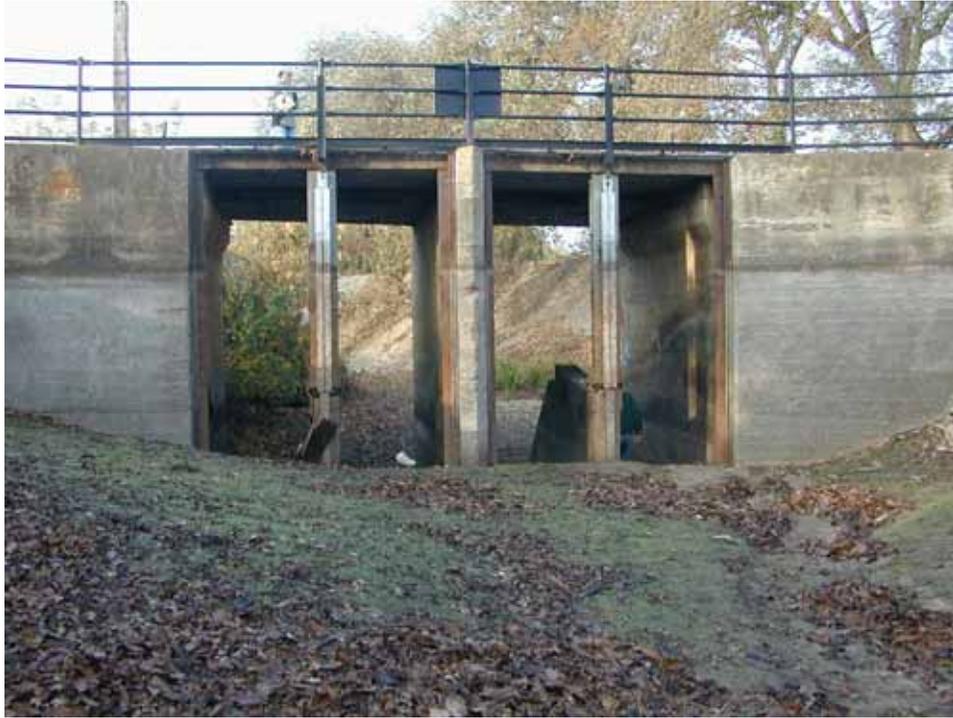
**Photo A-97. Upstream view of Pezzi Flashboard Dam. Note sediment accumulation at inlet**

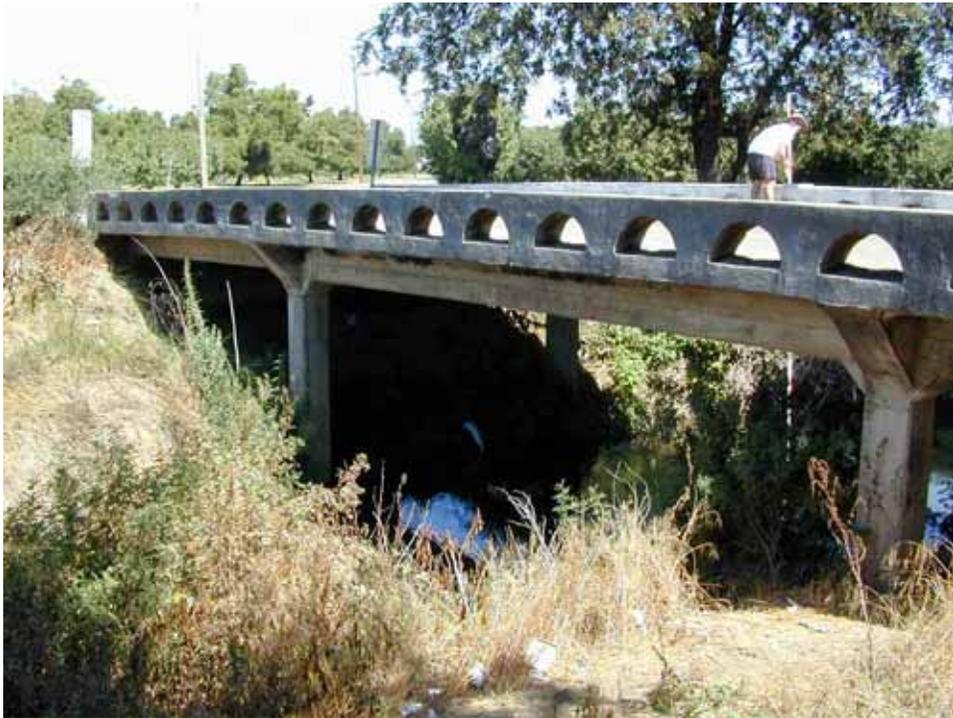
Because the structure has no apron or riprap scour protection and there is no visible water surface difference between one side of the structure and the other, it is not a barrier to fish migration. We will be confirming this by modeling fish passage at the McAllen Road Bridge.

**Photo A-100. Pezzi Road Bridge on the Calaveras River**

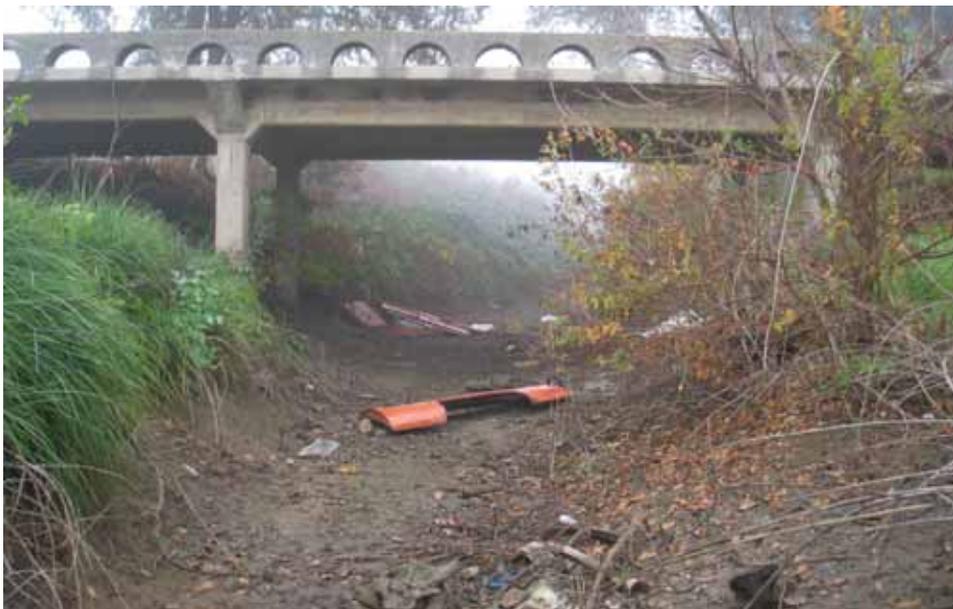
**Photo A-101. Trash under Pezzi Road Bridge**

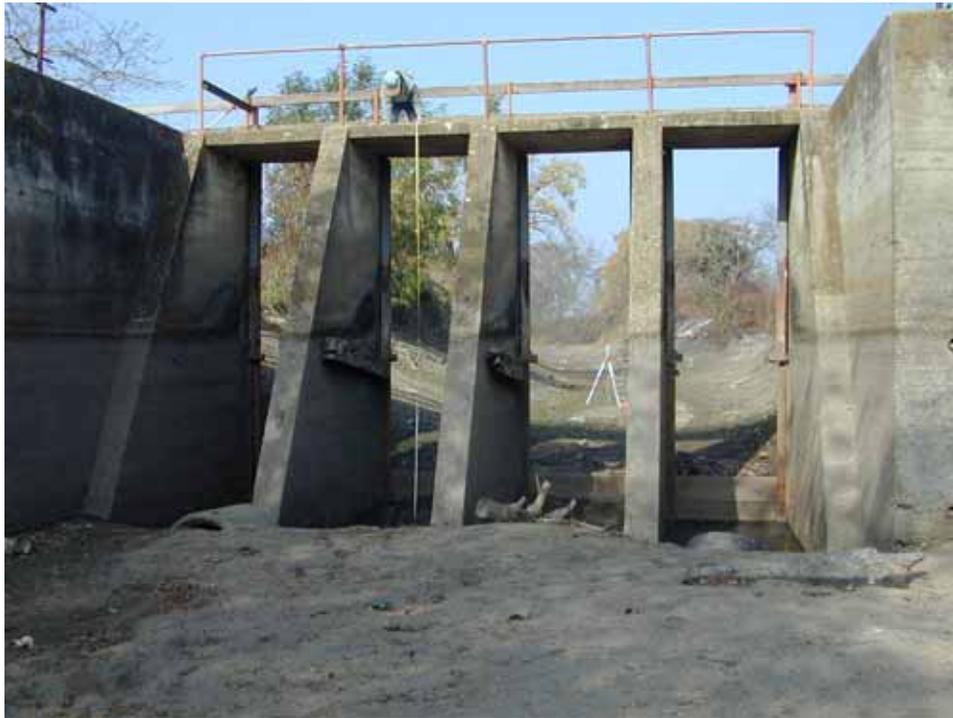
Downstream of the culvert, the channel continues its gradual meander, and has a wide, rounded trapezoidal shape. Concrete lines both banks for about 24 feet downstream of the structure's abutments. Beyond the concrete lining, the silty-clay lower banks and channel are free of debris and vegetation (Photo A-107). The upper side slopes are well vegetated with shrubs and trees (Photo A-108). Although there is a scour pool inside the culvert due to water flow over the flashboards, the scour is localized. Once outside the culvert, the channel thalweg rapidly returns nearly to that of the upstream elevation (Photo A-103).

**Photo A-103. View from downstream side of Murphy Flashboard Dam**

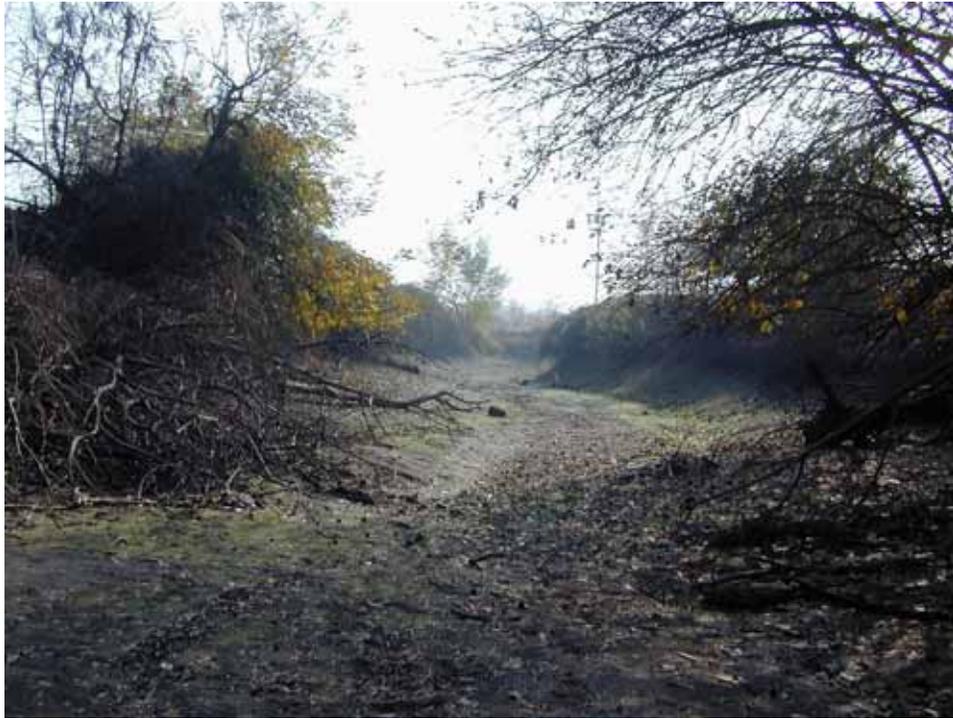
**Photo A-107. Calaveras River channel downstream of Murphy Flashboard Dam**

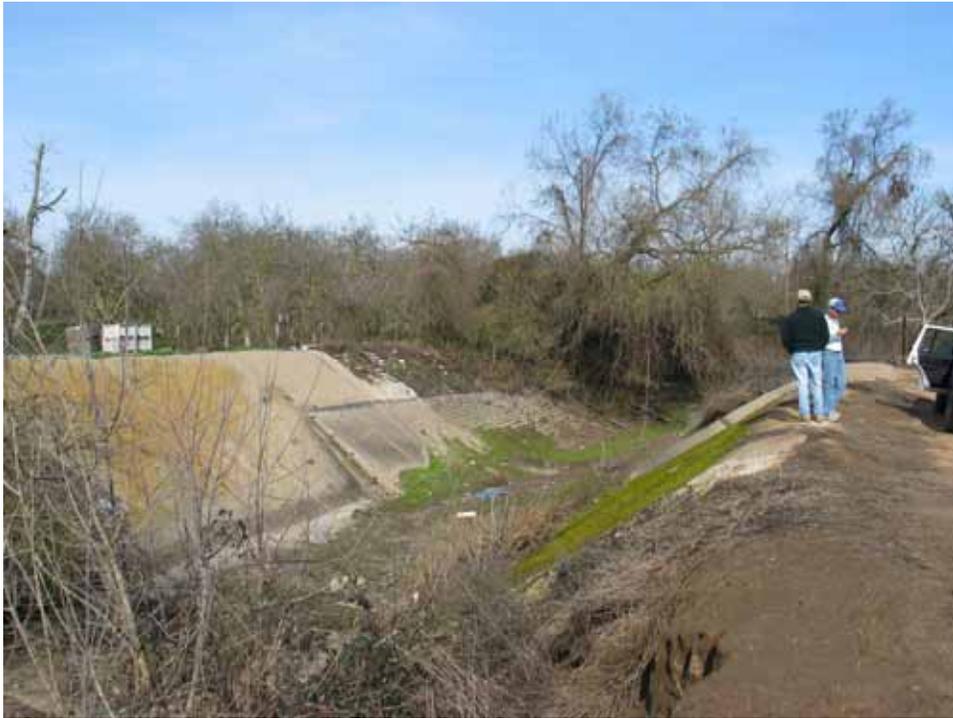
The minimum plunge pool depth of 2 feet for juvenile salmonids is met at Eight Mile Flashboard Dam. The modeling results from McAllen Dam will be used to assess fish passage at Eight Mile flashboard Dam.

**Photo A-115. Eight Mile Flashboard Dam base**

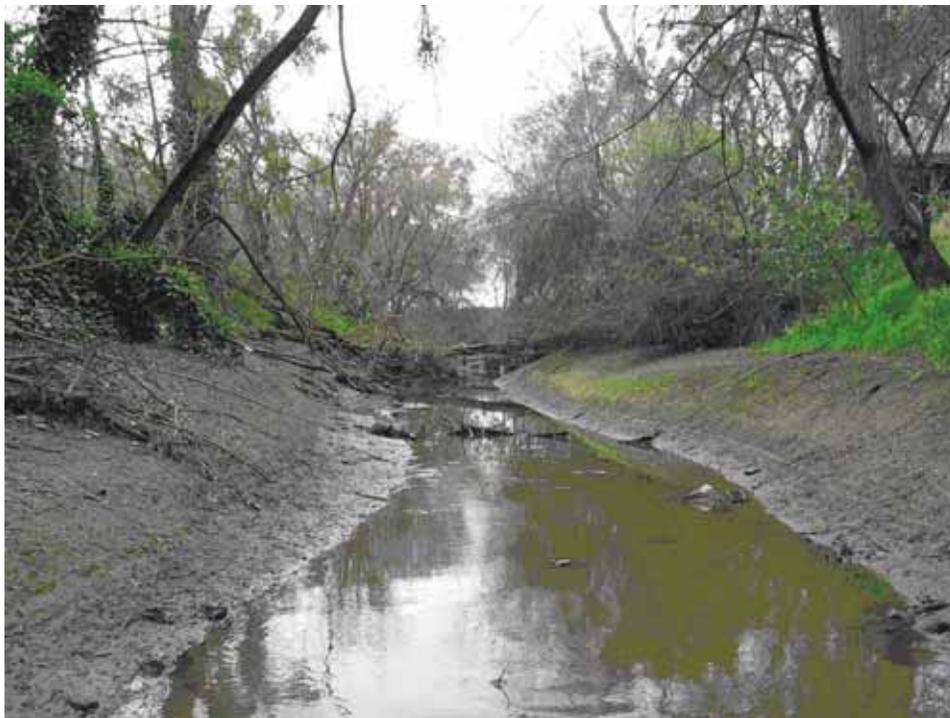
Downstream of the footbridge the river channel is bare earth composed of silty-clay soil. The channel is trapezoidal and has a slight meander. The downstream banks are steep. The right and left banks are heavily vegetated with bushy weeds and grasses until you reach the edge of the active channel where the banks give way to bare earth. Visible riparian trees provide shade to the river channel. Further downstream is a logjam across the river channel (Photo A-124).

**Photo A-124: Looking downstream from Jack Tone Footbridge on the Calaveras River**

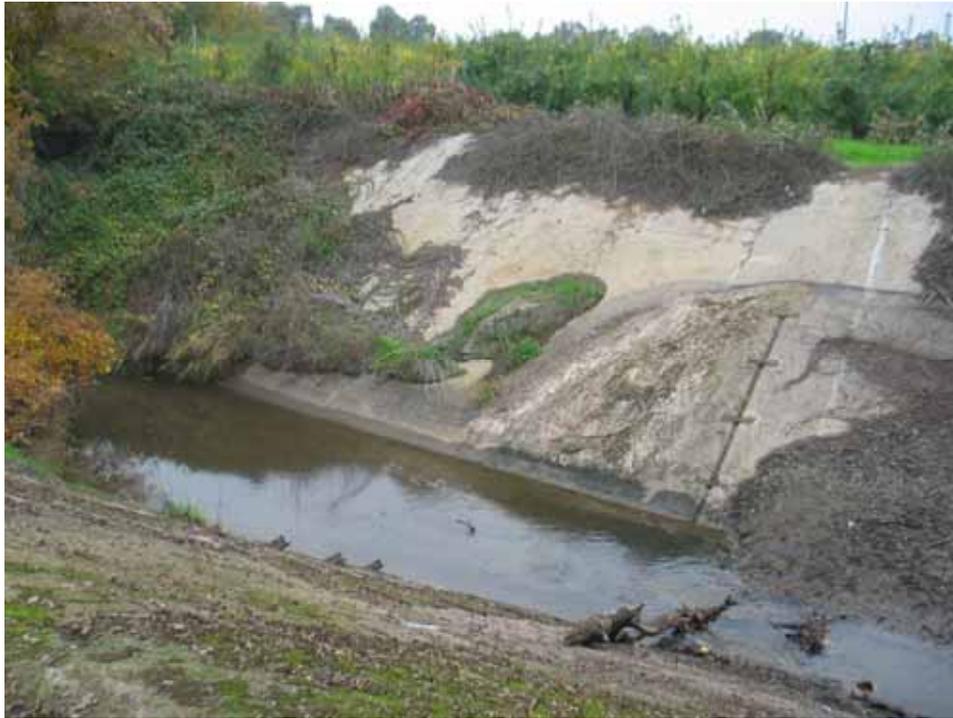
**Photo A-128. Looking at the base of Tully Flashboard Dam**

Tully Flashboard Dam is at river mile 17.9, immediately upstream of Tully Road Bridge. The base of the structure (Photo A-128) provides support for flashboards during irrigation season. When the flashboards are removed, the channel typically receives minimal flows.

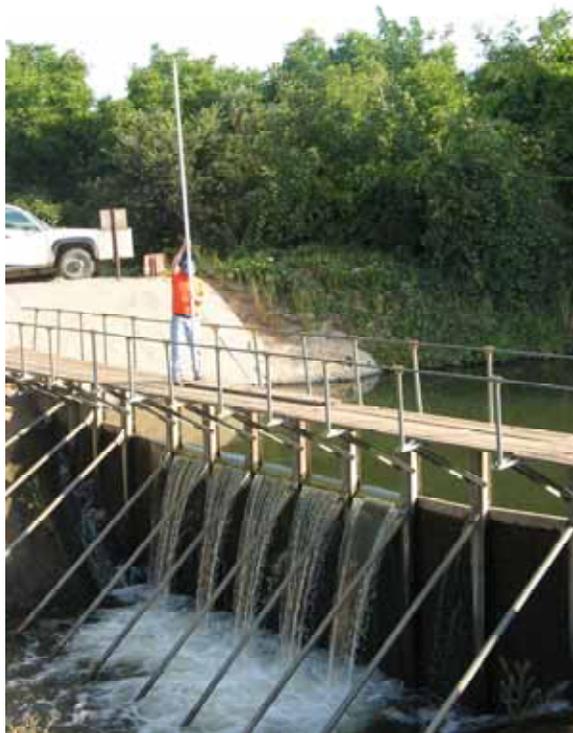
**Photo A-131. Looking at Tully Flashboard Dam**

Tully Flashboard Dam is 10 feet high and spans 67 feet across the river (Photo A-131). During the irrigation season, the dam creates a 7.2-foot water surface difference. Modeling results from McAllen Dam will be used to assess fish passage at Tully Flashboard Dam.

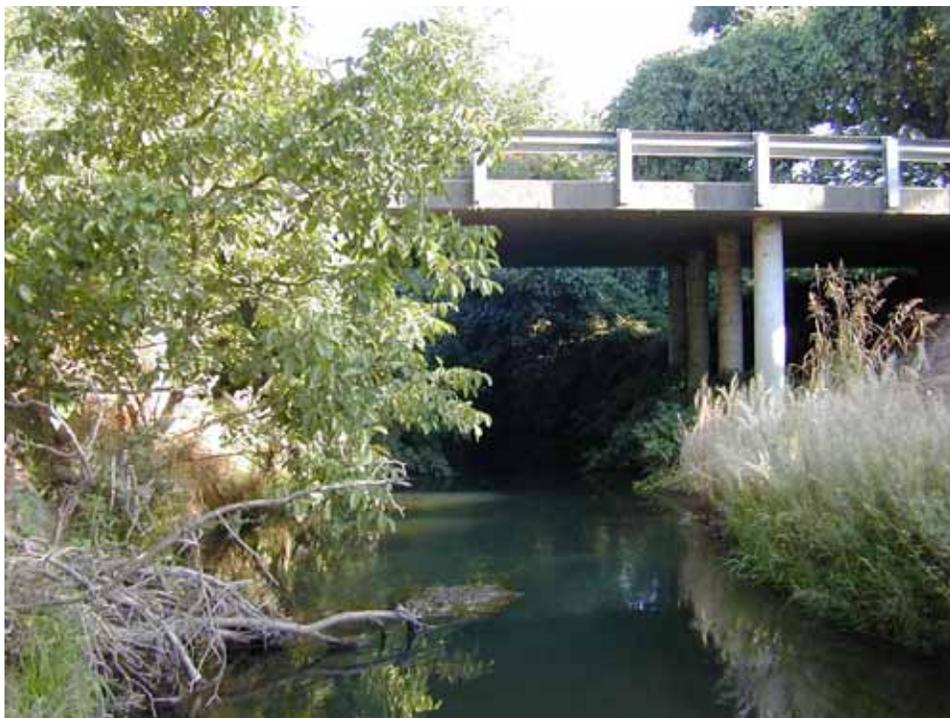
**Photo A-138. Upstream at Messick Road Bridge**

The Messick Road Bridge crosses perpendicular to the Calaveras River at river mile 20.1, downstream from the Calaveras Headworks (Photo A-138). The bridge appears to be in good condition with few signs of age.

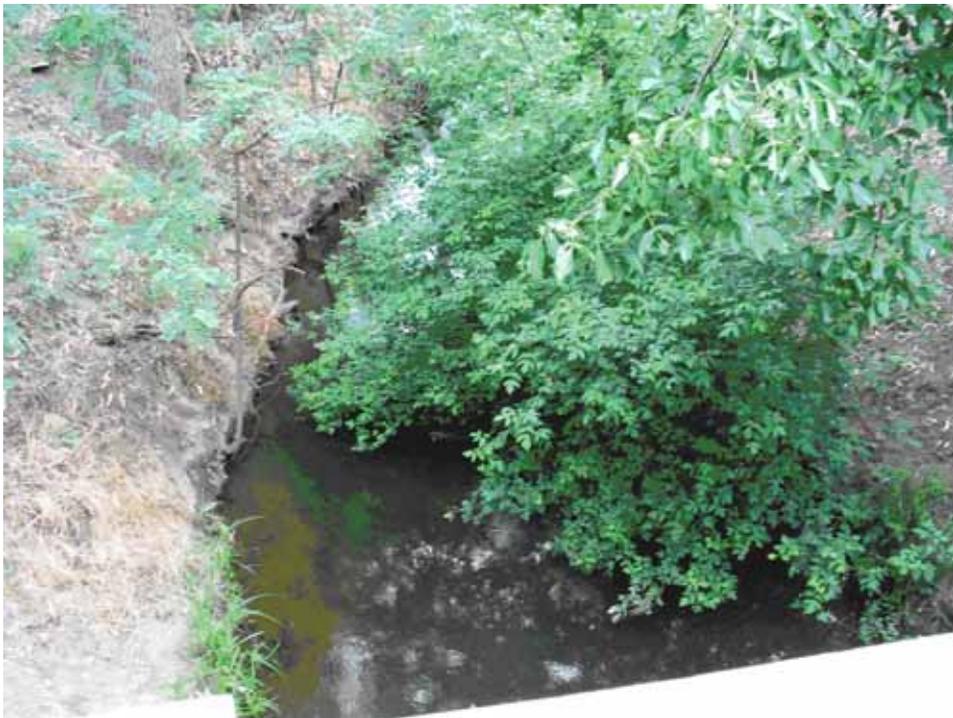
Downstream of the bridge, past the riprap, the river channel is bare earth composed of silty-clay soil. The channel is trapezoidal and has a slight meander. The right bank is heavily vegetated with bushy weeds, and the left bank is dominated by grasses. Visible riparian trees provide shade to the river channel (Photo A-143). The upstream and downstream areas surrounding the river are dominated by orchards.

**Photo A-143. Looking downstream from Guernsey Road Bridge at the log jam**

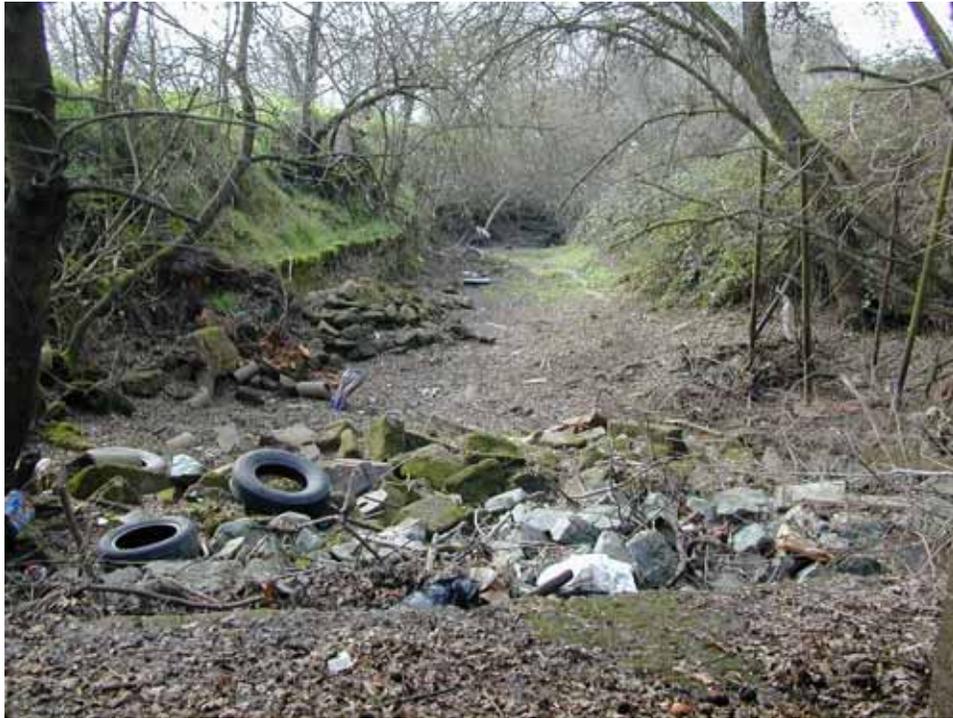
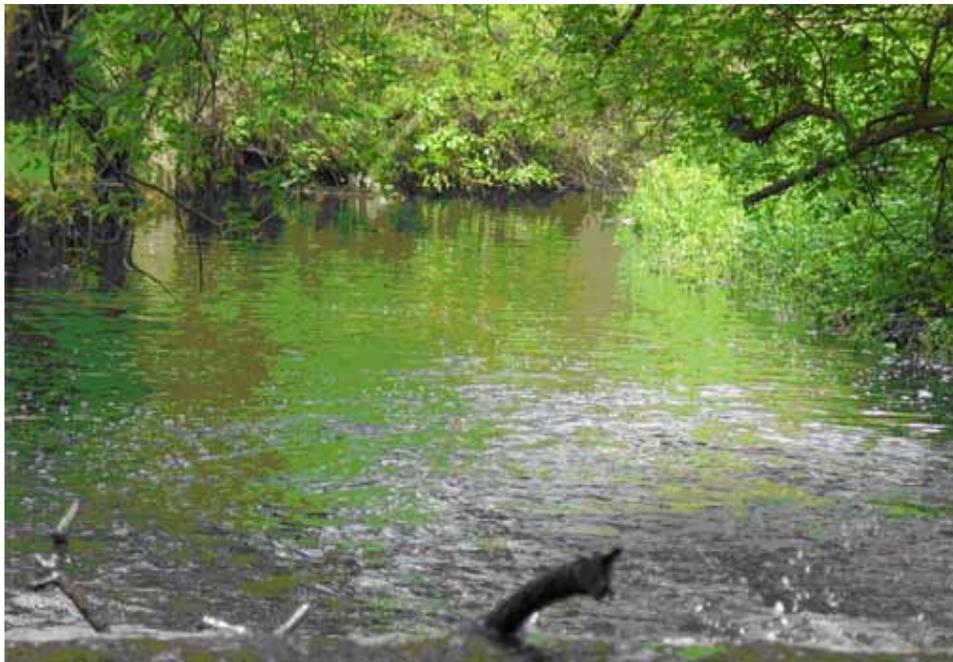
The downstream channel is similar to the upstream, except for the area immediately downstream from the outlet apron (Photo A-146 and Photo A-147). From the edge of the apron, a 3-foot drop onto a steep cascade over concrete rubble, debris, and riprap extends 36 feet downstream (Photo A-148 and Photo A-149). Concrete rubble also lines the channel banks near the culvert outlet and along the left side of the river (facing downstream).

**Photo A-146. Downstream channel from Clements Road Dam Outlet**

**Photo A-147. Channel downstream of Clements Road Dam during irrigation season**

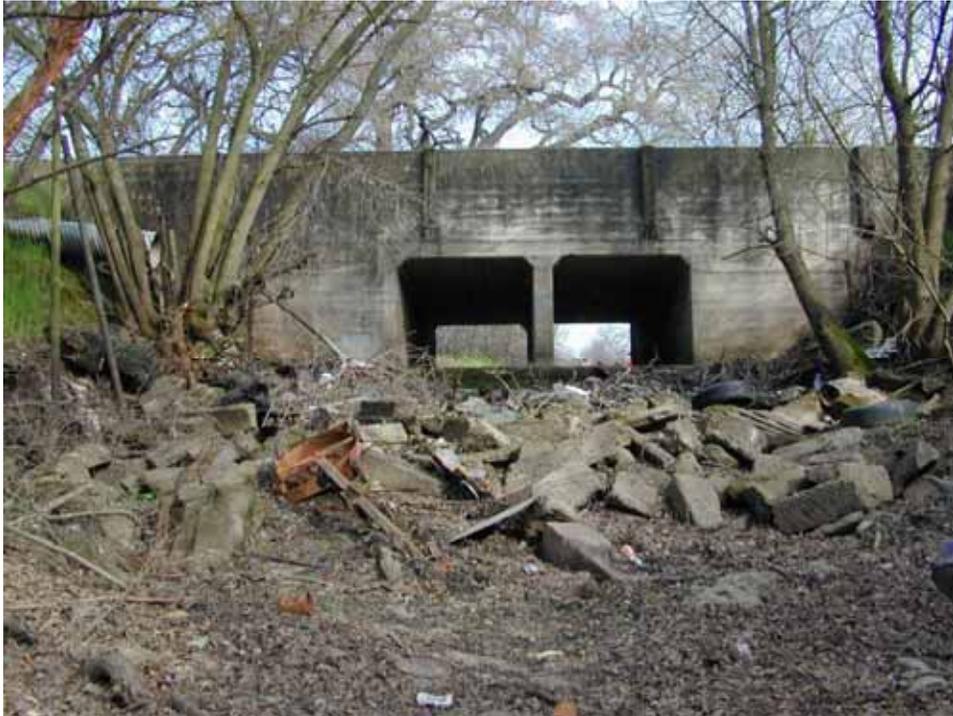
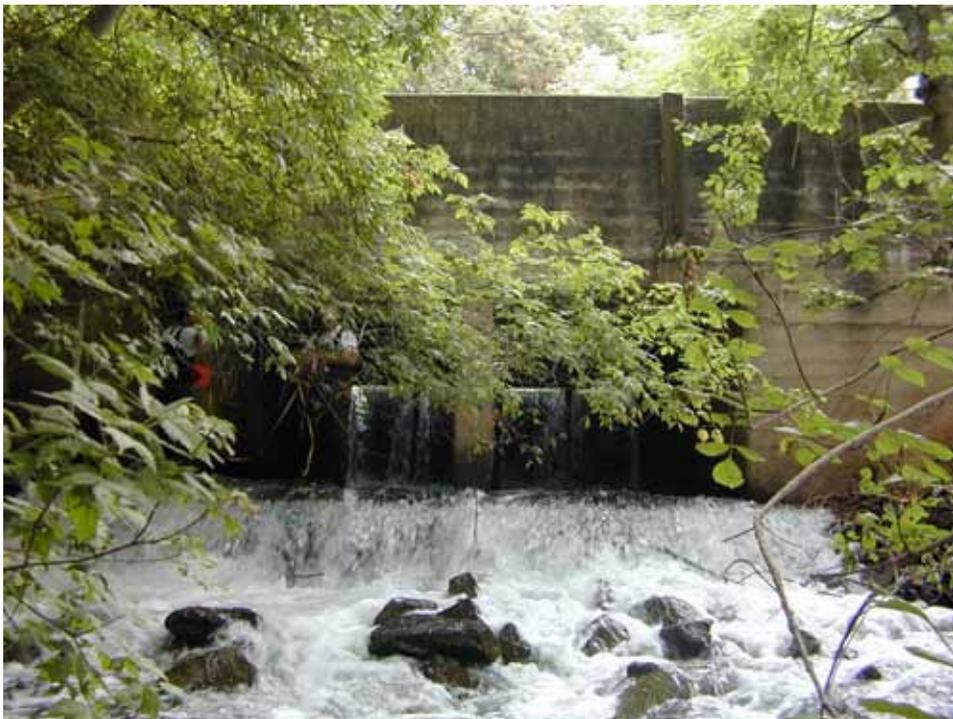
**Photo A-148. Downstream of Clements Road Dam looking upstream**

**Photo A-149. Downstream of Clements Road Dam looking upstream with flashboards installed**

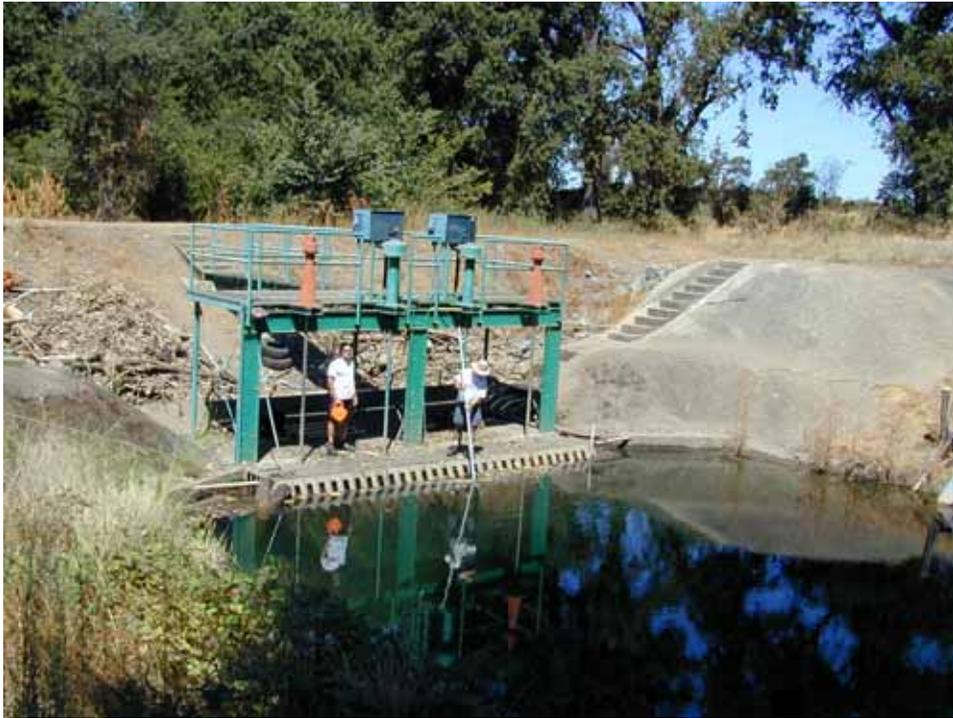
Calaveras Headworks is on the Calaveras River at about river mile 26 and near Bellota Weir. The Headworks, in combination with Bellota Weir, provide flow bifurcation control between Mormon Slough and the Calaveras River. The structure is at the head of the old Calaveras channel, perpendicular to the direction of flow, and includes an earthen berm, four culverts with control gates, a trashrack, and concrete slope lining (Photo A-183).

**Photo A-183. View from upstream of Calaveras Headworks**

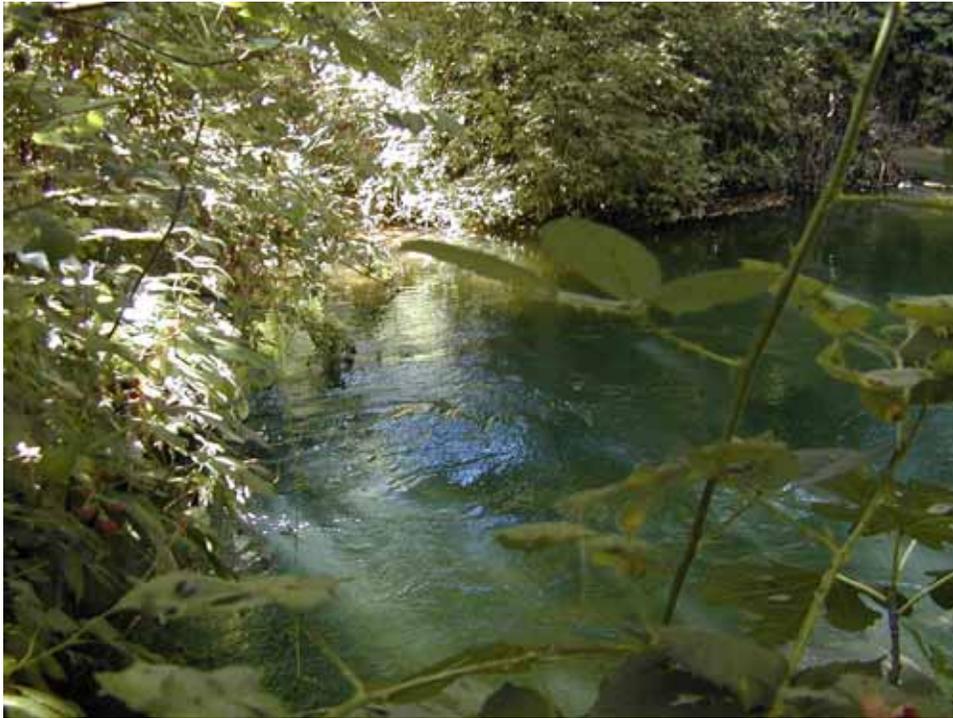
The Calaveras Headworks is a total barrier to upstream adult fish migration and likely a major impediment to downstream juvenile migration. The Headworks is operated to block most downstream flows from entering the Old Calaveras channel in the winter season, when adult salmon and steelhead are migrating. When the culvert gates are closed, the downstream channel is dry and impassible to fish. Winter flows in the system are directed into Mormon Slough, which is a constructed flood-control channel. During the mid-April to mid-October irrigation season, the Calaveras Headworks culvert gates are adjusted to deliver water downstream for irrigation uses. Juvenile downstream migrants may find their way through the gate openings and into the Old Calaveras Channel. Because juveniles prefer to stay in the upper to middle part of the water column, the location of the culverts near the bottom of the channel is not favorable for outmigration. If the Old Calaveras channel is to be used as a migration corridor, the Calaveras Headworks will require complete redesign, and the entire system operation will require modification. An assessment of fish passage at Calaveras Headworks is represented by the modeling results from Clements Bridge and flashboard dam.

**Photo A-187. Downstream culvert outlet at Calaveras Headworks**

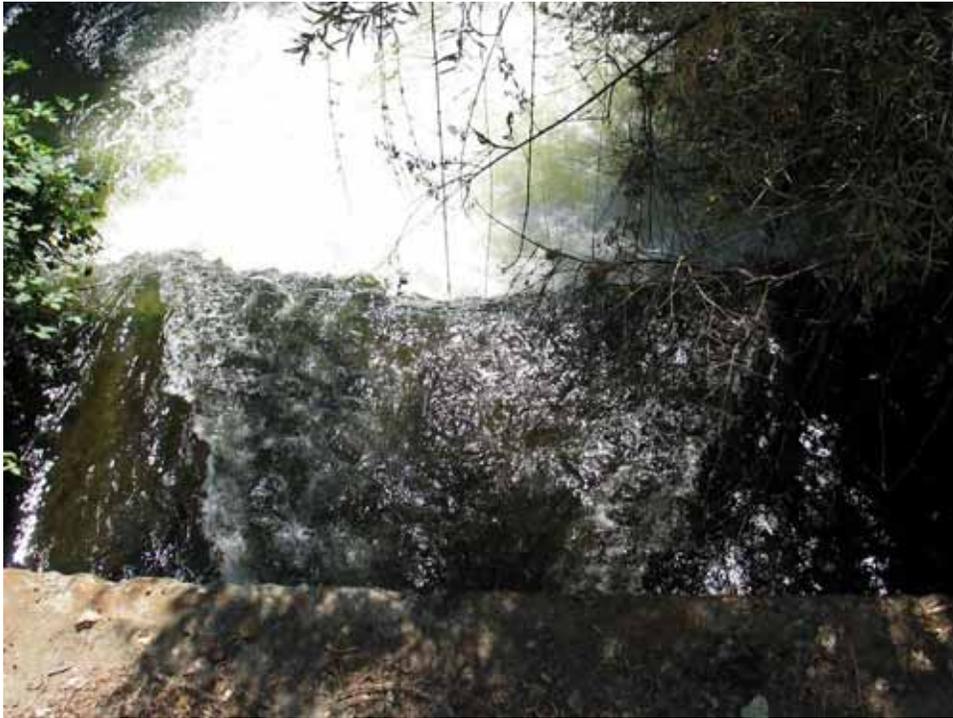
Downstream of the LFC, riparian forest surrounds both banks of the river channel (Photo A-194). The downstream end of the culvert contains an apron (Photo A-195). There is at least a 2-foot drop from the apron to the channel, further complicating salmonid fish passage. Downstream of the drop from the apron, the river water circulates in an eddy pattern, before continuing downstream. This could be an especially dangerous situation for juvenile fish.

**Photo A-195. From McGurk Low-flow Road Crossing looking at culvert apron**

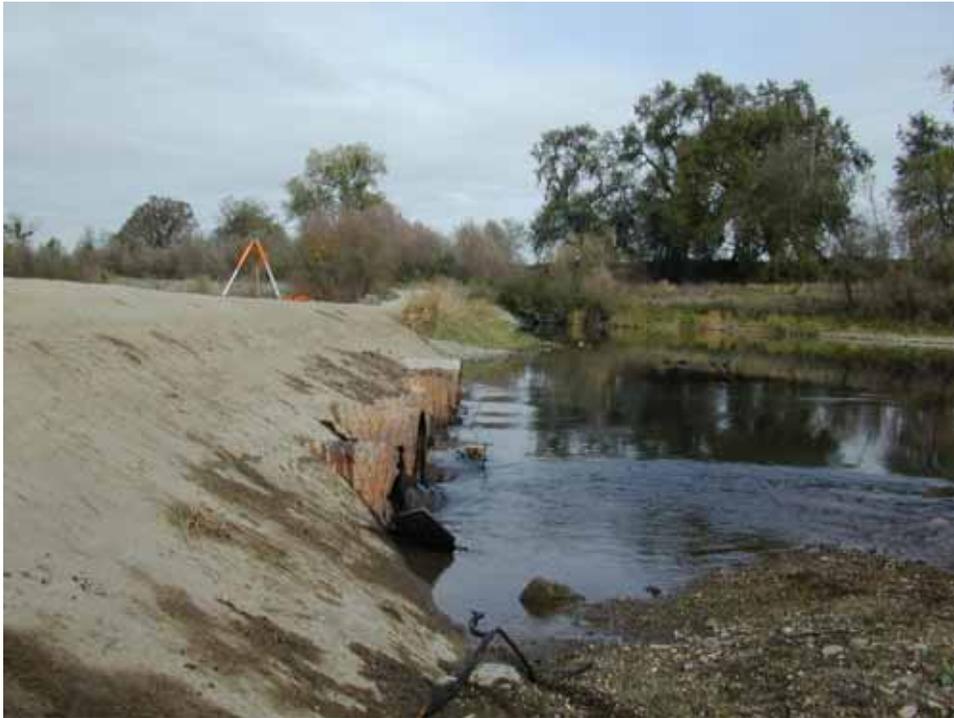
Downstream of the LFC, mature riparian forest surrounds the river channel (Photo A-199). The downstream side has similar characteristics and fish passage issues compared to the upstream side. Migrating adult salmonids may have difficulties locating the culverts and dealing with the water velocities passing through the culverts.

**Photo A-197. Culverts in Wilsons Low Flow Road Crossing**

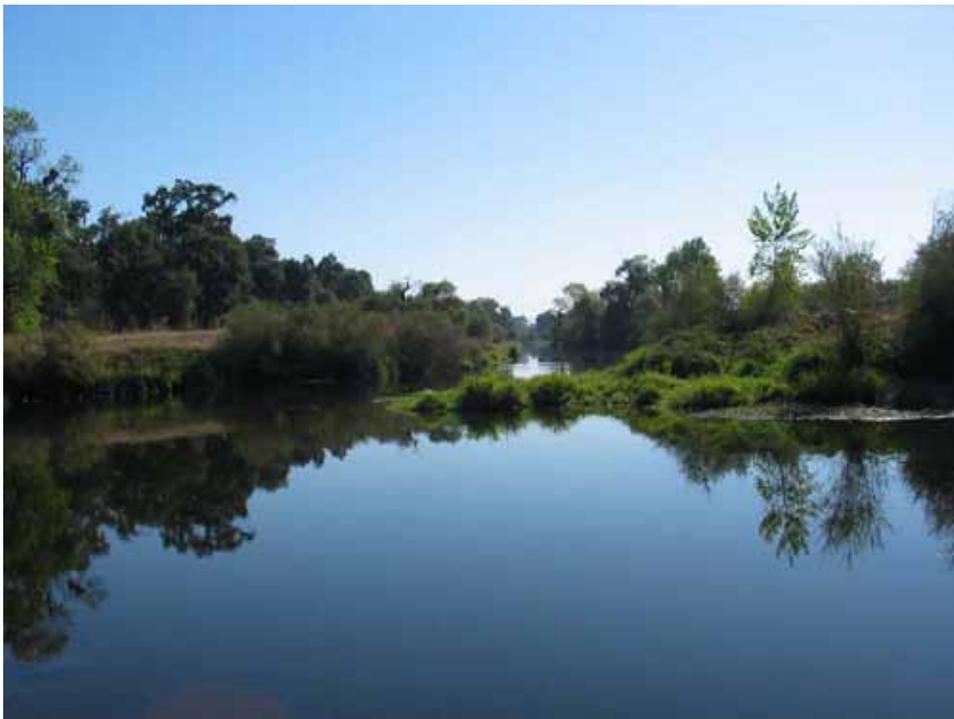
Upstream of the LFC, mature riparian forest surrounds the river channel (Photo A-198). Due to the width of the river channel upstream of the LFC, the water velocities in this area are low. The entire 350-plus-foot width of the river upstream of the LFC passes through 6 culverts clustered in the same location. This may result in high water velocities passing through each culvert. These conditions may create issues with migrating juvenile salmonids.

**Photo A-198. Upstream from Wilsons Low-flow Road Crossing**

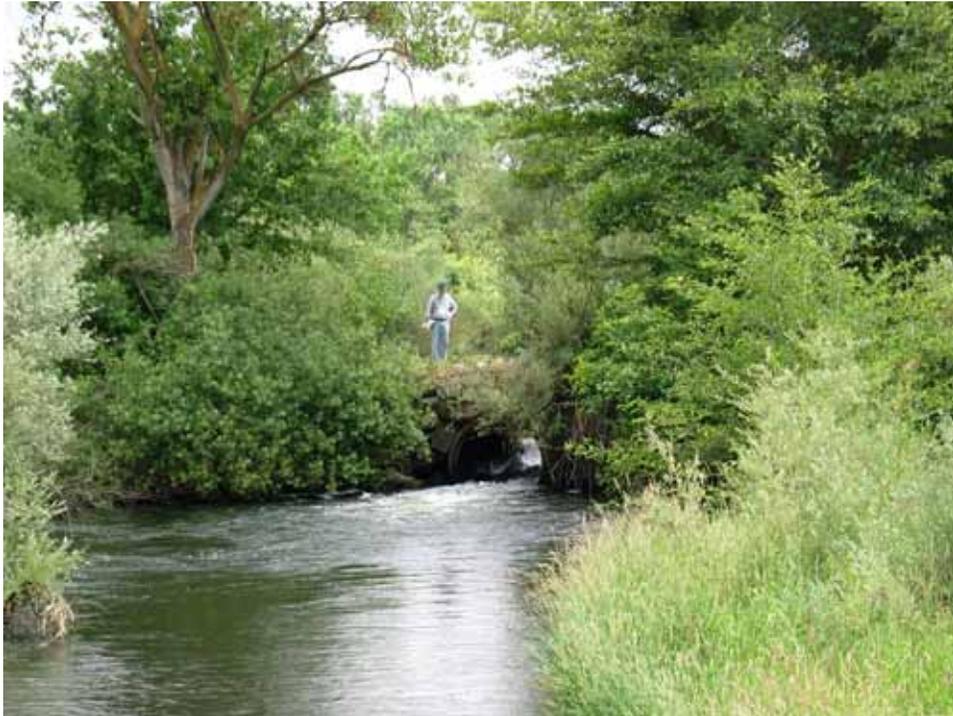
Both culverts within the LFC have similar dimensions. However, the upstream end of one of the culverts is almost completely blocked by woody debris and has minimal flow. With one culvert blocked, the other passes a majority of the flow, creating high water velocities (Photo A-203).

**Photo A-203. Downstream end of culvert within Old Dog Ranch Low-flow Road Crossing**

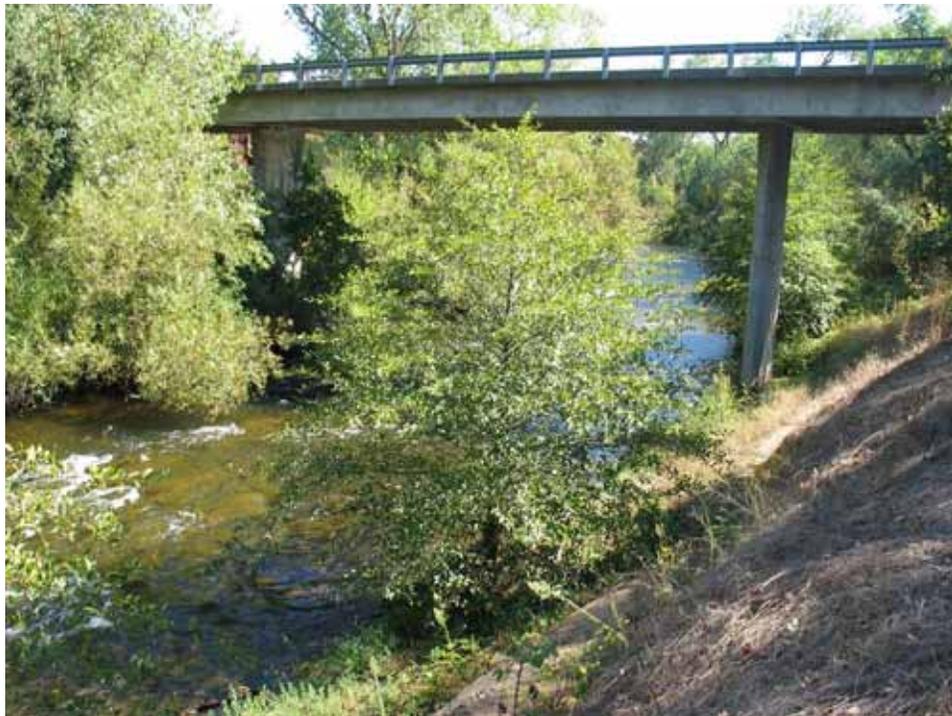
**Photo A-207. Shelton Road Bridge**

The Shelton Road Bridge crosses perpendicular to the Calaveras River near river mile 31, upstream of the Calaveras Headworks (Photo A-207).

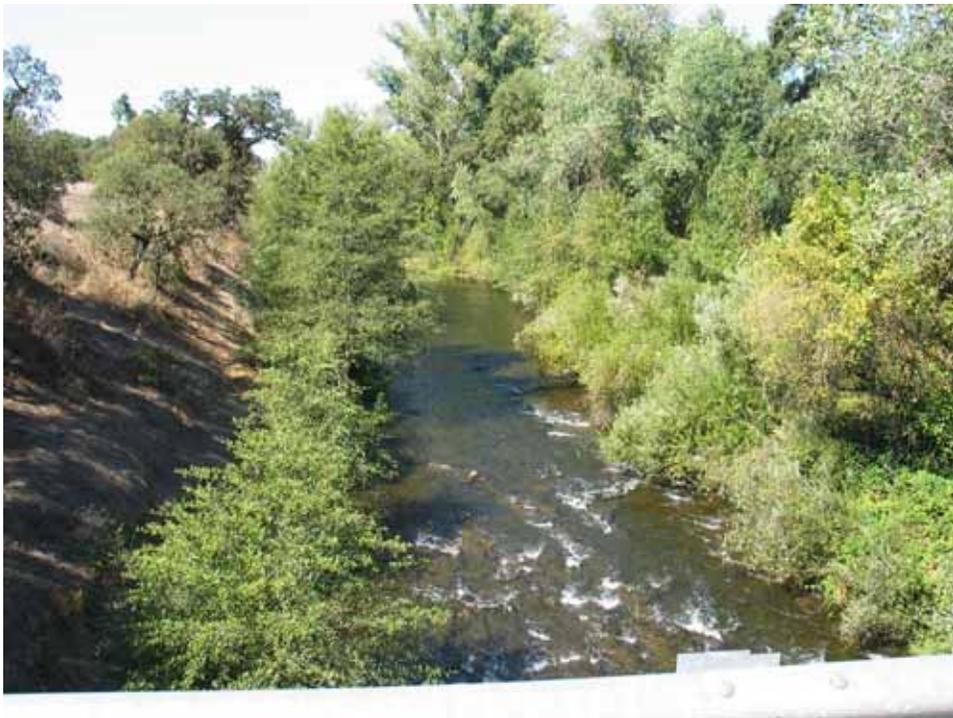
**Photo A-209. Downstream from Shelton Road Bridge**

The river channel downstream contains riffles, pools, gravels, larger streambed materials, and woody debris (Photo A-209). The channel is trapezoid in shape and has meander. Downstream, the right bank is gentle; the left bank is steeper. Both banks, especially right bank, contain riparian vegetation; including oaks, and willows.
