## Appendix A Site Descriptions

## **Appendix A Site Descriptions**

### **Calaveras River Downstream of Confluence with the Stockton Diverting Canal**

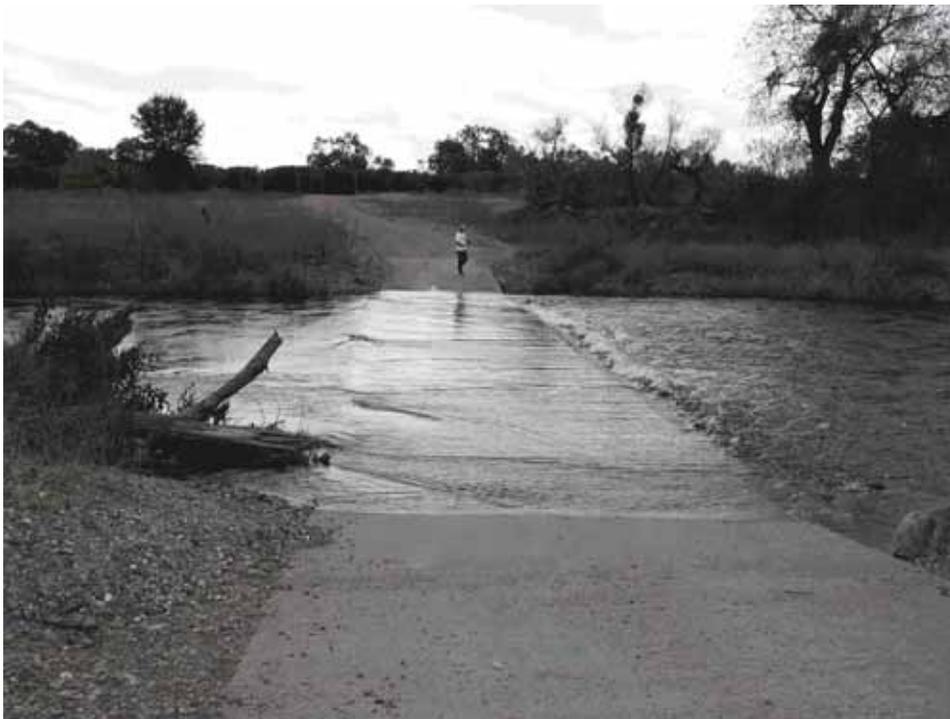
**Photo A-211. Gotelli Low-flow Road Crossing (River Mile 35.3)**

The Gotelli crossing is a culvert that provides for vehicular access across the Calaveras River (Photo A-211). The structure is on the Calaveras River at river mile 35.3, upstream of the Calaveras Headworks. The crossing consists of at least one circular corrugated metal culvert. The road crossing is paved and is 14 feet wide by 142 feet long. The bankfull channel width is 90 feet. There is a 3.2-foot drop from the crest of the road crossing to the channel bed. In certain flow conditions, this creates fish passage issues. There is some scattered rubble downstream of the crossing.

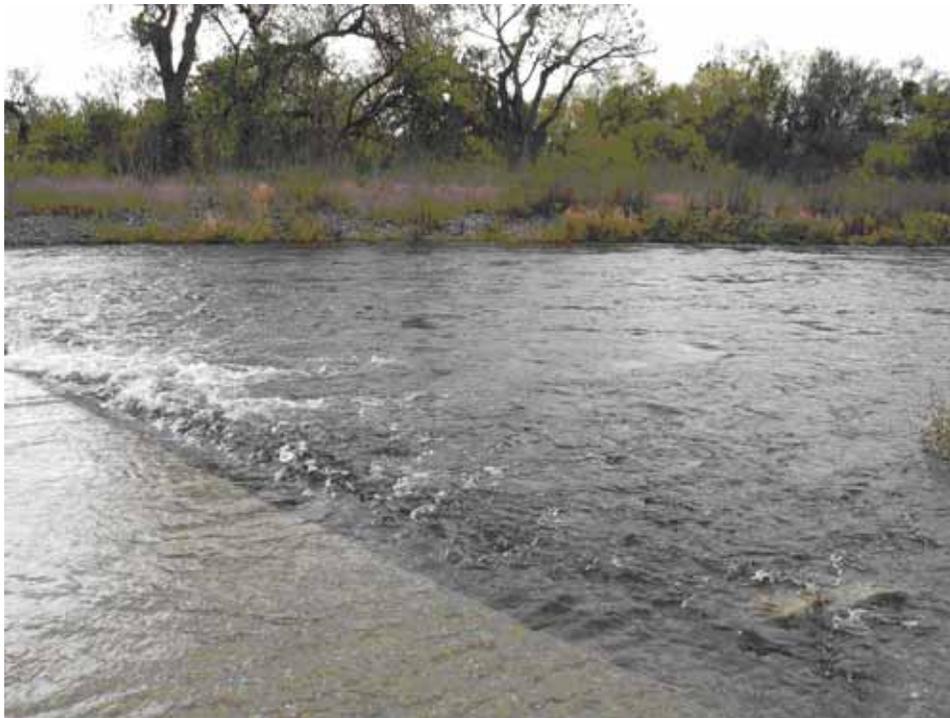
**Photo A-213. Calaveras downstream of Gotelli Low-flow Road Crossing (River Mile 35.3)**

The channel near the crossing is lined with rubble. Farther downstream, the channel is composed of a gravelly substrate. The other downstream channel properties are similar to that of the upstream channel (Photo A-213).

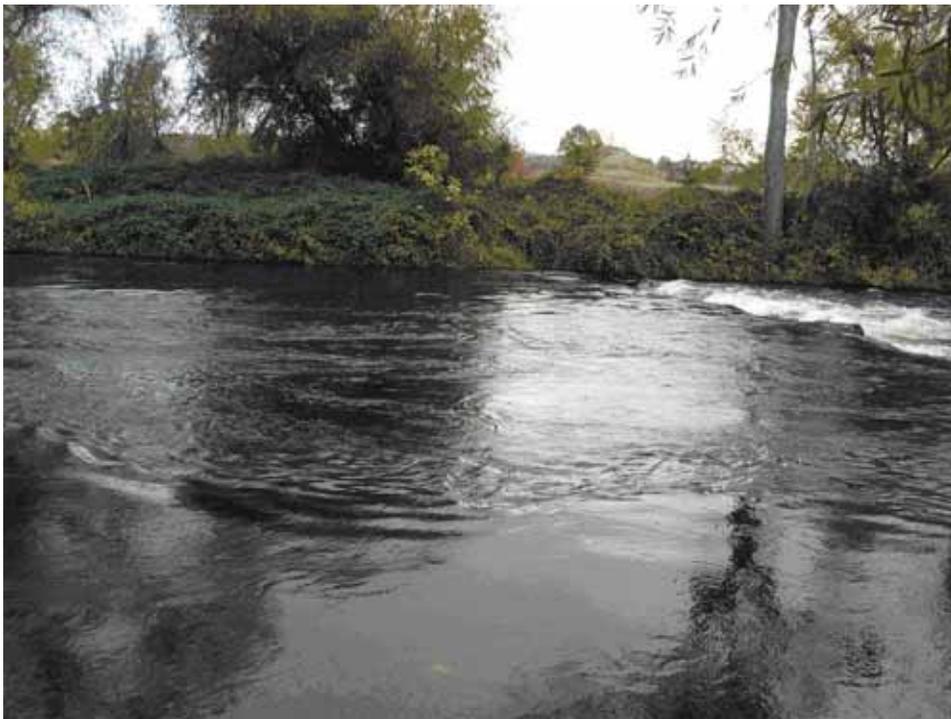
**Photo A-214. Rubble Dam upstream of Bellota Weir in Calaveras River channel**

The Rubble Dam upstream of Bellota Weir is in the Calaveras River at river mile 35.5, upstream of the Calaveras Headworks (Photo A-214). The rubble dam at the time of the photo was almost completely submerged by the river. Depending on the river flows, the rubble dam may be an impediment to upstream and downstream fish passage. A drop associated with the dam may hinder passage. The scattered rubble under low flow conditions may also create passage issues.

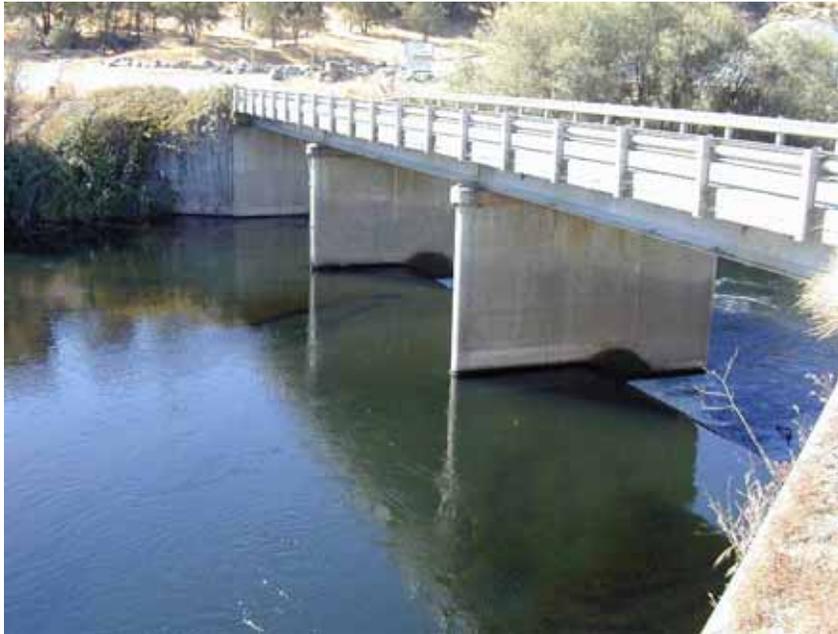
**Photo A-215. View across New Hogan Dam Road Bridge from upstream**

The bridge at New Hogan Dam Road crosses perpendicular to the Calaveras River near river mile 43. Approximately 125 feet long and 26 feet wide, the concrete bridge has 2 piers supporting the span that are approximately 2 feet wide by 26 feet long (Photo A-215). The piers divide the river into three channels of equal width. Concrete wing walls on both the upstream and downstream side of the bridge protect the end abutments. A concrete weir is beneath the bridge perpendicular to the flow at about the midpoint of the piers (Photo A-216). The weir is part of the gaging system at the bridge.

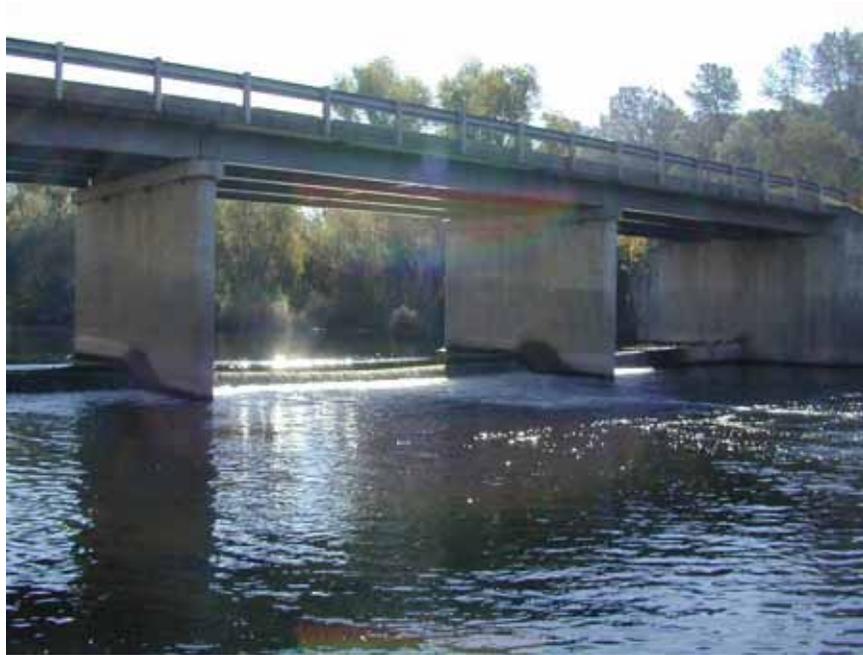
**Photo A-219. View across New Hogan Dam Road Bridge from downstream**

Because of the gaging weir and the channel constriction at the bridge, water flow is swift downstream of the structure (Photo A-219). The plunge pool below the weir is greater than 5 feet deep. The channel depth decreases to approximately 0.5 feet deep and flows over cobble substrate about 100 feet downstream of structure. The vegetation on the banks is the same as the upstream reach (Photo A-220).

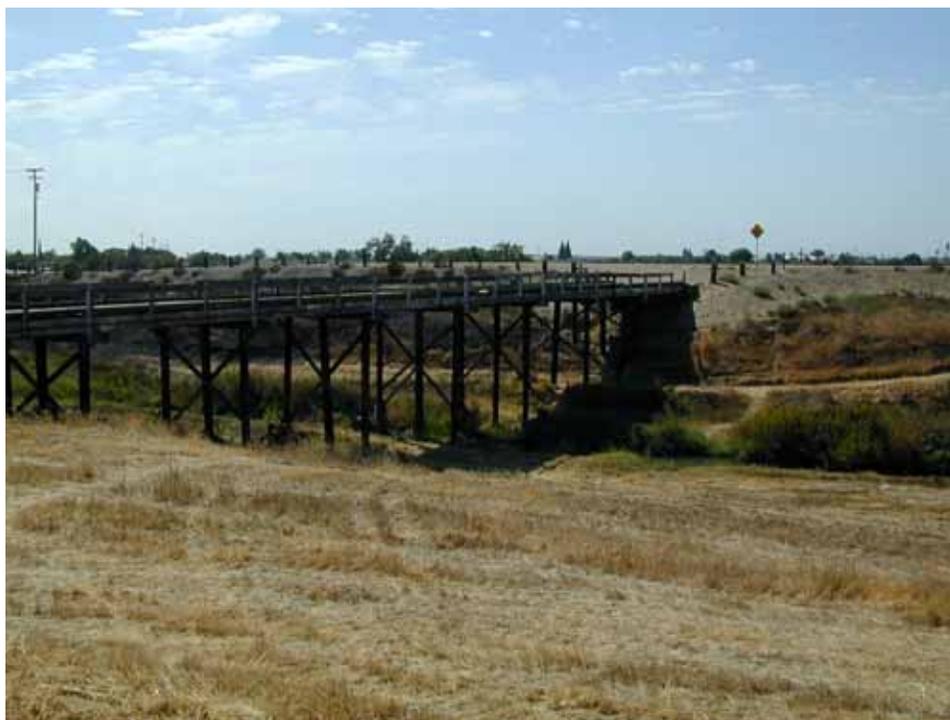
**Photo A-221. Wooden Bridge West of Wilson Way**

The wood bridge west of Wilson Way (Photo A-221) is 215 feet long and 23 feet high. It crosses the Stockton Diverting Canal west of Wilson Way and near Sanguinetti Lane. Ten piers spaced 20 feet apart support the bridge, each made up of 3 cross-braced columns. The active channel is 20 feet wide. The channel bottom is sandy with some coarse gravel, rocks, and debris, such as lumber and shopping carts, and weeds and brush cover the banks. Because there is no apron or riprap scour protection under the bridge and no visible water surface difference, it is not a barrier. We will confirm this by modeling fish passage at the Fine Road Bridge.

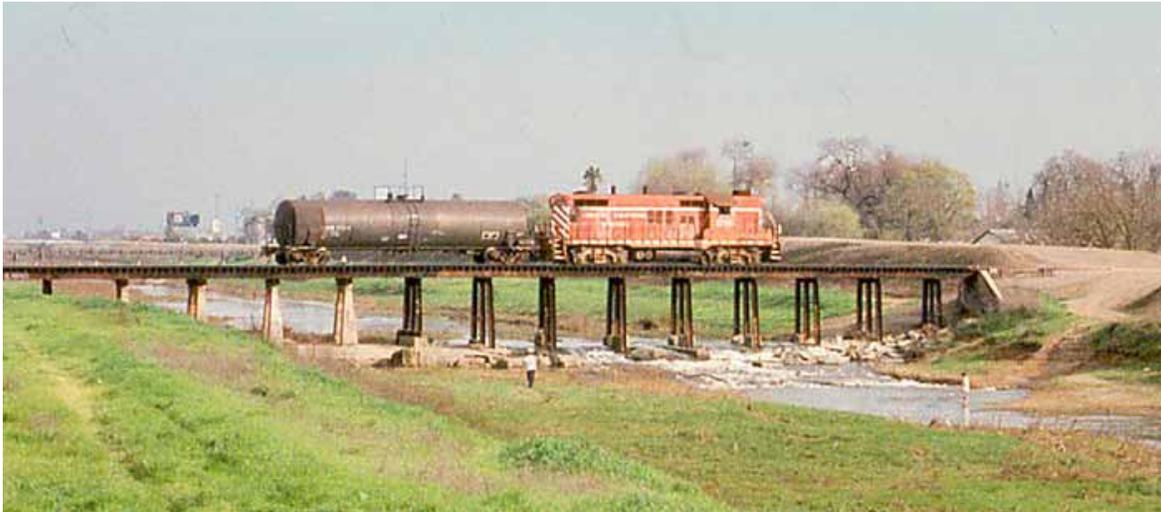
**Photo A-224. Downstream face of CCTRR**

The Central California Traction Railroad Bridge was one of the eight structures modeled in 2004. Central California Traction is an active railroad line that crosses the Stockton Diverting Canal near river mile 1. The structure is oriented perpendicular to the flow path, and the bridge piers are aligned parallel to the direction of flow. The bridge spans 245 feet across the flood diversion channel with an active channel width of 165 feet (Photo A-224).

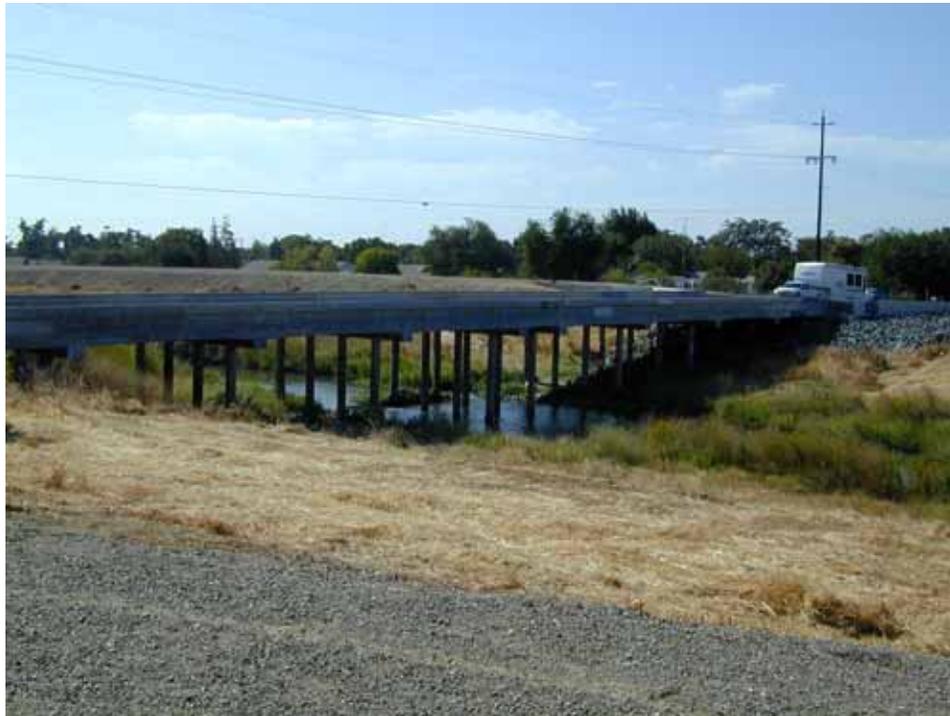
**Photo A-230. Cherokee Road Bridge from the left bank looking downstream**

Cherokee Road Bridge (Photo A-230) is a 17-foot-high concrete bridge that spans the 212 feet of the Stockton Diverting Canal. The site is three-tenths of a mile upstream of river mile 1.0. Nine piers, each made up of four columns, support the bridge. The piers are 24 feet apart except for the 9-foot gap between the center piers. Water primrose grows along the water edge and into the channel, while grasses grow on the channel banks. The active channel is 110 feet wide. Because the bridge has no apron or riprap scour protection and there is no visible water surface difference, it is not a barrier to fish migration. We will confirm this by modeling fish passage at the Fine Road Bridge.

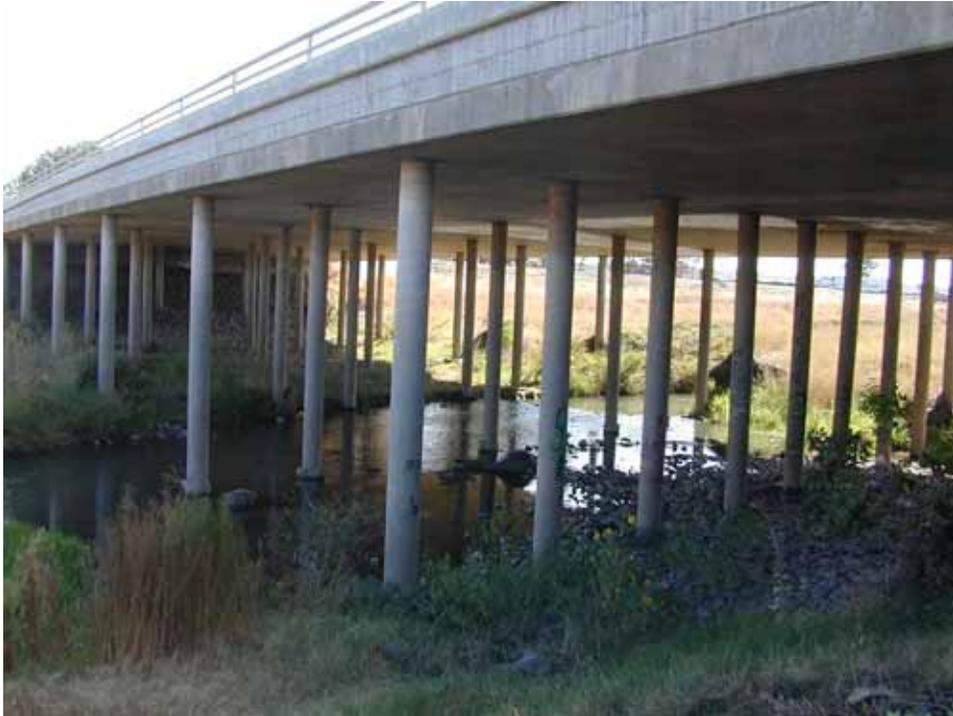
**Photo A-231. Waterloo Road Bridge looking upstream**

Waterloo Road Bridge (Photo A-231) is an 18-foot-high concrete bridge that spans the 257 feet of the Stockton Diverting Canal. The bridge is three-tenths of a mile downstream of river mile 2.0. Seven piers, each made up of nine columns, support the bridge. The active channel is about 110 feet wide. Because the bridge has no apron or riprap scour protection and there is no visible water surface difference, it is not a barrier to fish migration. We will confirm this by modeling fish passage at the Fine Road Bridge.

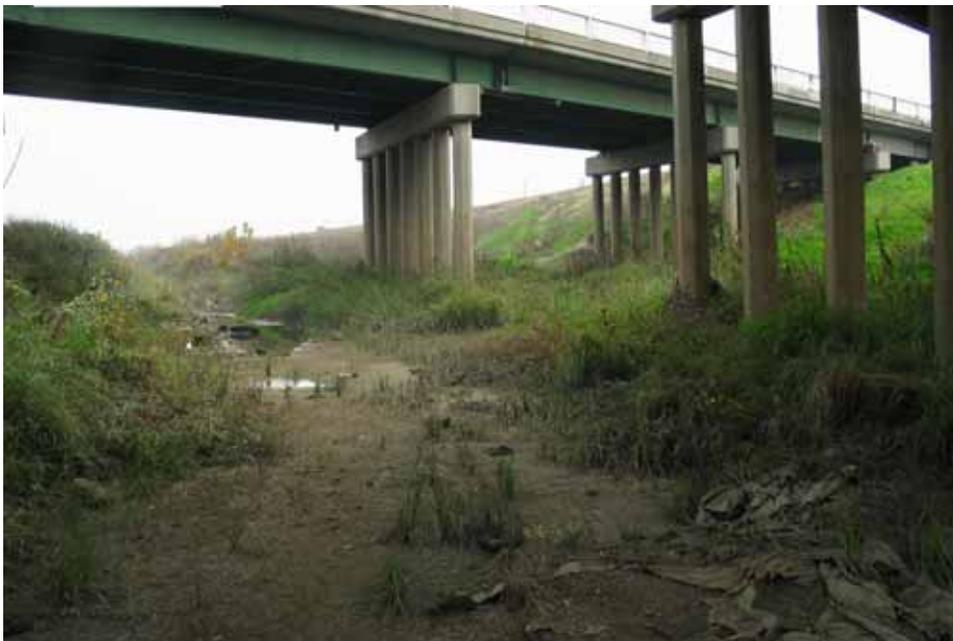
**Photo A-234. Highway 99 Northbound Bridge deck with low-flow channel dry**

The active channel is 29 feet wide with a silty bottom. Grass and weeds grow on the channel banks. Because the bridge has no apron or riprap scour protection and there is no visible water surface difference, it is not a barrier to fish migration (Photo A-234). We will confirm this by modeling fish passage at the Fine Road bridge.

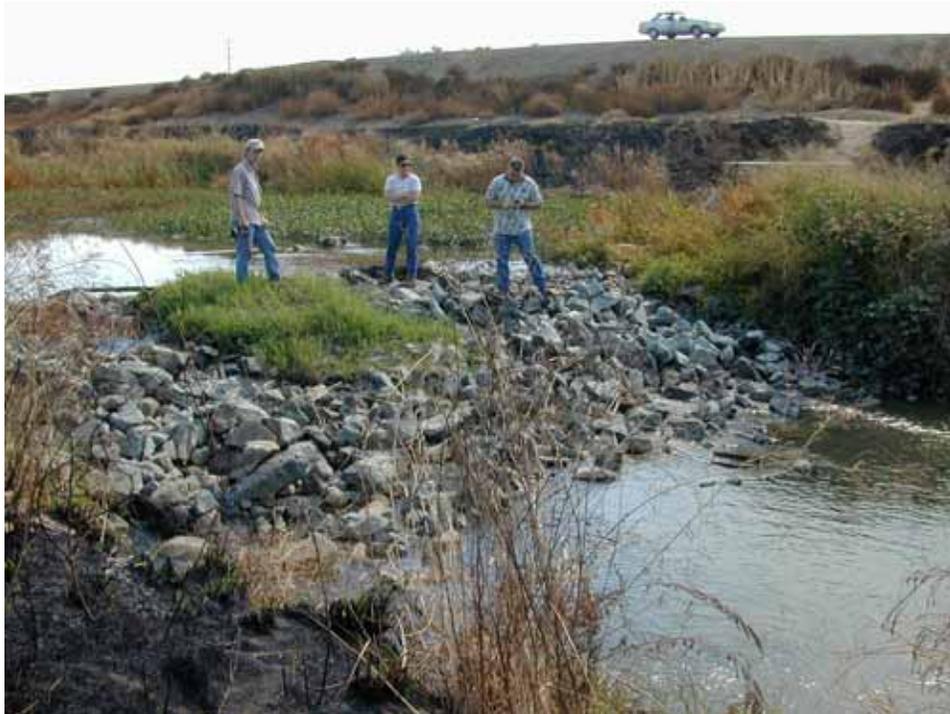
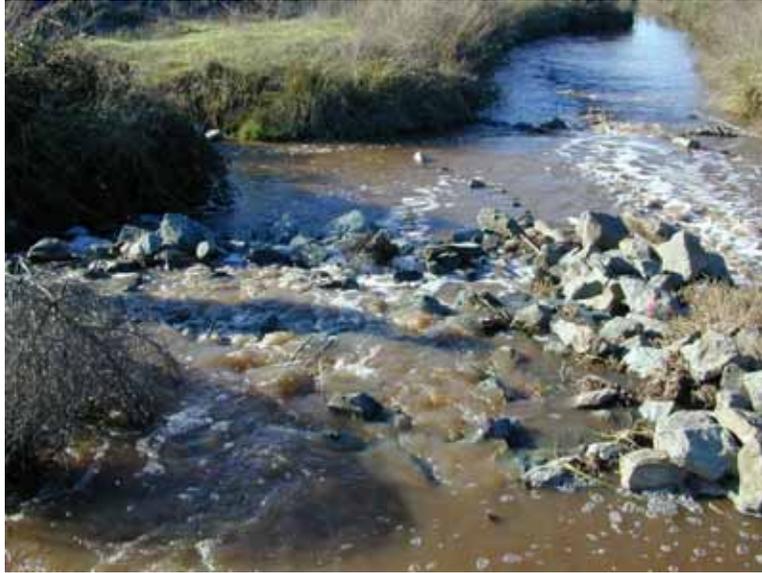
The concrete sill is oriented perpendicular to the flow path and is elevated above the downstream channel grade. Although the sill is about 12 feet wide, two notches 3 feet wide and 7 feet long are cut into the sill and extend through the riprap on the downstream side near the center of the span (Photo A-235 and Photo A-237). The downstream face of the dam is protected from scour by a large pile of broken concrete rubble and rock riprap extending about 50 feet downstream of the structure and extending 80 feet across the channel from the right bank (Photo A-238 and Photo A-239).

**Photo A-238. Riprap cascade at the downstream side of Budiselich Dam**

**Photo A-239. Plan view of riprap cascade downstream of Budiselich Dam**

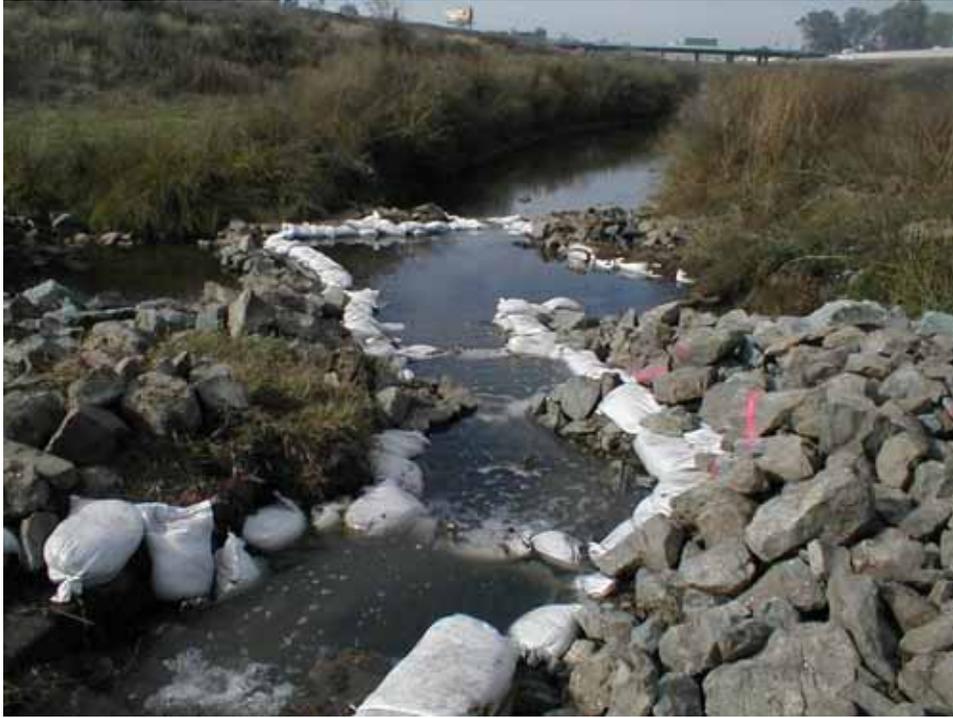
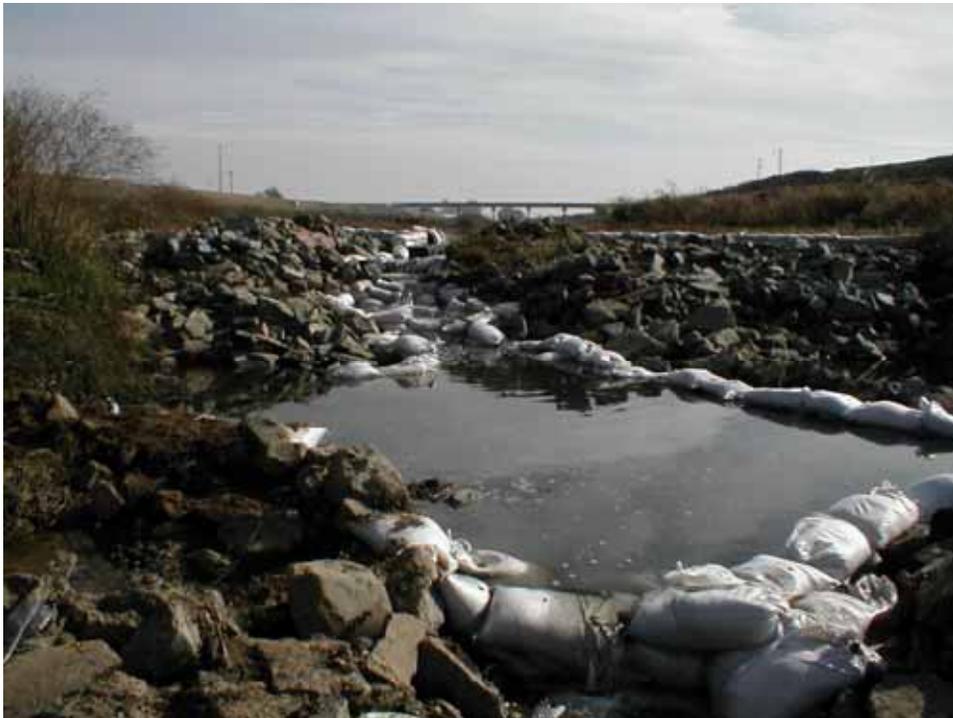
**Photo A-243. Temporary modification of the channel downstream from Budiselich Dam**

**Photo A-244. View upstream and over Budiselich Dam and temporary channel modifications**

In fall of 2001, modifications were performed to provide temporary improvements to fish passage conditions at Budiselich Dam. Sandbags were placed along the edge of the concrete perpendicular to the direction of flow to increase the depth over the sill (Photo A-242). A portion of the riprap was relocated, and sandbags were placed to create a flow path for migrating salmonids and improve water depth through the riprap cascade (Photo A-243, Photo A-244, and Photo A-245).

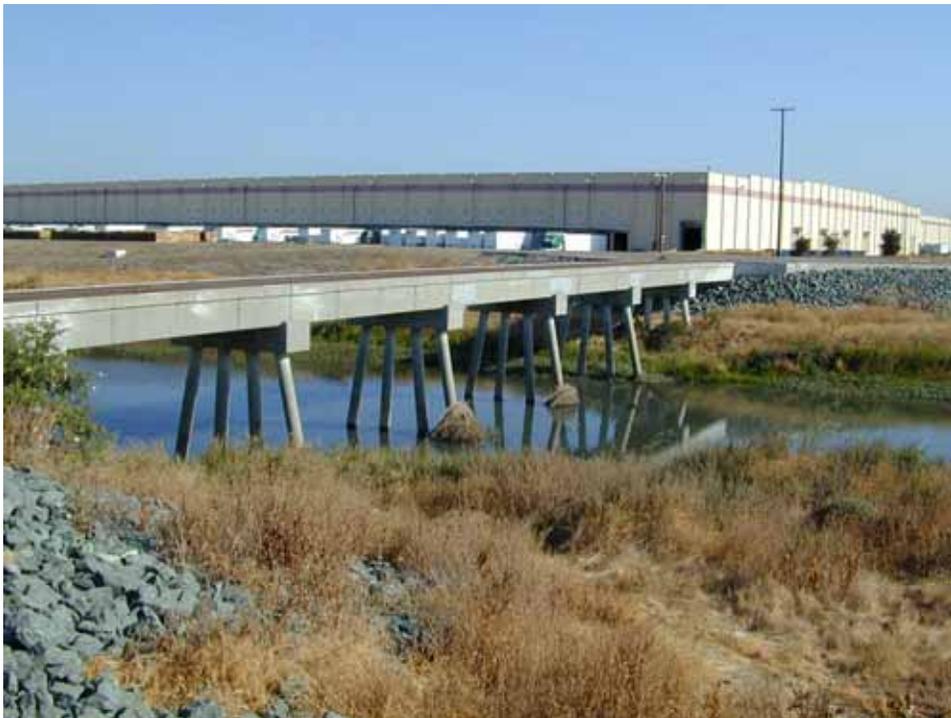
**Photo A-246. The Stockton Terminal and Eastern Railroad Bridge from upstream left bank looking downstream**

The Stockton Terminal and Eastern Railroad Short Line cross the Stockton Diverting Canal on a 305-foot-long, 18-foot-high concrete bridge. The bridge is one-tenth of a mile downstream of river mile 2. Nine rows of piers each with 4 columns 30 feet apart support the bridge (Photo A-246).

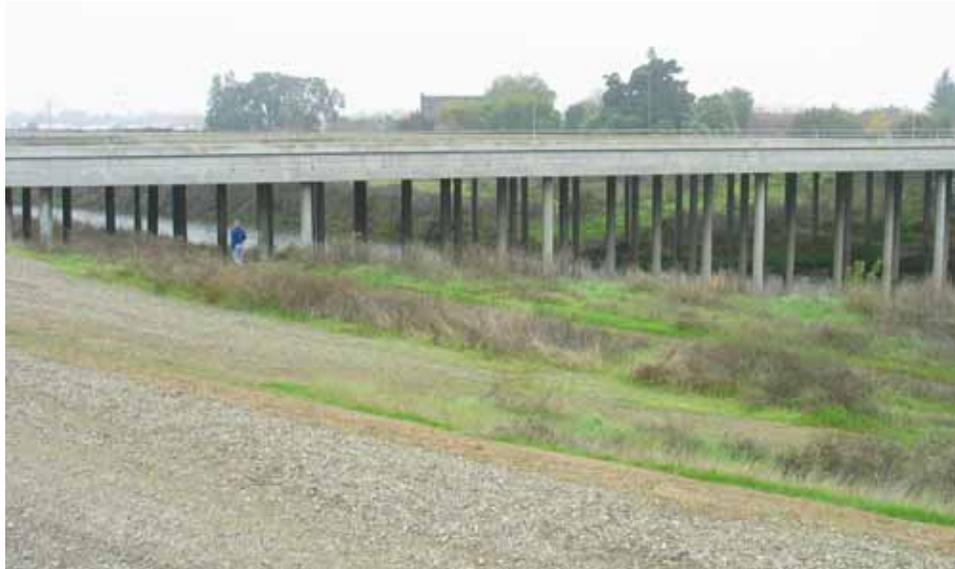
Highway 26 crosses the Stockton Diverting Canal at river mile 3. The bridge is a concrete span 305 feet long and 25 feet high. The crest length is 200 feet. Nine piers supporting the bridge, each with 10 columns, are 29 feet apart. Water primrose grows over most of the water surface during the summer. The active channel widens to 90 feet at the bridge (Photo A-249). The upstream channel is a long, flat, and trapezoidal. Waterweeds choke the channel in places (Photo A-250). Because the bridge has no apron or riprap scour protection and there is no visible water surface difference, it is not a barrier to fish migration. We will confirm this by modeling fish passage at the Fine Road Bridge.

**Photo A-249. Highway 26 Bridge looking south**

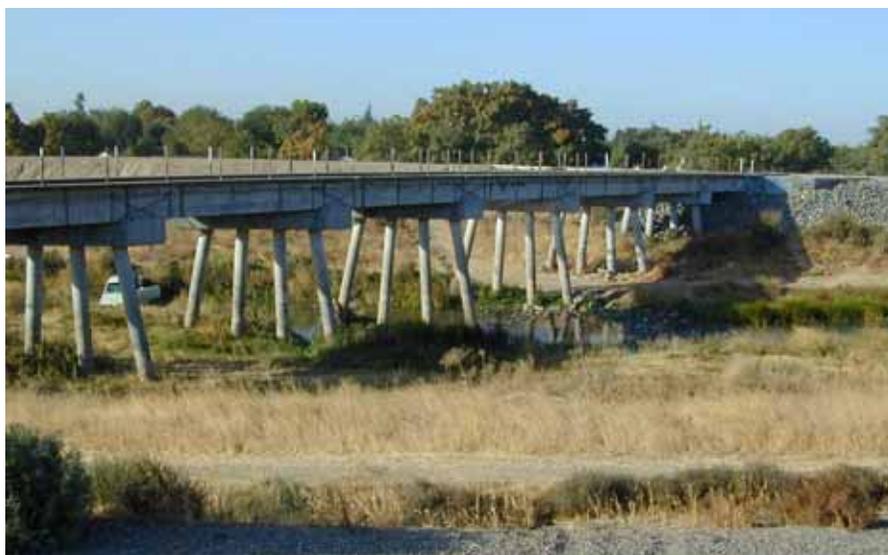
The Southern Pacific railroad bridge spans the Stockton Diverting Canal exactly between river mile 3 and river mile 4 (Photo A-251). The bridge spans 246 feet and is 20 feet high. Sixteen piers each with four posts span the channel. The distance between the piers varies between 9 feet and 15 feet. The apron measures 109 feet long and about 200 feet wide. We could not measure downstream drop to the apron because rubble filled the channel. The upstream rise to the top of the apron is 2 feet. There is a 7-foot notch in the middle of the channel.

The banks support weeds and grasses. Tires, metal, and plastic litter the channel. There is an abandoned car on the upstream left bank. Rocks placed across the bottom resemble a weir. Water flow is funneled toward the right bank. Fish passage is likely an issue here because of the apron, concrete debris, and large pieces of trash and rubble that litter the channel. We will use modeling results from Mormon Slough Railroad crossing to assess fish passage at Southern Pacific Crossing.

**Photo A-251. The Southern Pacific Railroad Crossing. Downstream is to the right.**

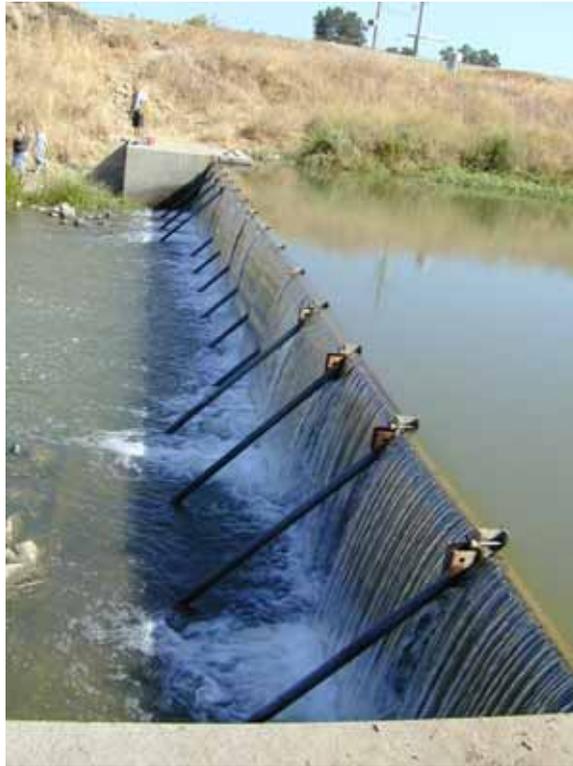
During irrigation season, 8-foot-high flashboards create a water surface difference between the dam crest and the plunge pool of 5.8 feet and an upstream wetted width of 86 feet (Photo A-256). The pool immediately downstream of the dam is 1.2 feet deep which does not meet the 2-foot minimum depth for juvenile salmonids. Budiselich dam model represents an assessment of fish passage at Main Street Dam.

**Photo A-256. Flashboards in place at Main Street Dam**

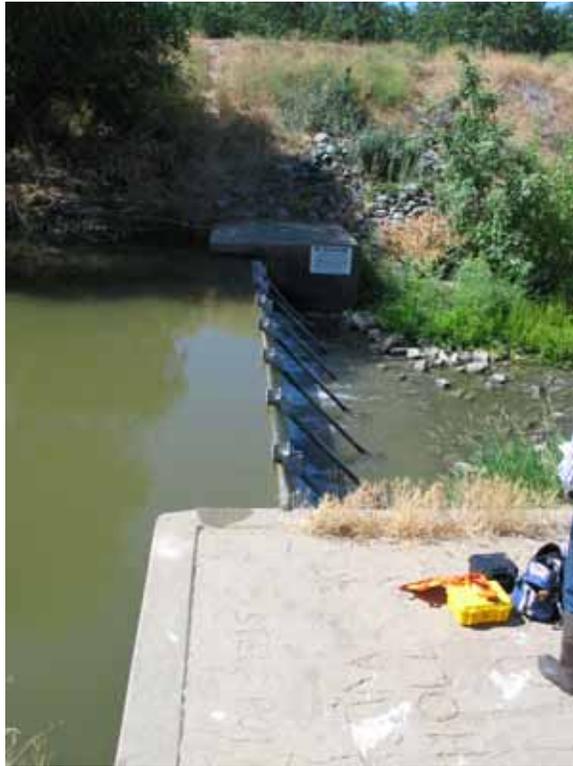
During irrigation season with 5-foot-high flashboards, the water surface difference between the dam crest and the plunge pool is 4.3 feet and the upstream wetted width is 62 feet (Photo A-260). The concrete dam base extends 8 feet downstream of the flashboards and is flush with the channel grade. Water spills over the flashboards into a shallow pool that is just over 6 inches deep at the base of the apron. A second pool 9 feet downstream is about 1.5-foot-deep. The 6-inch downstream plunge pool depth does not meet the minimum 2-foot requirement for juvenile salmonids. We will use modeling results from Lavaggi flashboard dam to assess fish passage at Panella flashboard dam.

**Photo A-260. Flashboards in at Panella Flashboard Dam**

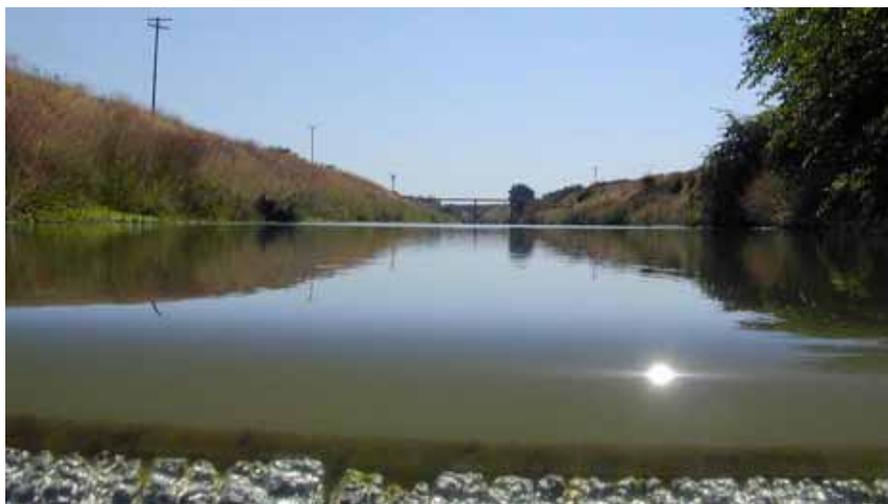
The bridge upstream of Panella Flashboard Dam crosses Mormon Slough at river mile 6.8. The bridge span is 152 feet long, and it is 19.3 feet high. Four sets of 2 piers each, with each pair 30 feet apart, support the bridge (Photo A-261). Riprap on the right bank from the water surface to the road crown extends 600 feet upstream and 50 feet downstream. There is also some riprap scattered in the channel under the bridge (Photo A-262). There is scattered riprap around the bridge piers on the right bank and around the pair of piers next to the Mormon Slough on the left bank.

We saw no channel barriers or difference in water surface elevation at the bridge. Because the bridge has no apron or riprap scour protection and there is no visible water surface difference, it is not a barrier to fish migration. We will confirm this by modeling fish passage at the Fine Road Bridge.

**Photo A-261. The bridge near Panella Dam**

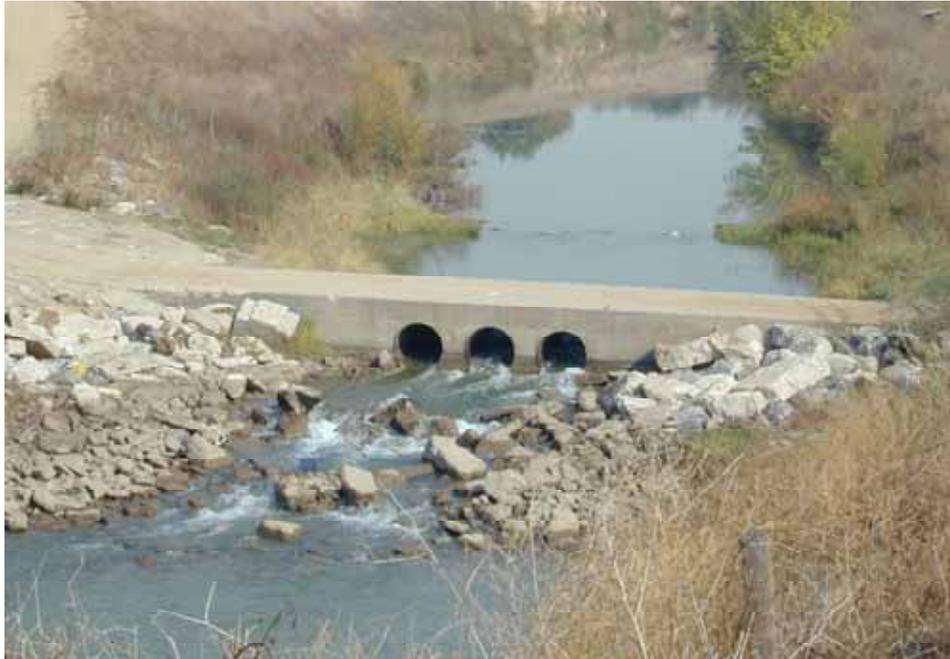
Caprini Low-flow Road Crossing was one of the eight structures modeled in 2004. The Caprini LFC is on Mormon Slough near river mile 8. The crossing is situated in the active channel perpendicular to the flow path (Photo A-263) and rises about 4 feet above the apron. The LFC is 45 feet in length and 10 feet in width. The structure is composed of a rectangular concrete road prism of unknown thickness overlaying three corrugated metal pipe (CMP) culverts.

**Photo A-263. Upstream at Caprini LFC**

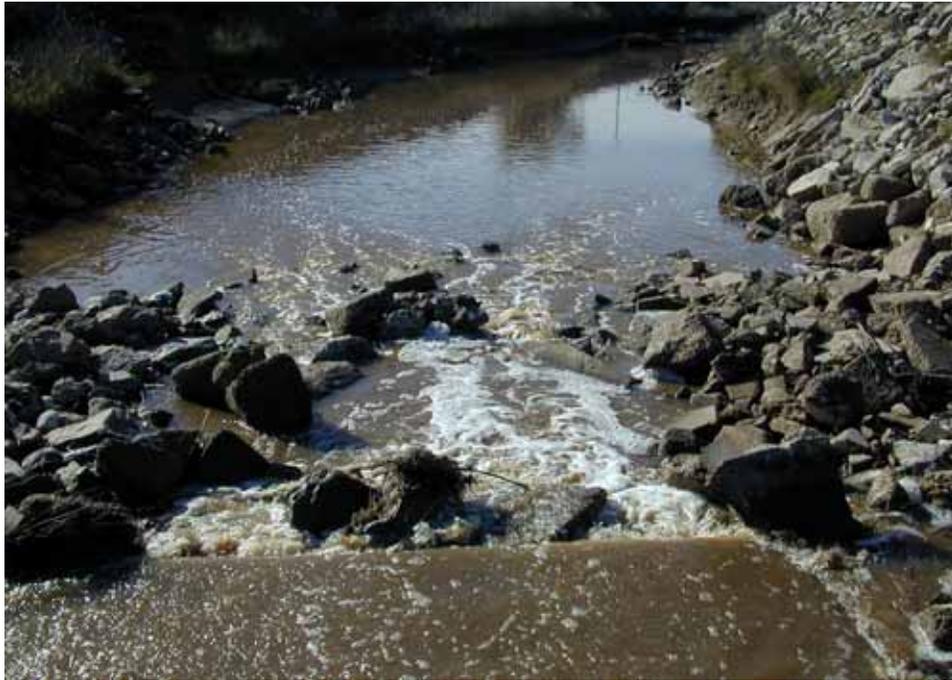
Immediately downstream of the concrete apron at the culvert outlets, a rock cascade forms a series of two major step pools from the outlet apron sill to a pool below (Photo A-267). The pool below is a significant plunge pool about 120 feet long and 4 feet deep under minimal flow conditions.

**Photo A-267. Plan view of rock cascade downstream of Caprini LFC**

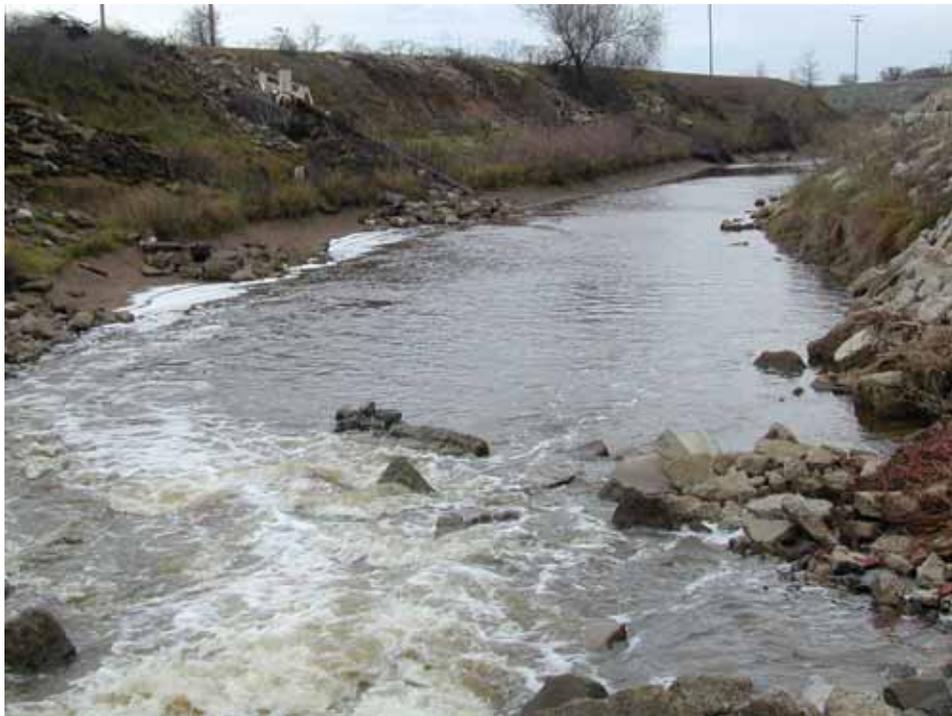
The downstream channel is highly degraded (Photo A-268). A typical downstream cross section is composed of a muddy clay bottom and earthen levee banks with sparse vegetation. The active channel exhibits signs of scour at the toe of the levee with bare clay side slopes where riprap has scoured away resulting in a channel littered with rocky debris. The debris was likely placed to inhibit down-cutting and probably has been redistributed by high flows. The levee banks are heavily armored with rock slope protection. The downstream flow regime appears to be subcritical for a fair distance downstream, characteristic of a glide (Photo A-268).

**Photo A-268. Channel downstream of Caprini LFC during receding storm flows**

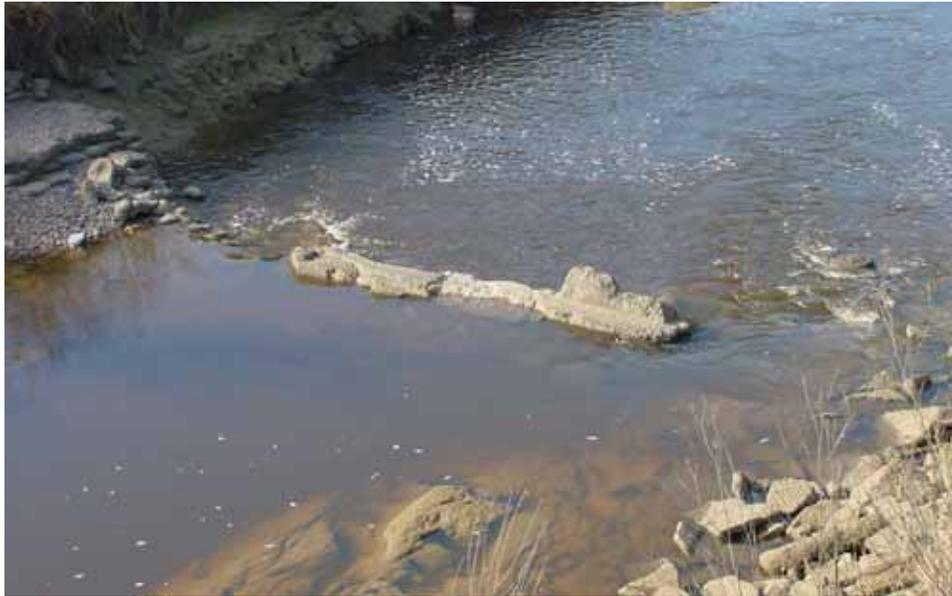
**Photo A-277. Concrete and rock weir downstream of Jack Tone Bridge**

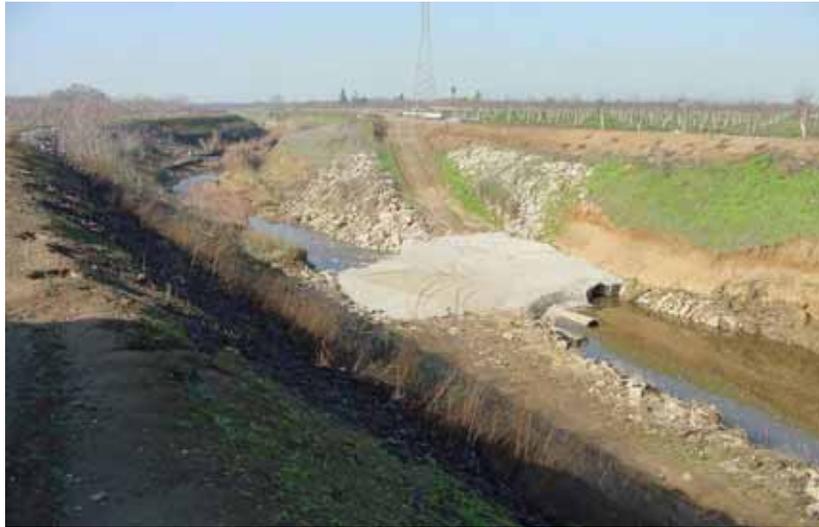
Hogan Low-flow Crossing was one of the eight structures modeled in 2004. The Hogan LFC is on Mormon Slough near river mile 8.4. The crossing is in the active channel perpendicular to the flow path (Photo A-278). The structure is made of an irregular rectangular concrete road prism of unknown thickness poured over three not uniformly placed reinforced concrete pipe (RCP) culverts.

**Photo A-278. Hogan Low-flow Road Crossing from levee looking downstream**

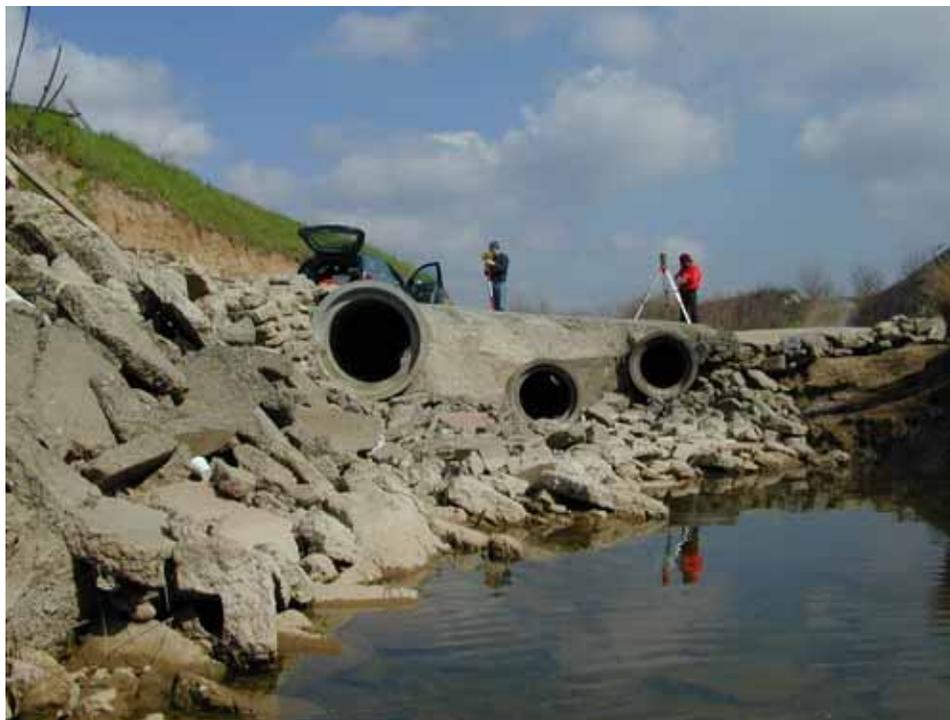
Downstream of the culverts riprap appears to have been scoured away. Although there are concrete pieces immediately downstream around the culverts, the rubble extends only sporadically for 100 feet. Riprap is spread intermittently across the 45 feet of channel width and along 50 feet of the right bank. Where the riprap has been scoured away, the downstream channel is also degraded. A typical cross section is composed of a muddy clay bottom and earthen levee banks with sparse vegetation. The active channel exhibits signs of scour with bare clay side slopes. Riprap covers the right bank (Photo A-283). Some of the riprap was likely placed to inhibit down cutting and has probably been redistributed by high flows. The top of the levee banks also are heavily armored with riprap. The downstream left bank is undercut where the roadway meets the left bank. The downstream flow regime appears to transition from a pool near the structure to a riffle a few hundred feet downstream.

**Photo A-279. At-grade view downstream of Hogan Low-flow Road Crossing culvert outlets**

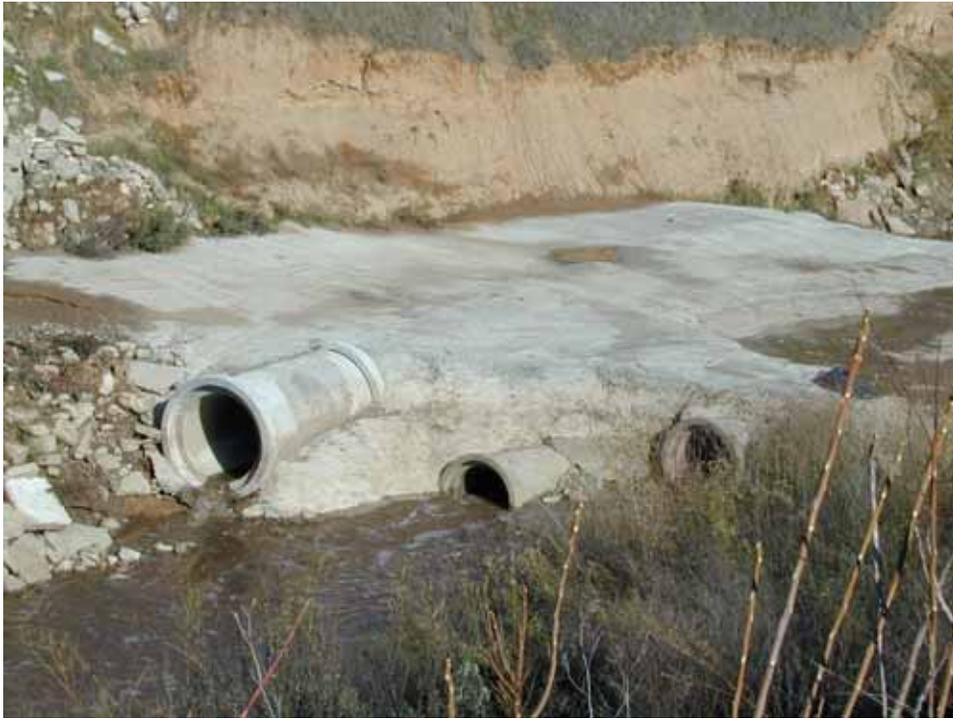
The road surface is made of rough concrete overlay and is 50 feet wide. The structure is in poor condition exhibiting scour damage and signs of numerous repairs. Several concrete surface overlays and a crude concrete over-pour across the upstream and downstream faces of the structure are evident. Each of the culverts appears to have been retrofit with extensions (Photos A-280 and A-281).

**Photo A-280. Cross-view of Hogan Low-flow Road Crossing culvert inlets**

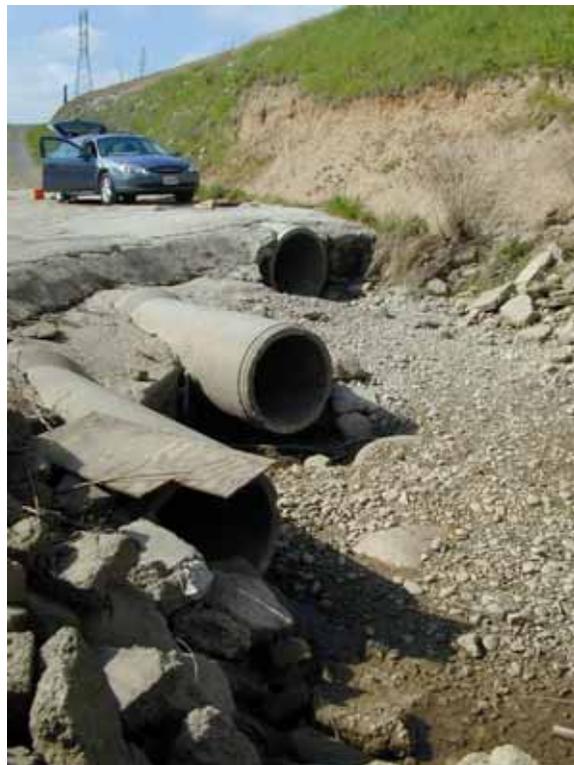
**Photo A-281. Hogan Low-flow Road Crossing irregular road prism, concrete over-pour, and culvert extension as seen from downstream**

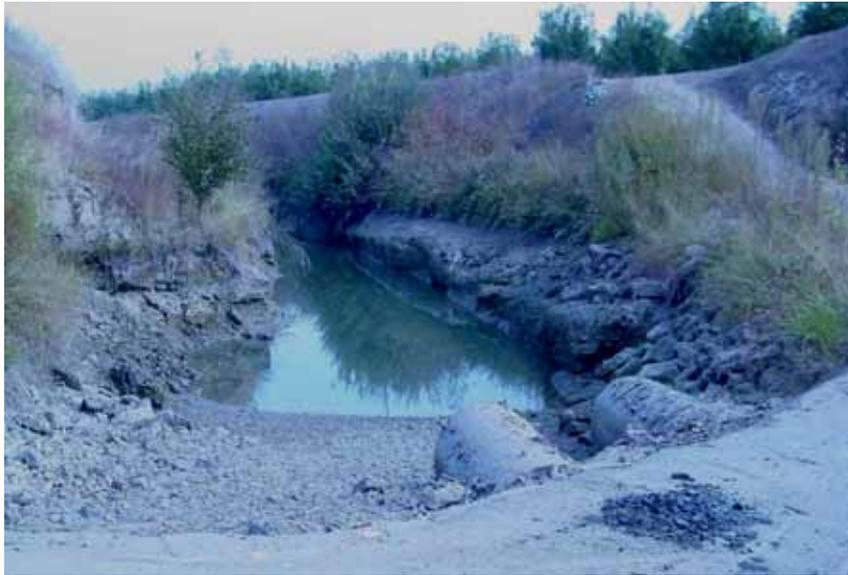
The bed of the upstream channel (Photo A-282) has degraded leaving the inlets of the culverts perched above the bed. A typical cross section is composed of a gravelly-clay bottom with some alluvial deposits of gravelly-silt at the culvert inlets. Weeds, grass, and occasional shrubs line muddy clay banks. Some riprap is present along the lower banks and bed leading up to structure particularly on the left bank adjacent to the structure. The upstream flow regime appears to be subcritical for a fair distance upstream, characteristic of a glide. The structure is the dominant controlling feature for the upstream pool.

**Photo A-282. Hogan Low-flow Road Crossing 'dry' upstream channel**

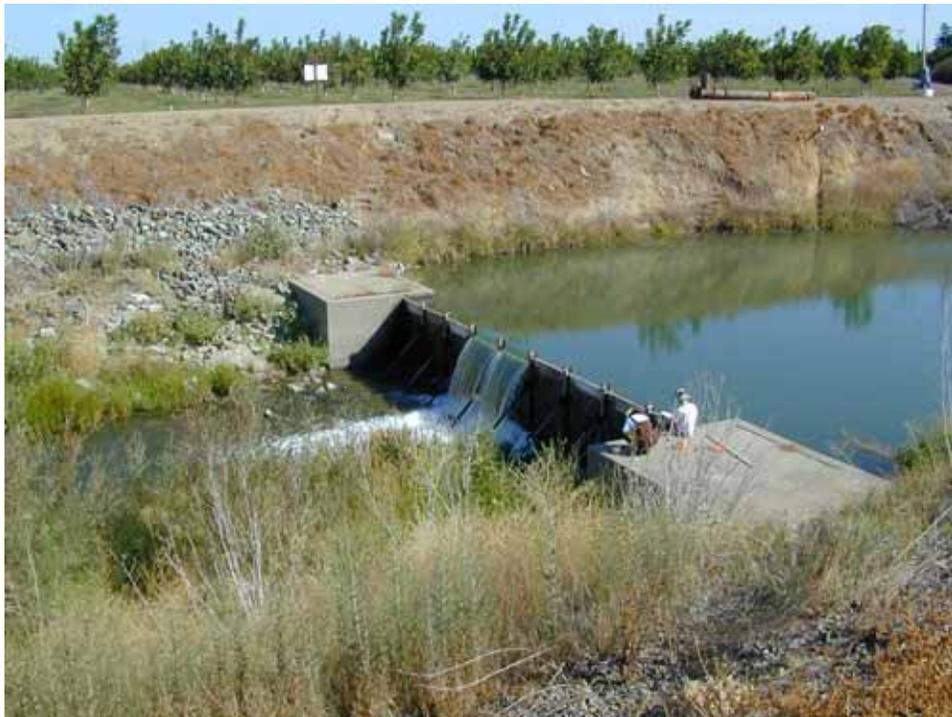
During irrigation season when the flashboards are in place, the crest to pool height is about 6 feet and the upstream wetted channel is 72 feet (Photo A-289). The bankfull channel is 90 feet wide and the flashboard crest length is 45 feet. Also, the flashboards are 7 feet high; water flowing over the dam creates a plunge pool of about a foot. The minimum plunge pool depth of 2 feet for juvenile salmonids is not met at McClellan Flashboard Dam. We will use modeling results from Piazza flashboard dam to assess fish passage at McClellan Flashboard Dam.

**Photo A-289. McClean Flashboard Dam with flashboards installed**
