## Appendix A Site Descriptions

## **Appendix A Site Descriptions**

### **Calaveras River Downstream of Confluence with the Stockton Diverting Canal**

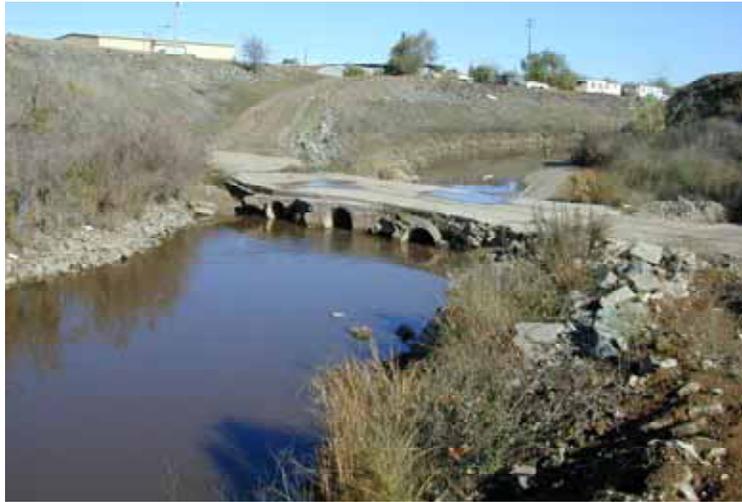
The Fujinaka Low-flow Road Crossing is on Mormon Slough near river mile 10.0. The crossing is in the active channel perpendicular to the flow path (Photo A-290) and is 6 feet above the average channel bottom. The structure, which is 110 feet long, is composed of a rectangular concrete road prism of unknown thickness penetrated by three circular concrete culverts.

The road surface is made of rough concrete overlay and is 25 feet wide. The structure is in poor condition with scour damage and many signs of repair work.

**Photo A-290. Upstream at Fujinaka Low-flow Crossing**

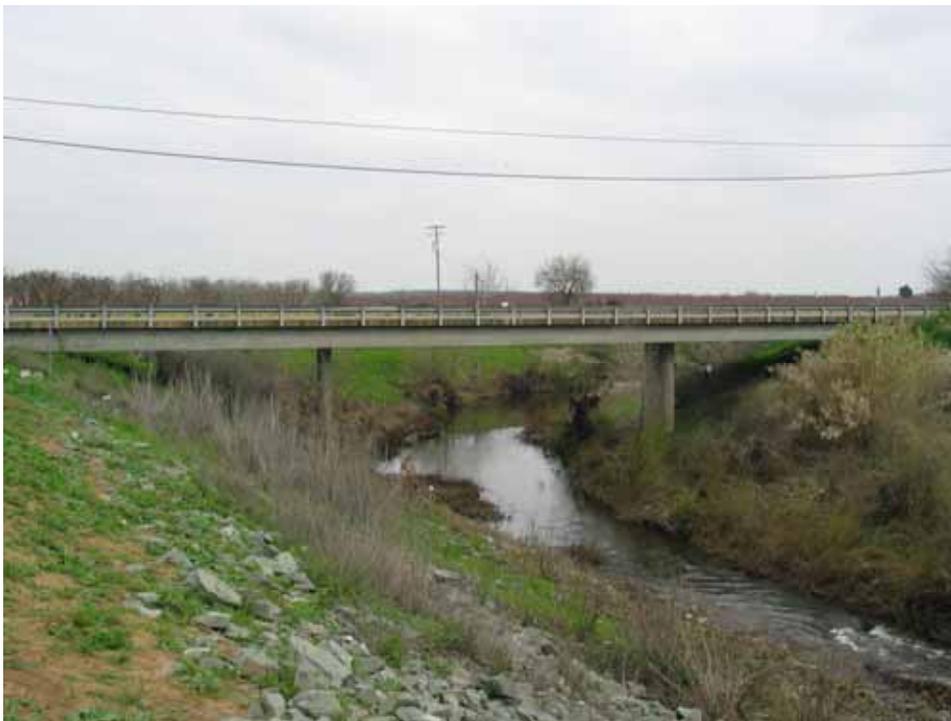
**Photo A-293. Copperopolis Road Bridge from downstream looking upstream**

Copperopolis Road Bridge is a 190-foot concrete bridge crossing Mormon Slough at river mile 10 (Photo A-293). Two concrete piers stand 62 feet apart and are just outside the 50-foot-wide active channel. The banks are steep under the bridge. Dense *Arundo* and willow grow on the left bank. The right bank slope is more gradual upstream of the bridge where the channel also widens. The narrow low-flow channel runs over a rocky substrate. Downstream of the bridge, two rock weirs cross the channel. The first is 250 feet downstream (right side of Photo A-293); the second, another 75 feet farther. The rock weirs should be examined during low flows.

Because the bridge has no apron or riprap scour protection and there is no visible water surface difference between one side of the bridge and the other, it is not a barrier to fish migration. We will confirm this by modeling fish passage at the Fine Road Bridge.

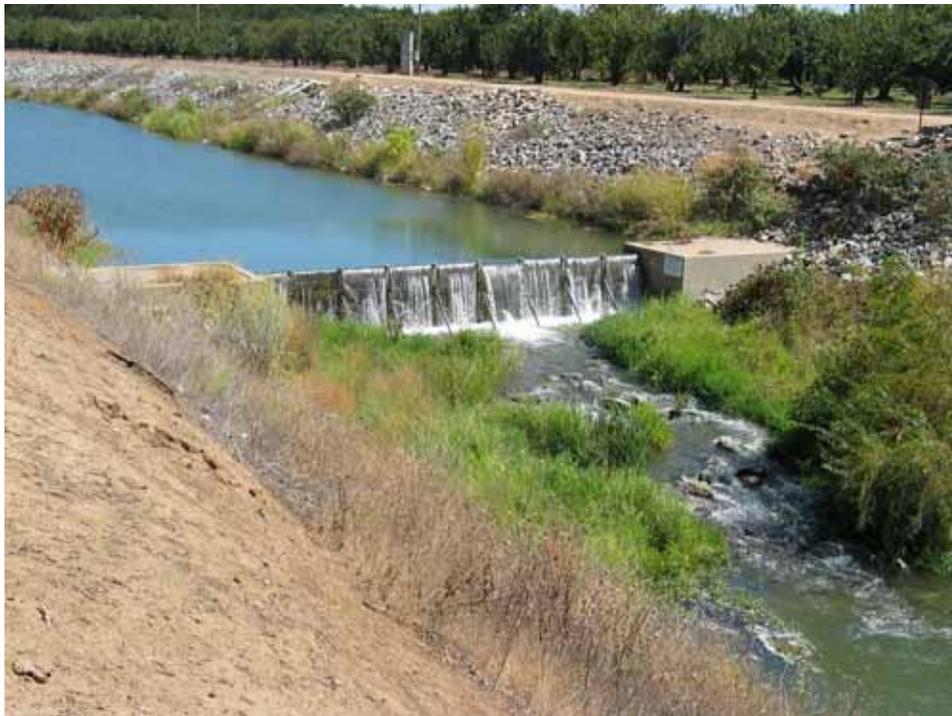
**Photo A-297. Flashboards in place at Prato Flashboard Dam**

With flashboards up during irrigation season, the upstream wetted channel width is 77 feet and flashboards span 46 feet across Mormon Slough (Photo A-297). The flashboards are about 7 feet high and the water surface difference between the dam crest and the plunge pool is about 6 feet. The plunge pool is a foot deep, which does not meet the 2-foot minimum depth for juvenile salmonids. We will use modeling results from Piazza Flashboard Dam to assess fish passage at Prato Flashboard Dam.

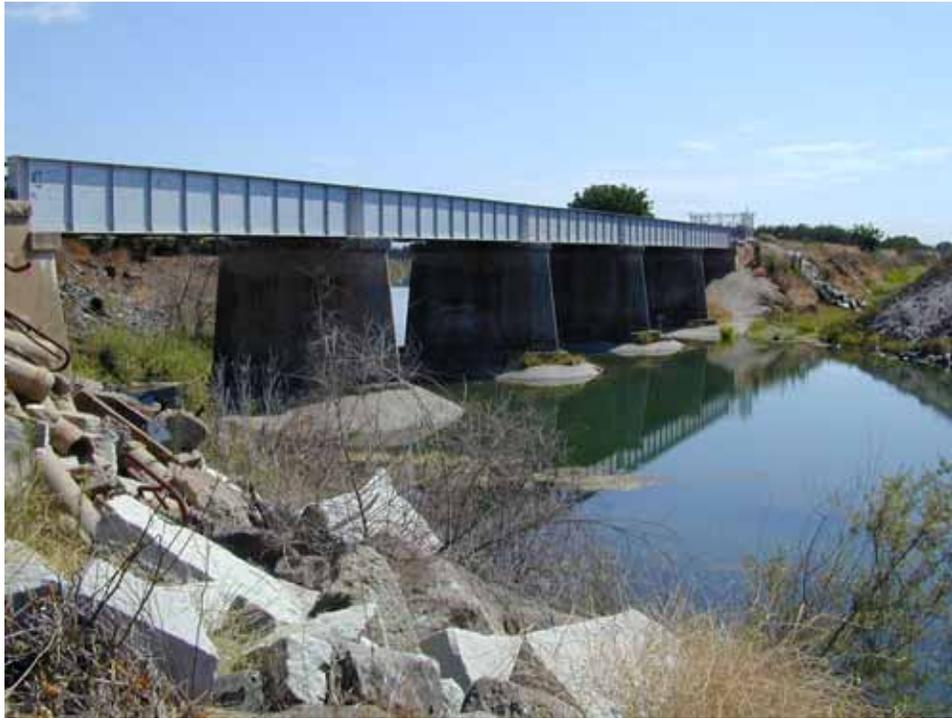
**Photo A-298. View across downstream side of MSRRX**

The Mormon Slough Railroad Bridge (MSRR) is where the old Southern Pacific line crosses Mormon Slough near river mile 13. The structure spans about 240 feet across the bankfull channel (Photo A-298) on a skewed alignment. The structure is supported by two end abutments and four elongated hexagonal concrete piers with conical spread footings in the active channel. The structure appears abandoned because the tracks have been removed and ends barricaded. However, the structure is being preserved for potential future use by SEWD.

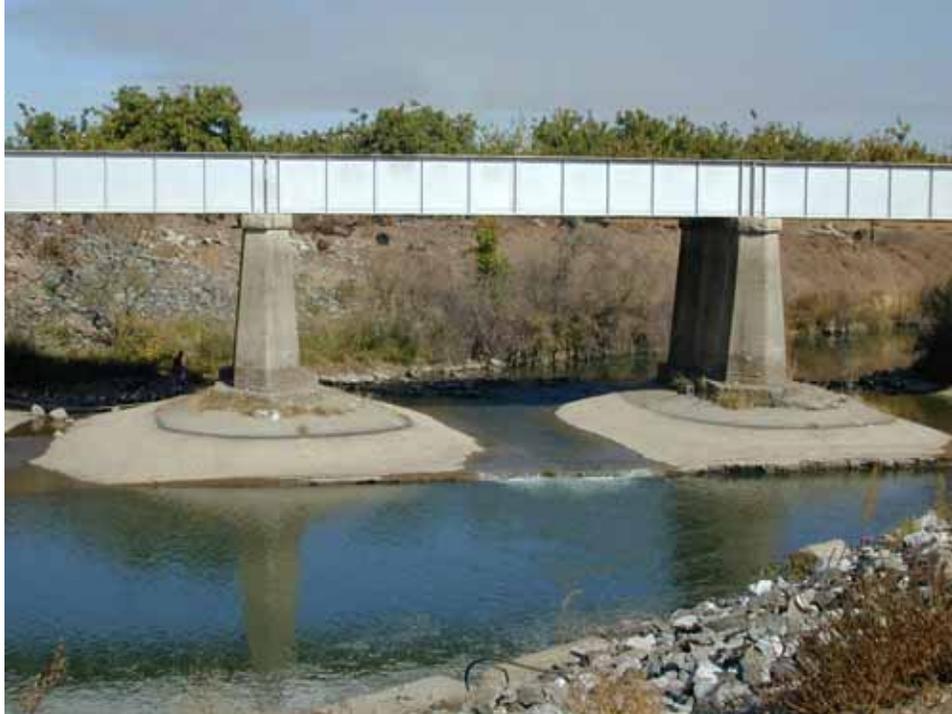
**Photo A-299. MSRRX bridge piers and apron, typical**

The four Mormon Slough Railroad Crossing Piers are 50 feet apart (Photo A-299). The piers' footings are incorporated into a concrete apron extending continuously across the channel between the abutments and 15 feet downstream and upstream of the bridge. The apron has a total width of 50 feet and there is a 9-foot drop from the apron to the channel (Photo A-300). Overall, the structure appears to be in fair condition. The structure itself is at a steep angle to the flow path. The piers project a large area with unequal flow pressures causing different flow profiles between individual piers.

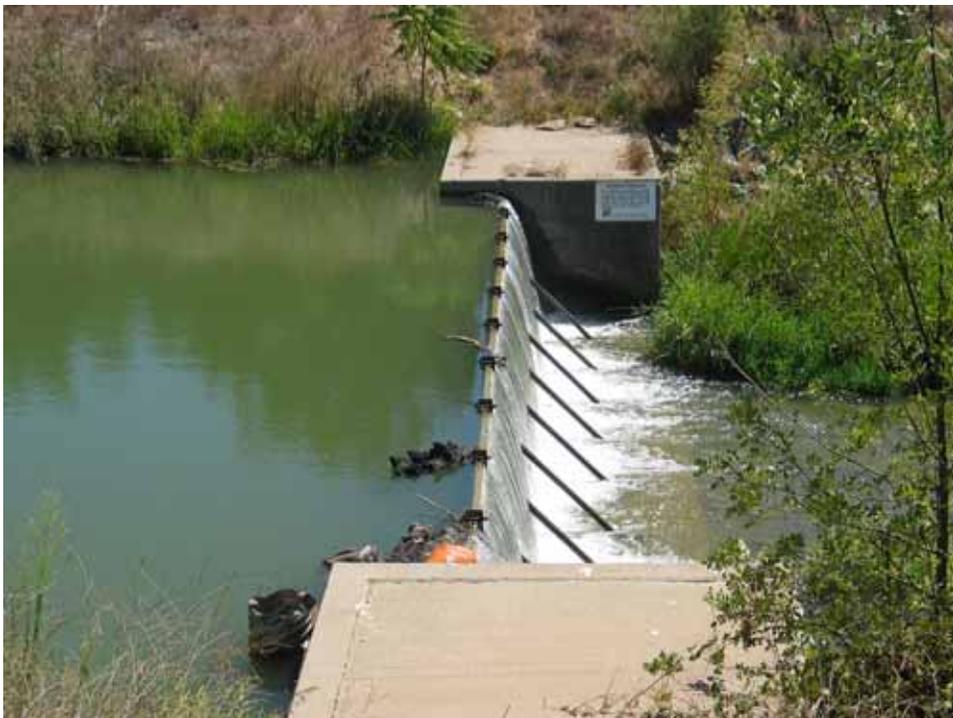
**Photo A-311. Flashboards in place at Piazza Flashboard Dam**

During irrigation season when flashboards are installed, the upstream wetted channel is 137 feet wide. The flashboards are 7 feet high and the water surface difference between the crest and the plunge pool is about 6 feet. Water flowing over the dam creates a plunge pool depth of a foot, which does not meet the 2-foot minimum plunge pool depth requirement for juvenile salmonids. The flashboards span 50.4 feet across Mormon Slough (Photo A-311). The concrete apron downstream of the flashboards is 8.7 feet long.

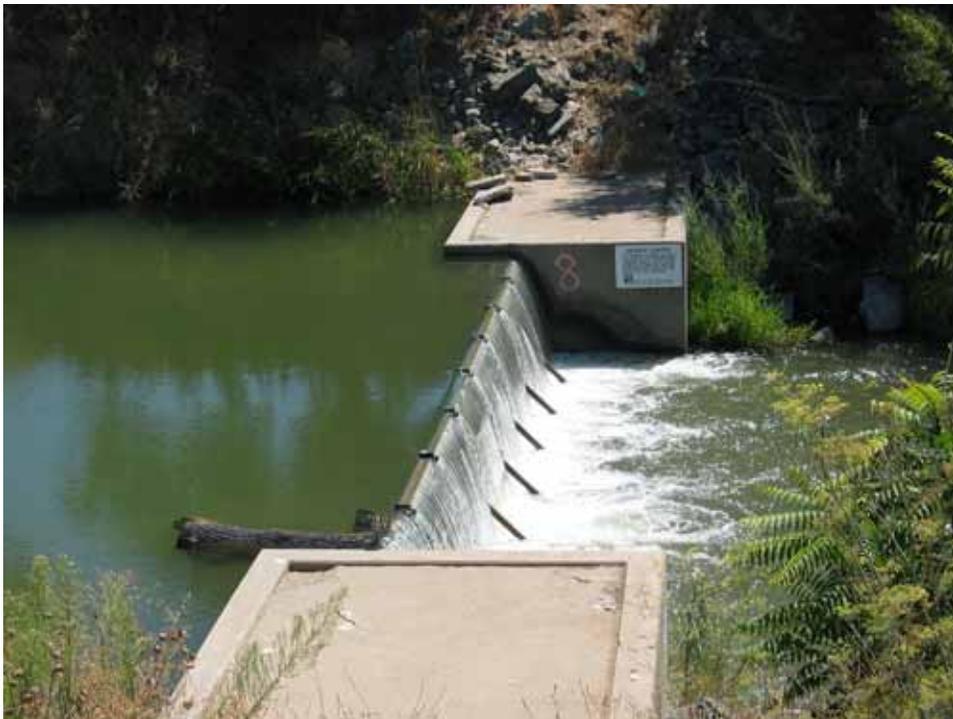
**Photo A-317. Flashboards in place at Bonomo Flashboard Dam**

During irrigation season with flashboards, the upstream wetted channel is 74 feet wide (Photo A-317). The flashboard dam is 42 feet wide. The water surface difference between the crest and plunge pool is about 5 feet and the plunge pool is 6 inches deep. The dam does not meet the minimum plunge pool depth of 2 feet for juvenile salmonids. We will use modeling results from Piazza Flashboard Dam to assess fish passage at Bonomo Flashboard Dam.

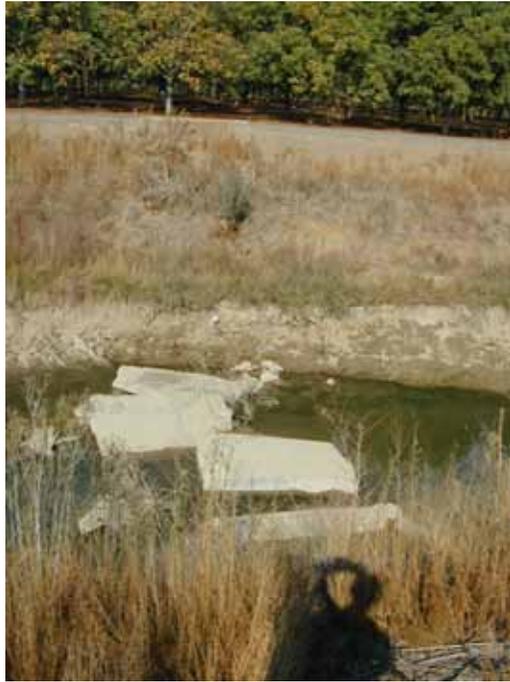
**Photo A-318. Concrete slabs of remnant structure**

There are concrete slabs on the channel bottom on Mormon Slough near river mile 12.7. We suspect they are remnants of an old bridge (Photo A-318). We did not measure or survey the site. The pieces of concrete might be a barrier to fish migration and should be removed.

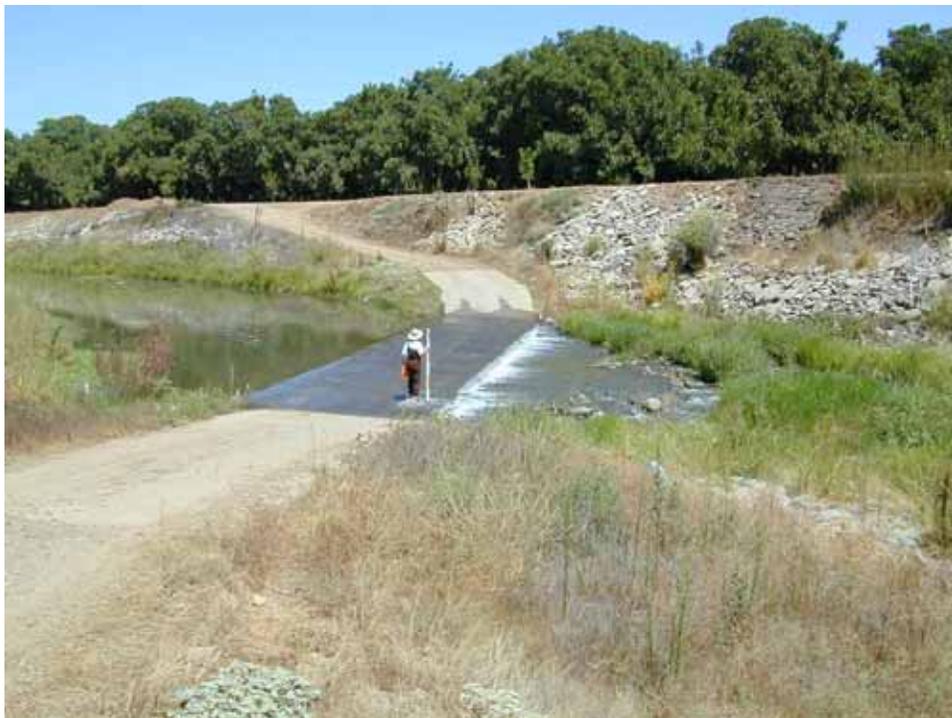
**Photo A-320. View across Hosie Low-flow Road Crossing**

The Hosie LFC (Photo A-319) is on Mormon Slough near river mile 13.2. The crossing is situated in the active channel slightly skewed to the flow path and is elevated 1.5 feet above the downstream channel bottom (Photo A-320). The structure is made of a rectangular reinforced concrete pad of unknown thickness, about 160 feet long and 13 feet wide. The concrete pad is in poor condition showing signs of scour and exposed reinforcement wire (Photo A-321).

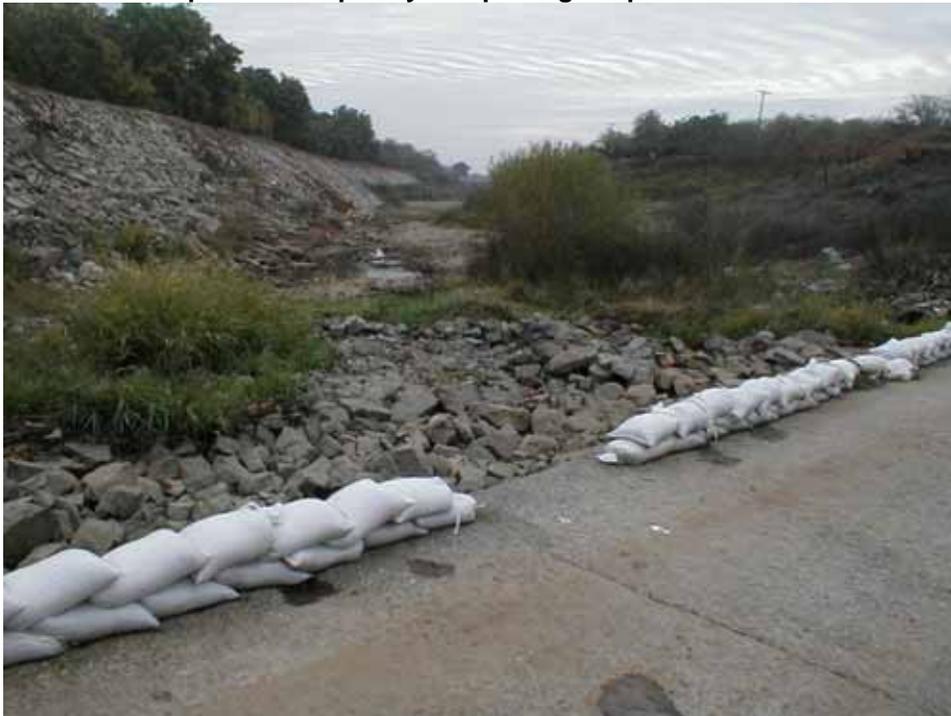
**Photo A-322. View upstream across Hosie Low-flow Road Crossing. Sandbags installed to provide temporary fish passage improvement.**

Some temporary solutions to improve fish passage conditions were done at this site in fall 2001. A series of shallow step pools leading to the structure from the downstream pool were built from small boulders and large cobble on-site and a sandbag dike was placed along the downstream sill of the structure (Photo A-326). The goal of this retrofit was to aid better fish passage by improving the migration path to the structure, consolidate the braided low-flow water to two concentrated flow paths, and increase the water depth on the road. The modifications from 2001 should be checked and any necessary maintenance or sandbag replacement made to continue providing temporary fish passage improvement.

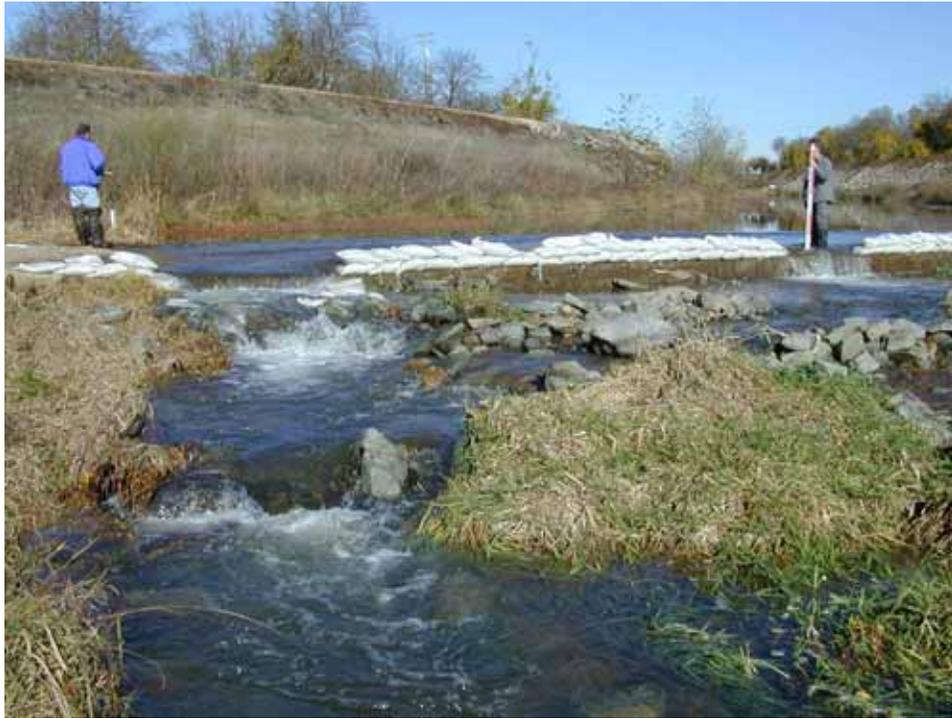
The downstream channel is typically similar to the upstream except the brush is absent on the left bank (Photo A-323). The downstream face of the structure and the channel bottom 45 feet downstream are littered with rocky debris likely placed to inhibit degradation. A field visit on January 19, 2005, found riprap covering the entire 155-foot width of the downstream channel. The rocky debris consisted of large boulders and concrete chunks covered with a tough bamboo-like grass. The grass covered riprap formed three elongated islands parallel to the flow (Photo A-324). Pieces of concrete riprap lined the downstream left bank from toe to the top of the bank.

**Photo A-323. Hosie Low-flow Road Crossing downstream channel. Sandbags installed to provide temporary fish passage improvement.**

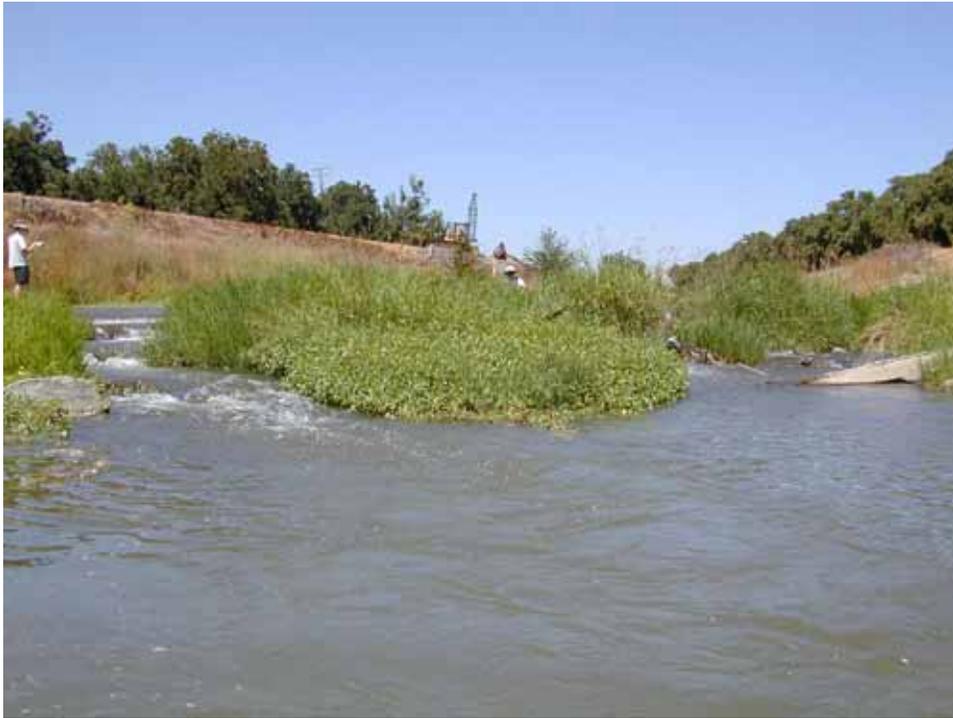
A tail water control was not found during the field survey on January 14, 2004. The downstream flow regime appears to be subcritical characteristic of a glide (Photo A-325). As the water spreads across the structure, the rocks and vegetation tend to create a braided channel under some conditions as the flow leaves the structure.

**Photo A-325. Vegetation in active channel downstream of Hosie Low-flow Road Crossing**

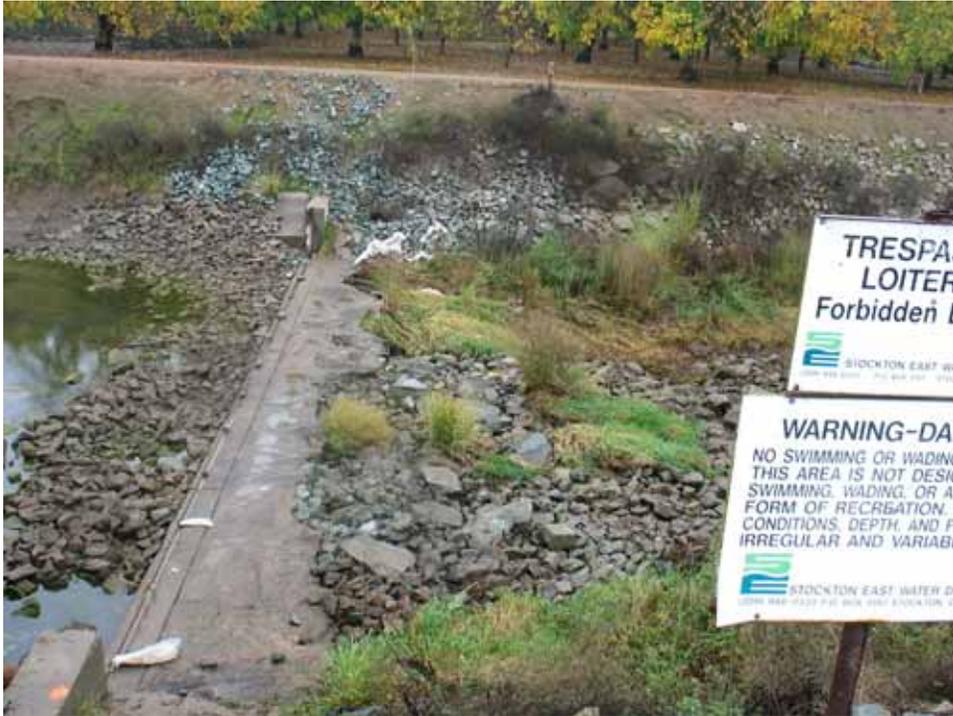
**Photo A-327. Hosie Flashboard Dam from right bank**

The Hosie Flashboard Dam is on Mormon Slough at river mile 13.4 (Photo A-327). The Hosie Flashboard Dam base spans 77 feet between abutments and is 11 feet wide. Riprap extends 77 feet across the channel and 49 feet downstream. There is no drop between the dam base and the downstream riprap. Upstream riprap scour protection is flush with the dam base. The dam base is in poor condition with the concrete eroding from the downstream side.

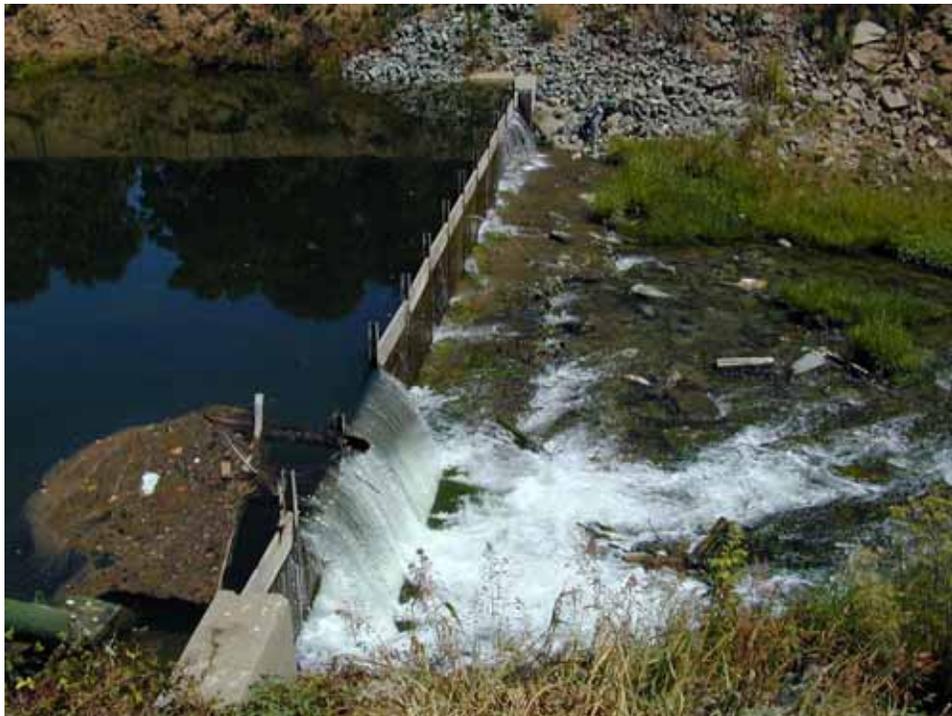
With all the flashboards in place, the crest length is 78 feet. Upstream wetted width is 105 feet (Photo A-330). The crest to pool height is 4 feet and the plunge pool depth is 6 inches, which does not meet the minimum plunge pool depth of 2 feet for juvenile salmonids. We will use modeling results from Lavaggi Flashboard Dam to assess fish passage at Hosie Flashboard Dam.

**Photo A-330. Hosie Flashboard Dam with all but two flashboards**

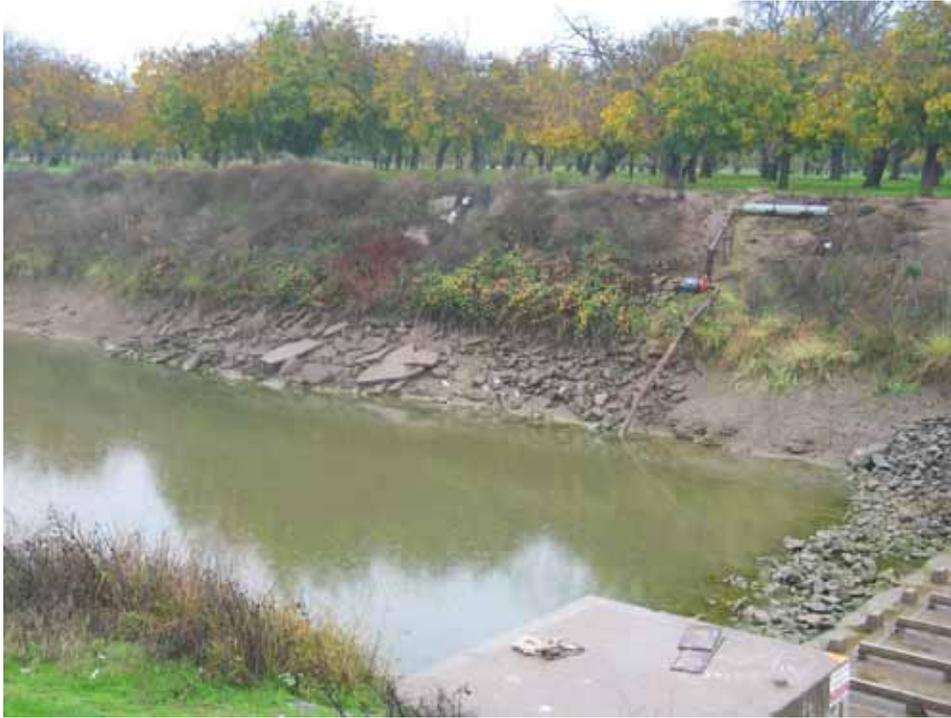
**Photo A-333. Upstream of Avansino Street Flashboard Dam**

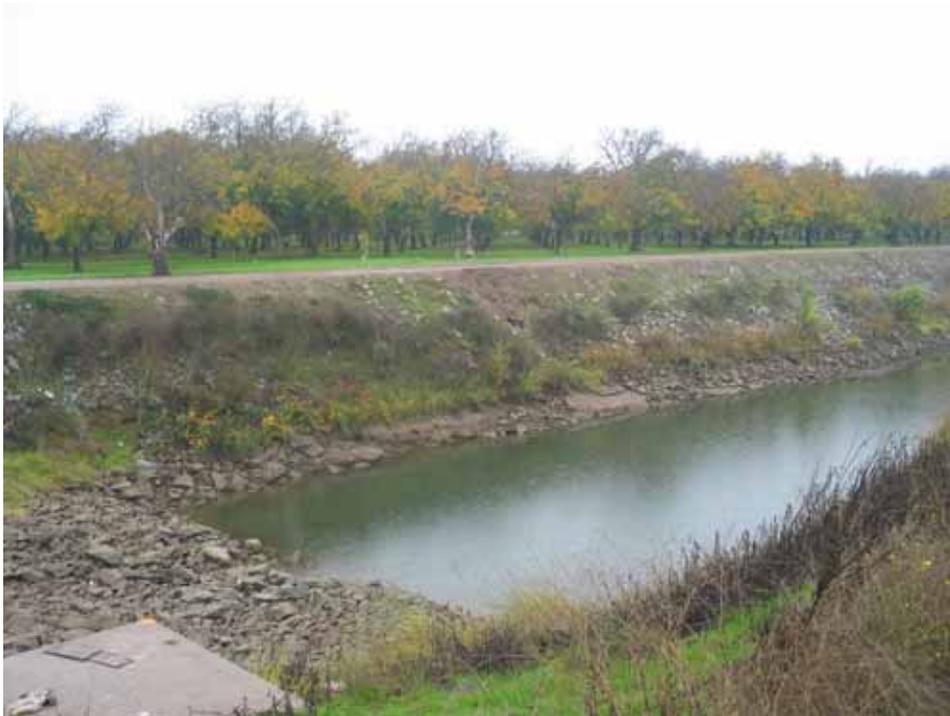
The Avansino Street Flashboard Dam base spans 61 feet between the concrete abutments and is 11 feet wide. There is no notch in the foundation. The base drops 6 inches to the downstream riprap. Riprap lines the entire width of the channel bottom for 33 feet downstream of the dam base. Riprap protection also lines the upstream (Photo A-333) face of the dam base and extends up the banks around the abutments. The lower banks along this stretch of the channel are scoured next to the low-flow channel and grass and shrubs cover them above the scour line (Photo A-334). The upper banks have little riparian cover.

**Photo A-334. Downstream of Avansino Street Flashboard Dam**

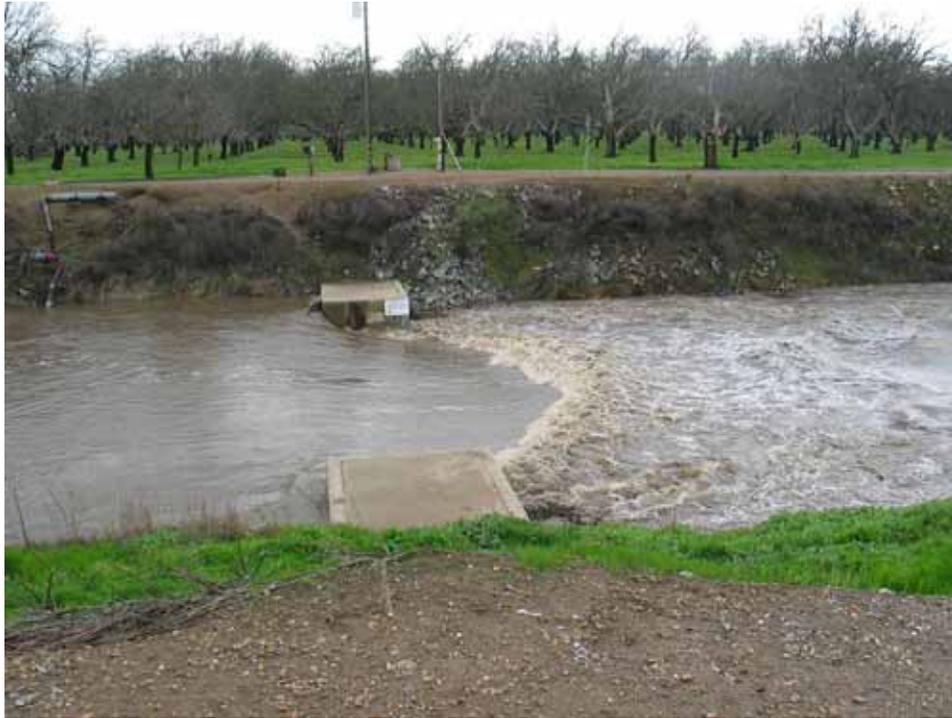
**Photo A-335. Avansino Street Flashboard Dam during high flows**

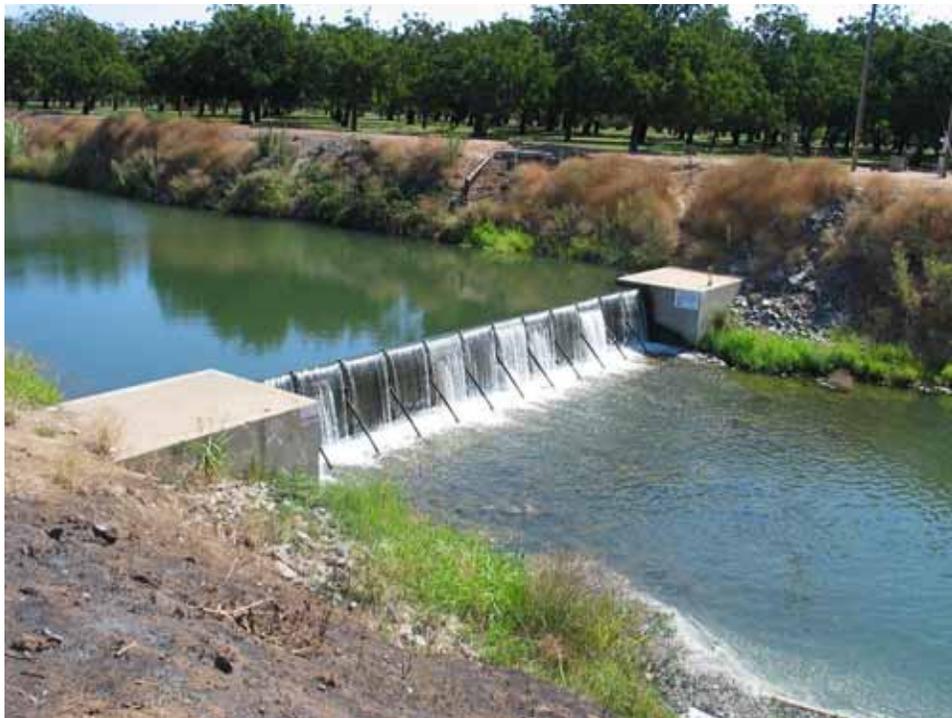
**Photo A-336. Flashboards in place at Avansino Street Flashboard Dam**

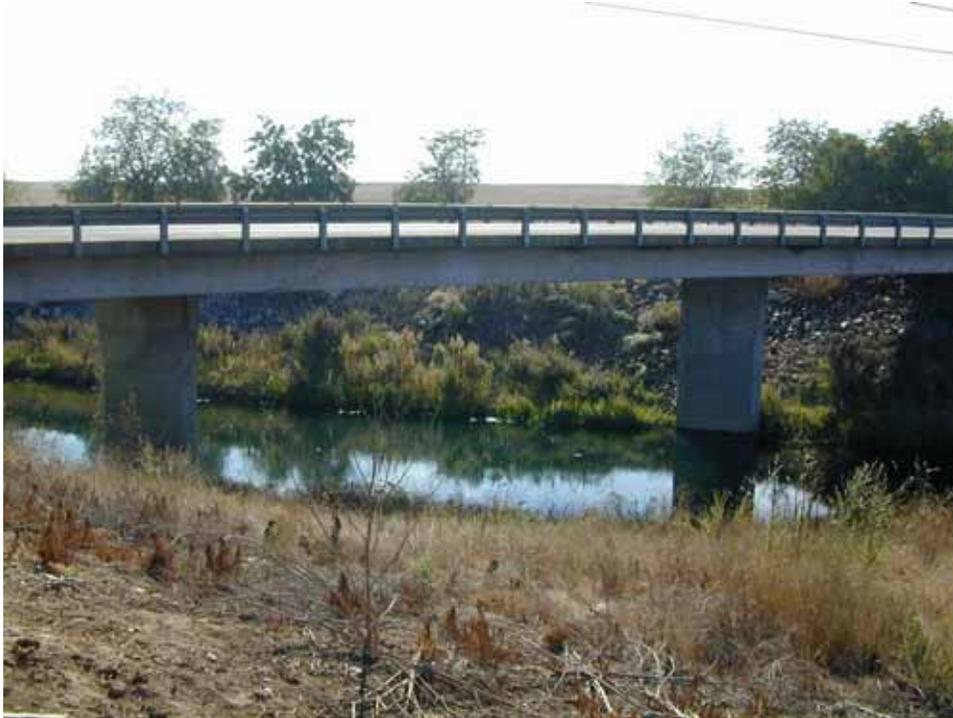
Fine Road Bridge is a concrete and steel structure 206 feet long across Mormon Slough four-tenths of a mile upstream of river mile 15 (Photo A-337). The structure is supported by two concrete piers 65 feet apart. The piers stand at the edges of the active channel. Although the active channel measures 65 feet wide below the bridge, it narrows to 49 feet away from the bridge. The channel upstream and downstream of the bridge is straight. The banks are steep, and for the most part, covered with grass. The channel has a silty bottom.

**Photo A-337. Fine Road Bridge**

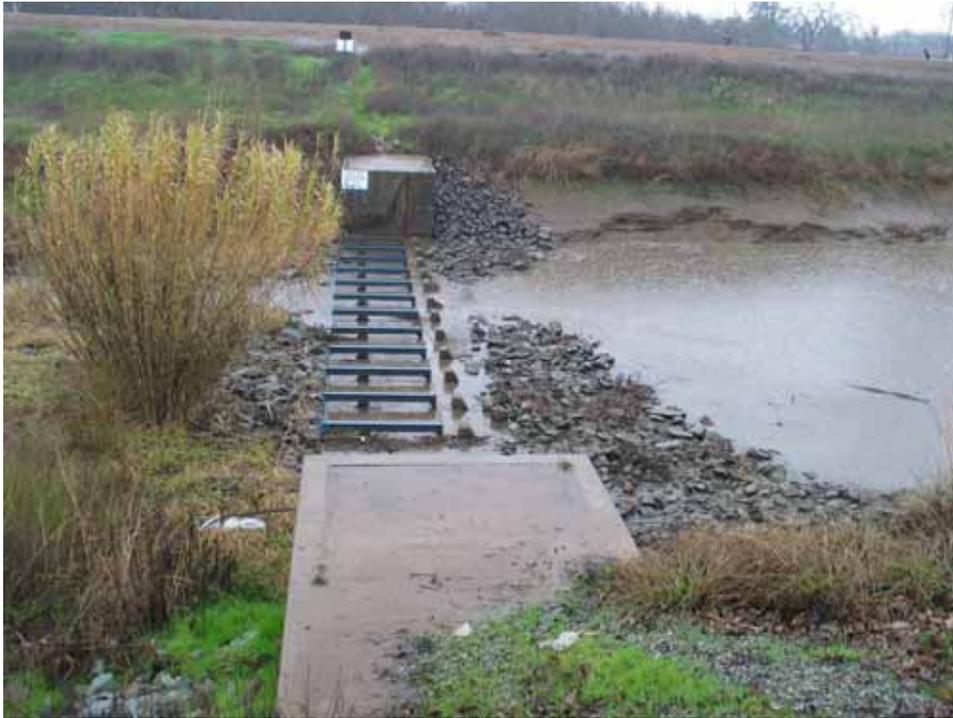
Fine Road Flashboard Dam is on Mormon Slough about river mile 16 (Photo A-338). It is a seasonal dam, with flashboards in during the irrigation season. The flashboards usually are removed between October and March when Mormon Slough is a flood control channel.

**Photo A-338. Fine Road Flashboard Dam base from the right bank**

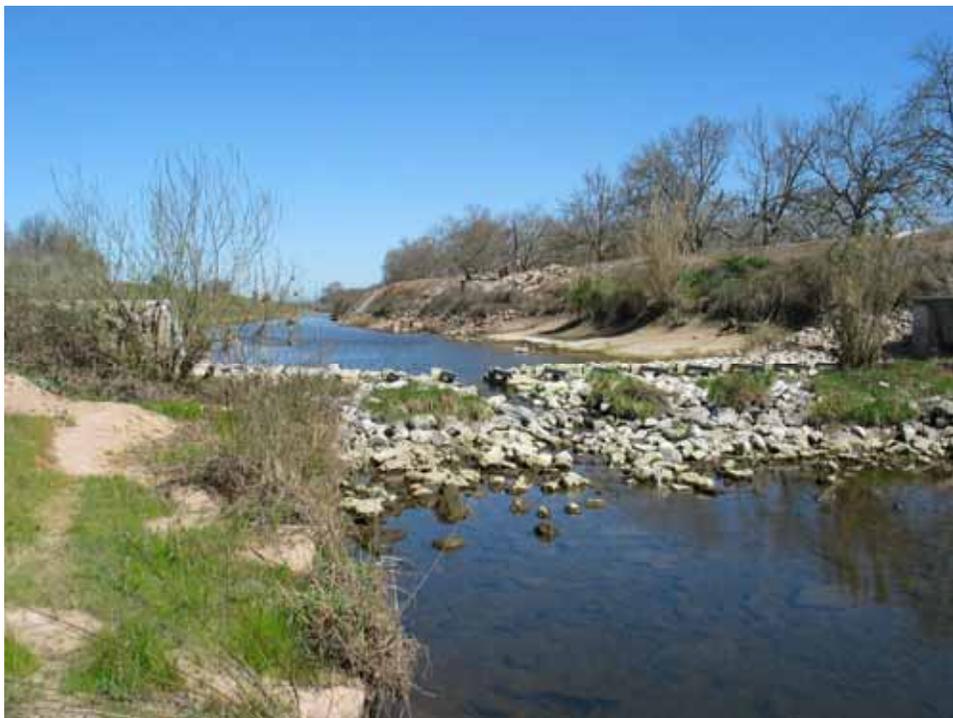
**Photo A-339. Fine Road Flashboard Dam looking upstream at the notch in the riprap apron**

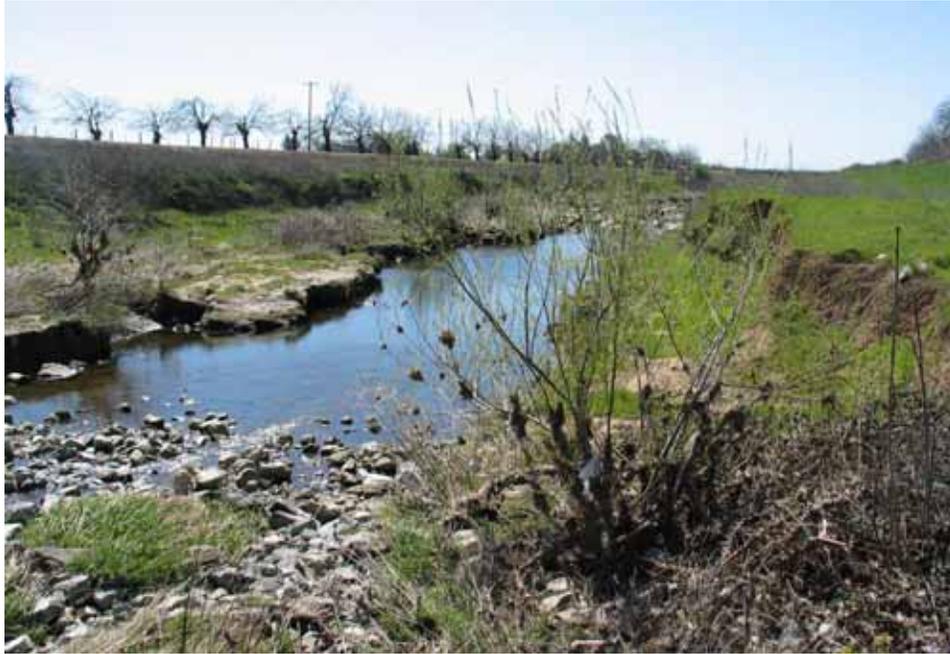
**Photo A-340. Looking downstream of the Fine Road Flashboard Dam at the severe erosion in the low-flow channel and the terrace above it**

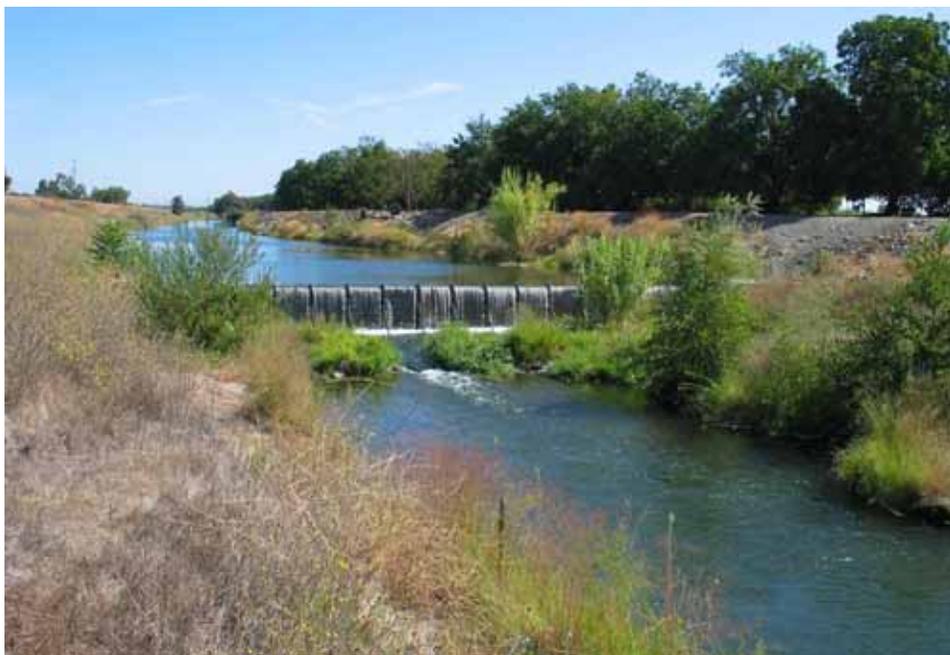
Some weedy aquatic plants are growing on portions of the downstream riprap (Photo A-341). With the flashboards up, the upstream wetted channel is 97 feet wide. The dam span is 81 feet and the drop from the dam crest to the downstream pool is 6 feet. The bank full channel width is 215 feet. Winter weedy grasses grow on the upper right bank. The left bank has no vegetation and is most likely managed for pest control next to the orchards. We will use modeling results from Lavaggi Flashboard Dam to assess fish passage at Fine Road Flashboard Dam.

**Photo A-341. Looking upstream toward Fine Road Flashboard Dam with flashboards in showing development of riparian habitat**

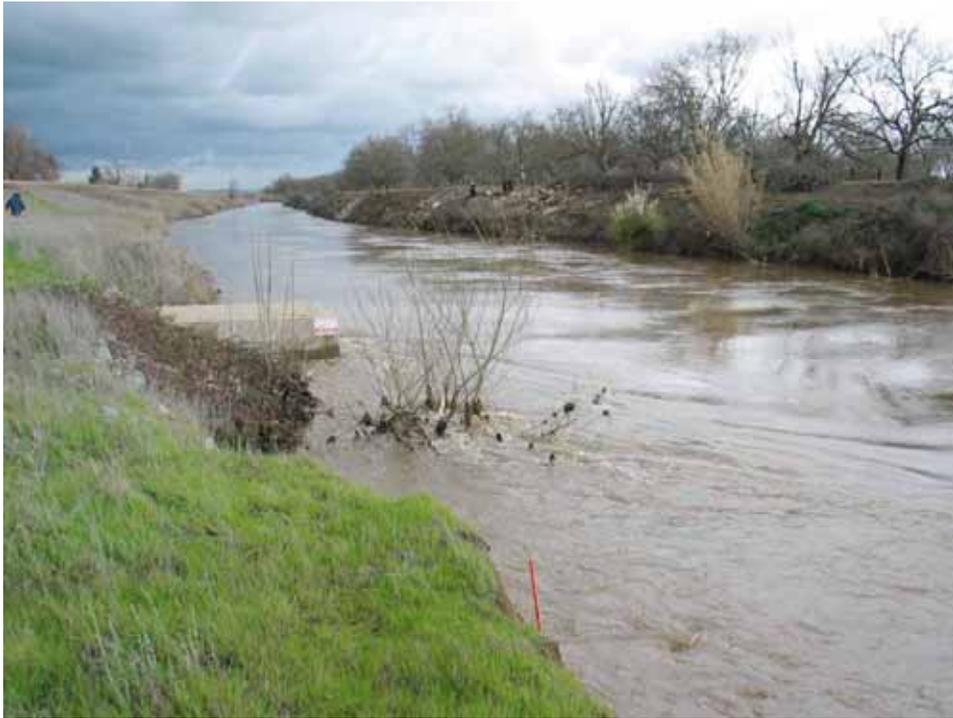
**Photo A-342. Looking upstream from downstream of the Fine Road Flashboard Dam at bank full channel**

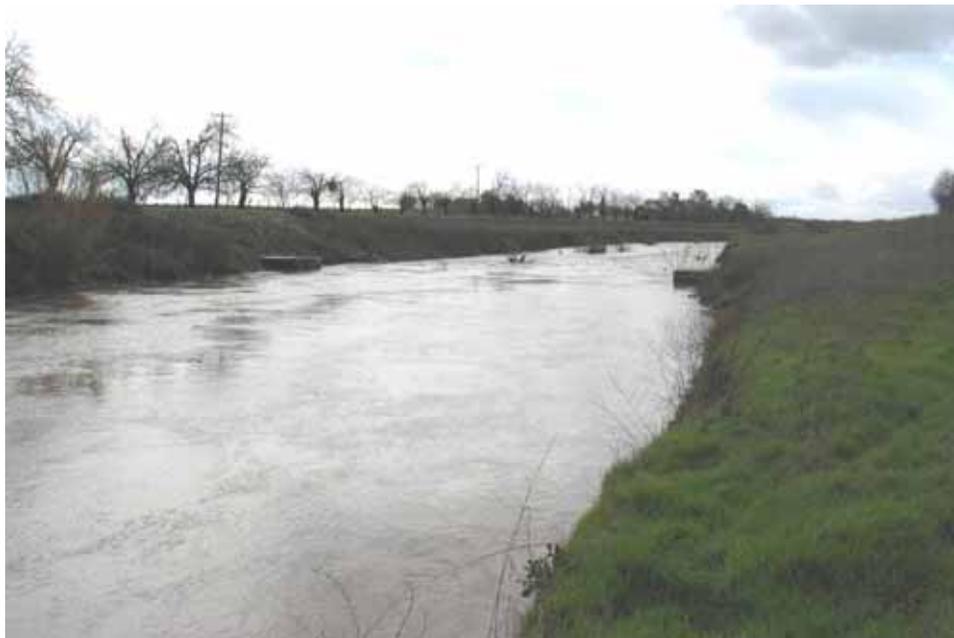
**Photo A-343. Upstream of Fine Road Flashboard Dam looking downstream**

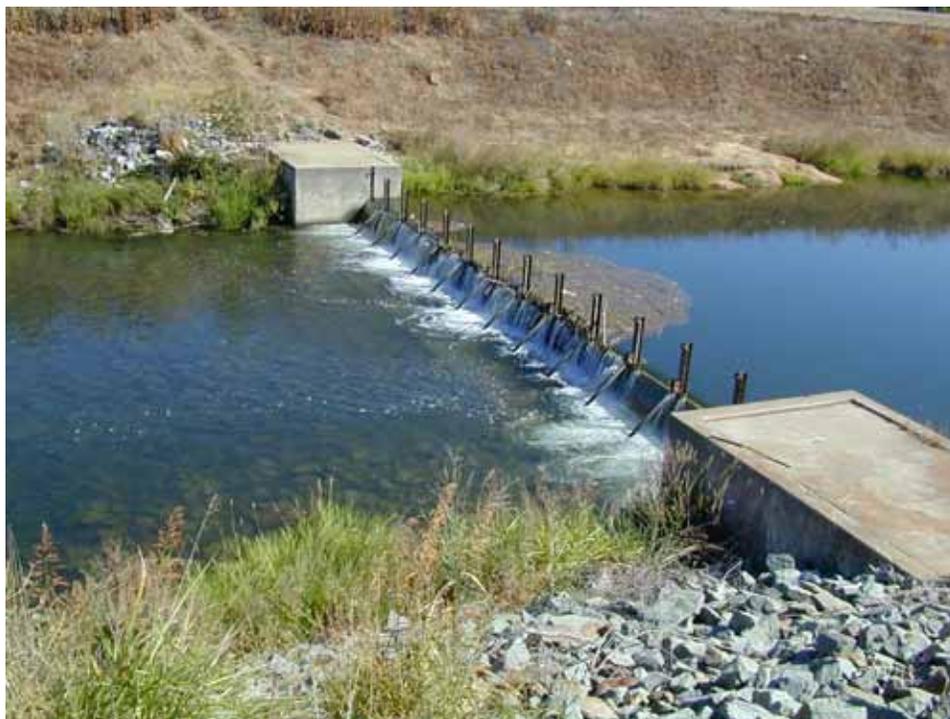
**Photo A-344. Highway 26 Flashboard Dam taken from the downstream left bank**

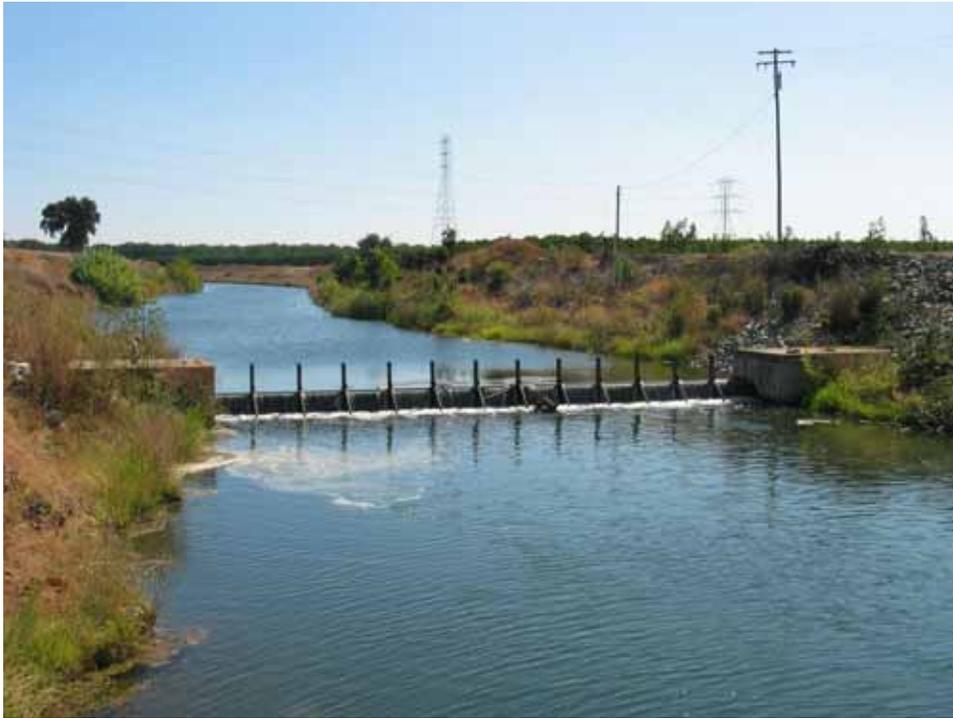
**Photo A-345. Hwy 26 Flashboard Dam as seen from downstream**

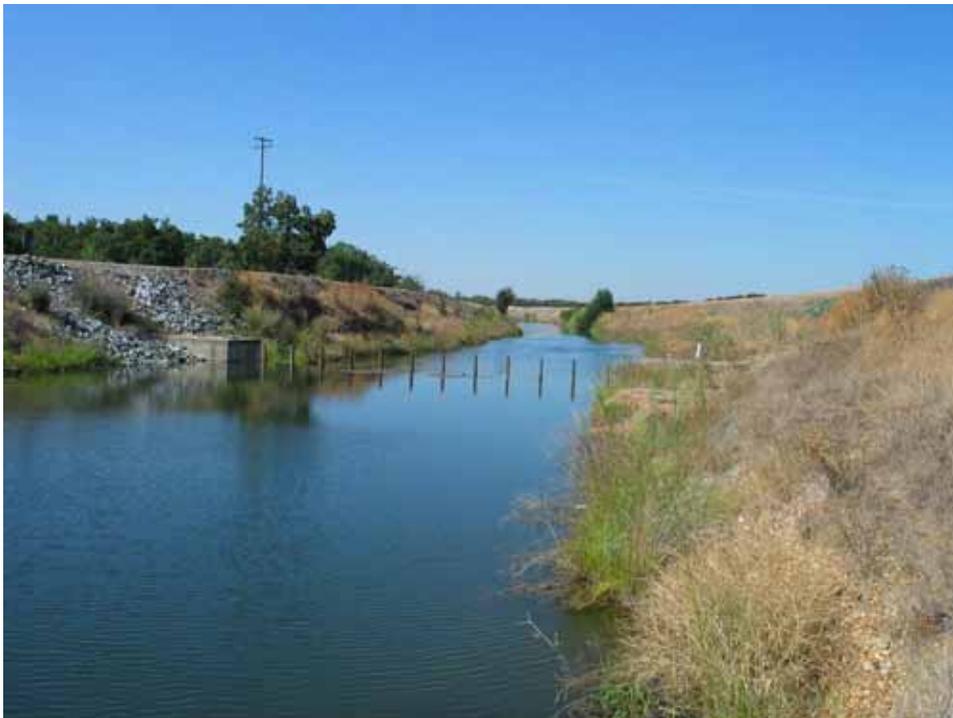
**Photo A-346. Highway 26 Flashboard Dam looking downstream**

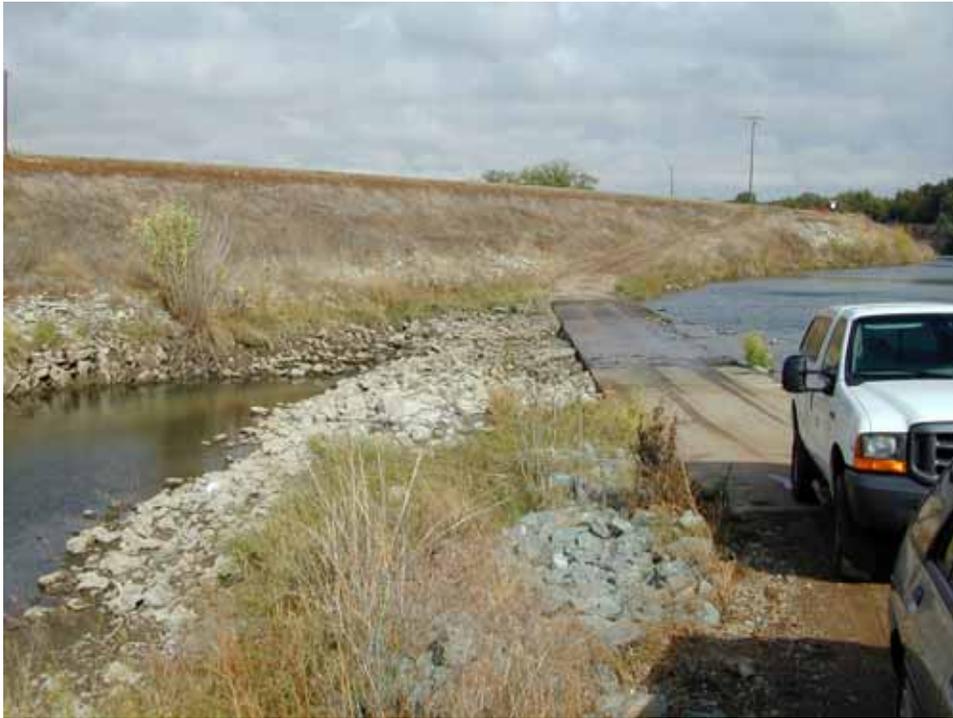
Watkins Low-flow Road Crossing was one of the eight structures modeled in 2004. The Watkins LFC (Photos A-347 and A-348) is on Mormon Slough near river mile 19. The crossing is situated in the active channel slightly skewed to the flow path. The drop from the structure crest to the channel bed has ranged from 1 foot to 2.2 feet from 2003 to 2005. The structure is made of a rectangular reinforced concrete pad of unknown thickness, about 142 feet long and 13 feet wide. A culvert of unknown dimensions exists under the road (Photo A-349).

**Photo A-347. Watkins LFC, overview**
