## Appendix A Site Descriptions

## **Appendix A Site Descriptions**

### **Calaveras River Downstream of Confluence with the Stockton Diverting Canal**

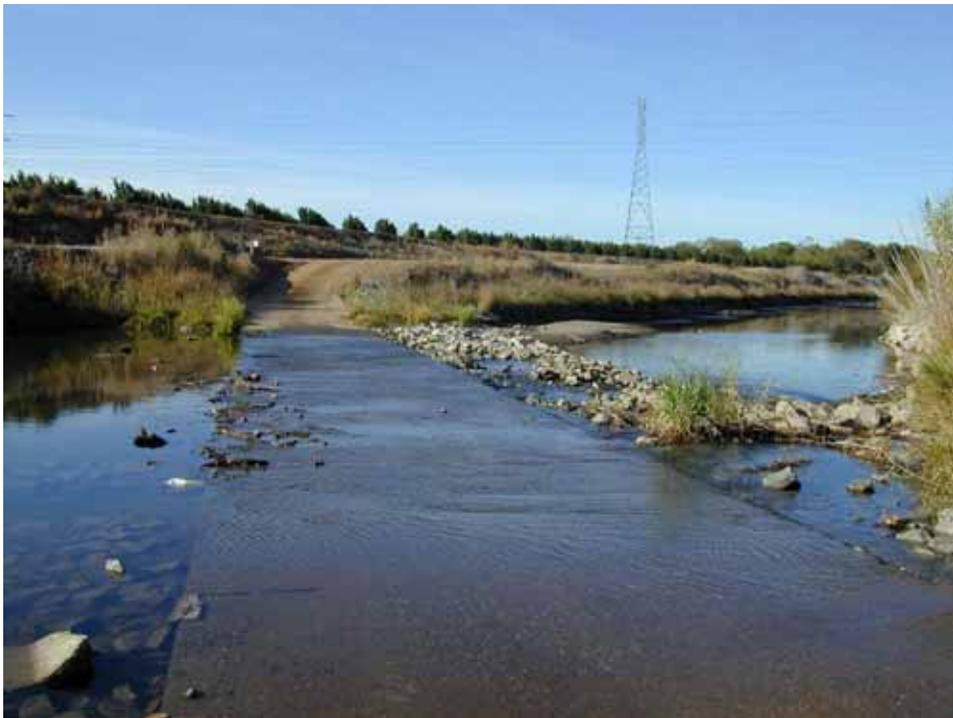
Watkins Low-flow Road Crossing was one of the eight structures modeled in 2004. The Watkins LFC (Photos A-347 and A-348) is on Mormon Slough near river mile 19. The crossing is situated in the active channel slightly skewed to the flow path. The drop from the structure crest to the channel bed has ranged from 1 foot to 2.2 feet from 2003 to 2005. The structure is made of a rectangular reinforced concrete pad of unknown thickness, about 142 feet long and 13 feet wide. A culvert of unknown dimensions exists under the road (Photo A-349).

**Photo A-348. View across Watkins LFC**

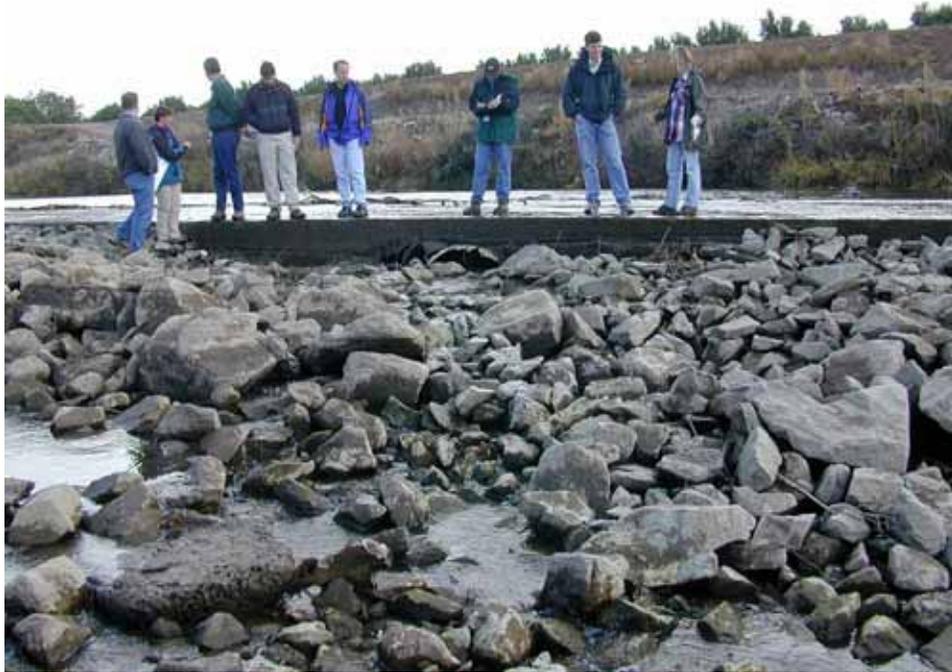
**Photo A-349. View upstream to Watkins LFC**

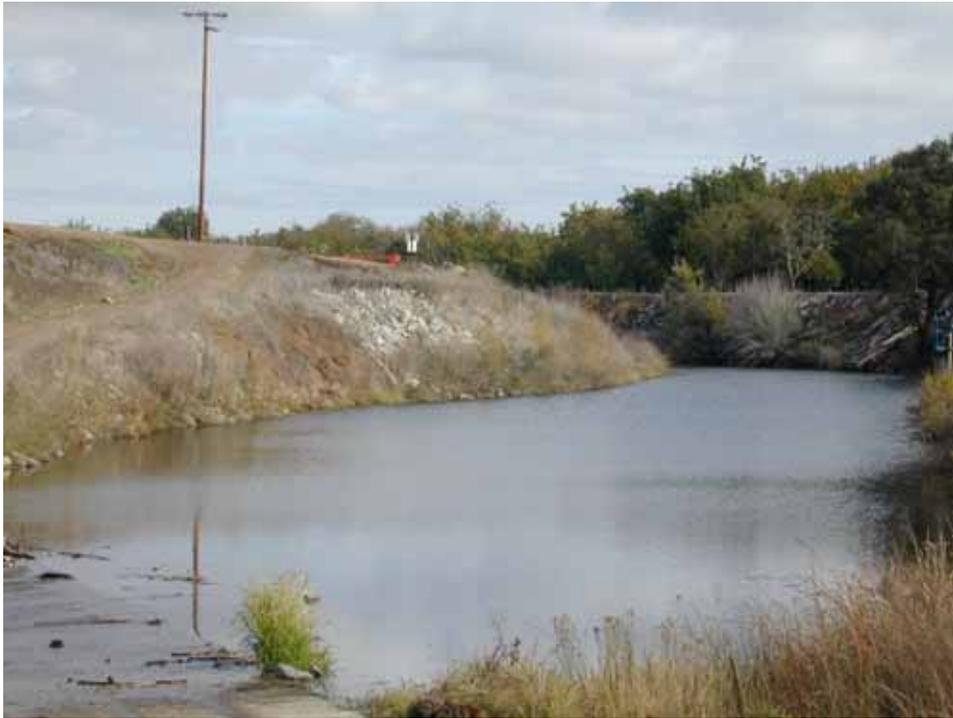
**Photo A-351. Channel upstream of Watkins LFC**

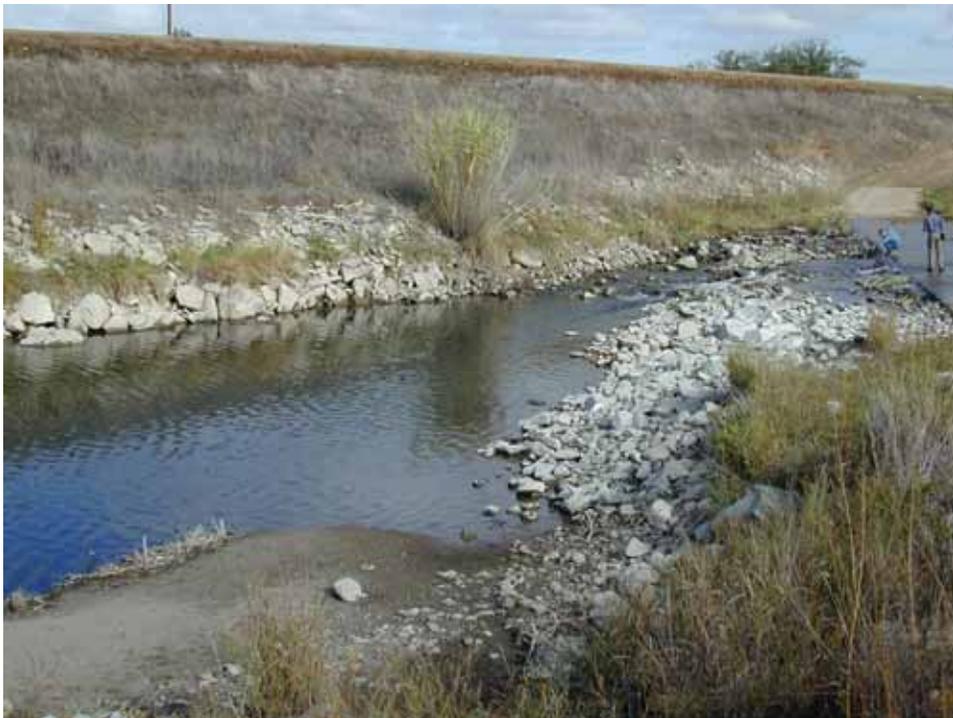
**Photo A-352. Channel downstream of Watkins LFC**

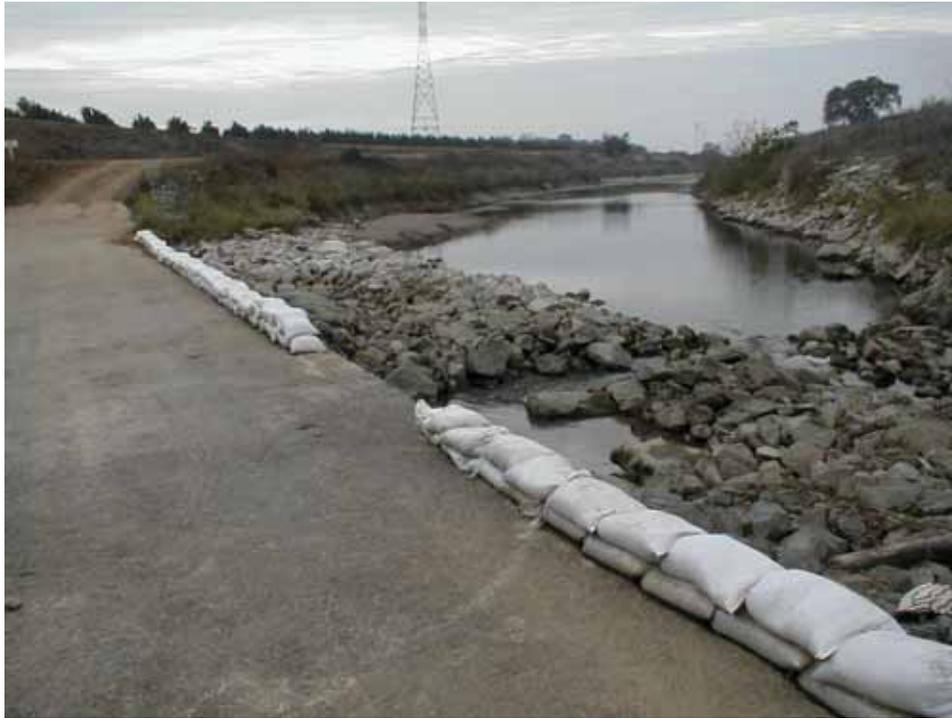
**Photo A-353. Watkins LFC 'dry' downstream channel**

Some temporary solutions to improve fish passage were done at this site in fall of 2001. The rock pile along the downstream face of the structure (Photo A-353) was rearranged to provide a concentrated low-flow path over a rock cascade that loosely mimics a series of step pools (Photo A-355). A sandbag dike was also placed along the downstream sill of the structure (Photo A-354). The goal was better fish passage by improving the migration path to the structure, consolidate the widespread low-flow water to a single concentrated flow path, and increase the water depth on the road. The modifications from 2001 should be checked and any necessary maintenance or sandbag replacement made to continue providing temporary fish passage improvement.

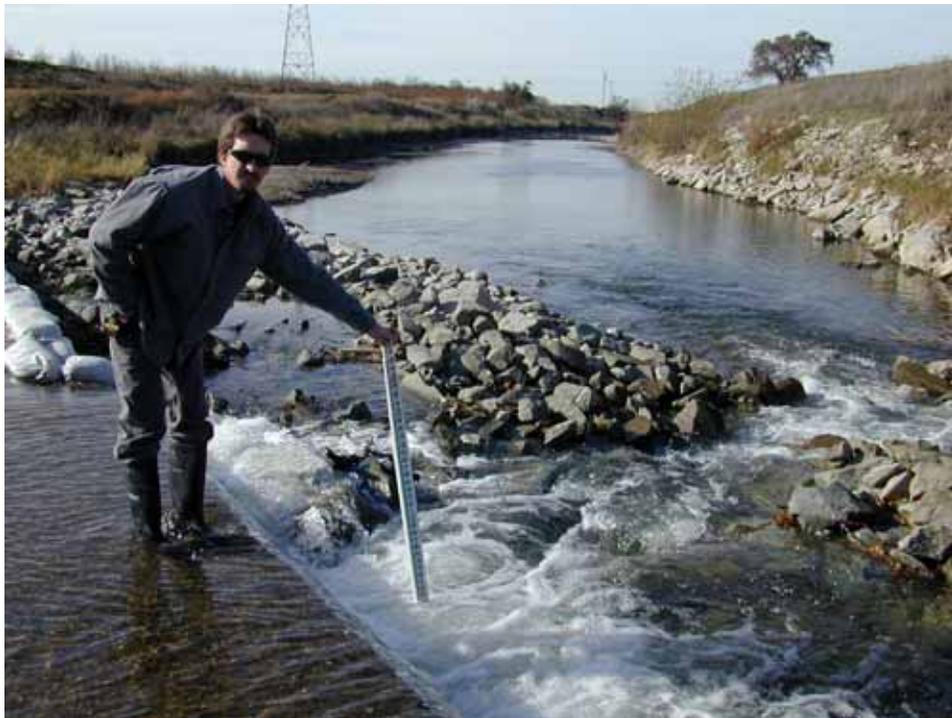
**Photo A-354. Watkins LFC 'wet' downstream channel**

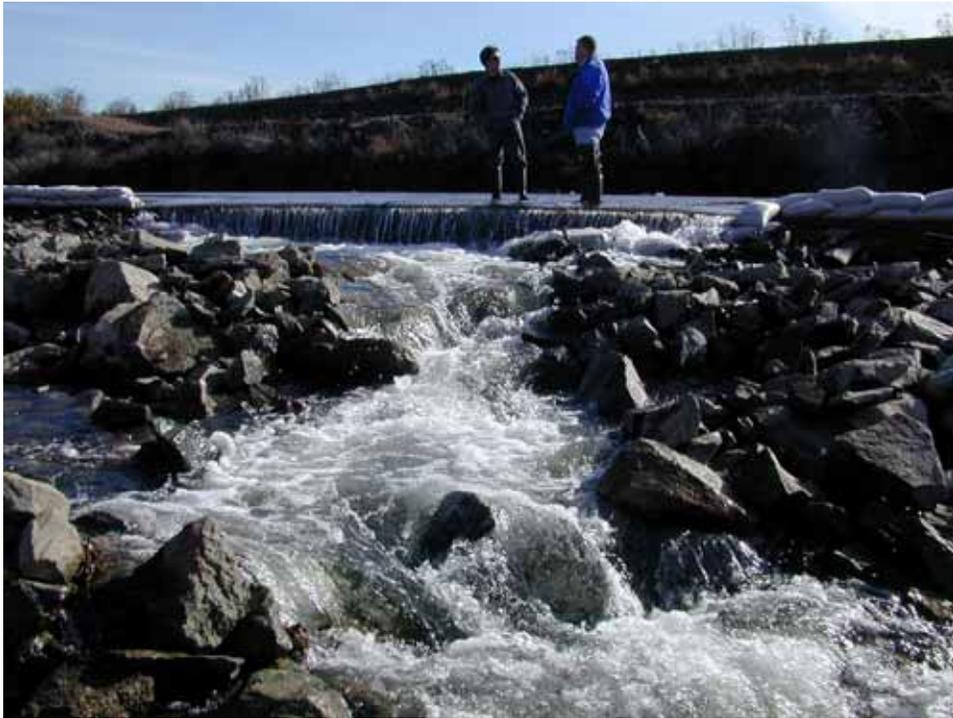
**Photo A-355. Rock cascade approaching Watkins LFC**

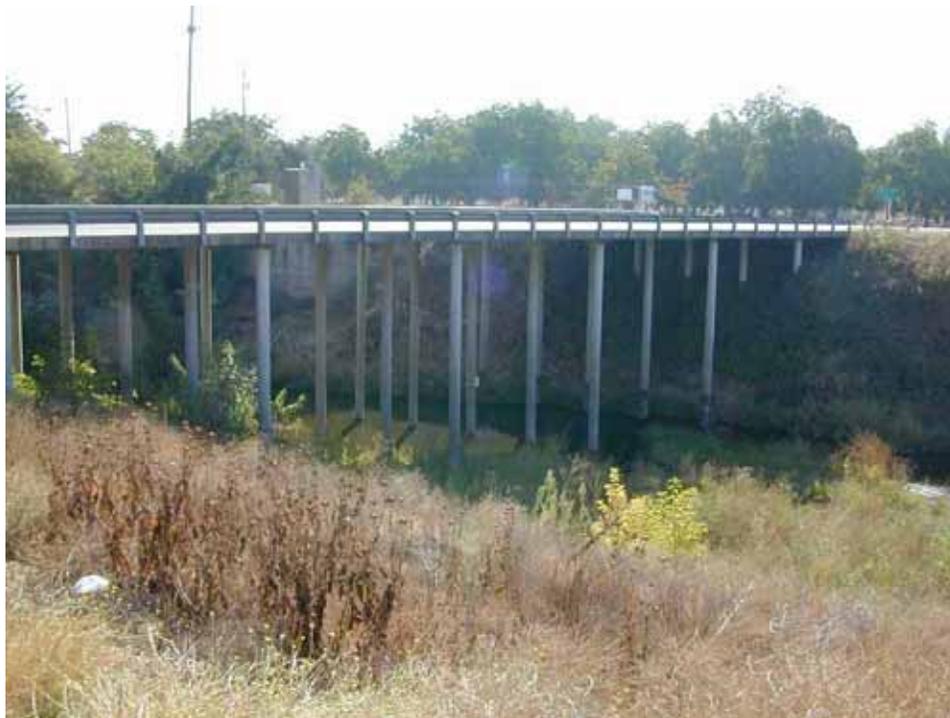
Escalon Bellota Road Bridge is a 222-foot-long concrete structure that crosses Mormon Slough about a quarter mile downstream from Bellota Weir at river mile 18 (Photo A-356). Eight rows of piers with five columns each support the bridge. Weeds and brush cover the steep slopes. Vegetation also grows on the bars within the channel. The channel has a meander both upstream and downstream of the bridge. Several of the point bars support large, dense stands of *Arundo*. Because the bridge has no apron or riprap scour protection and there is no visible water surface difference, it is not a barrier to fish migration. We will confirm this by modeling fish passage at the Fine Road Bridge.

**Photo A-356. Escalon Bellota Bridge**

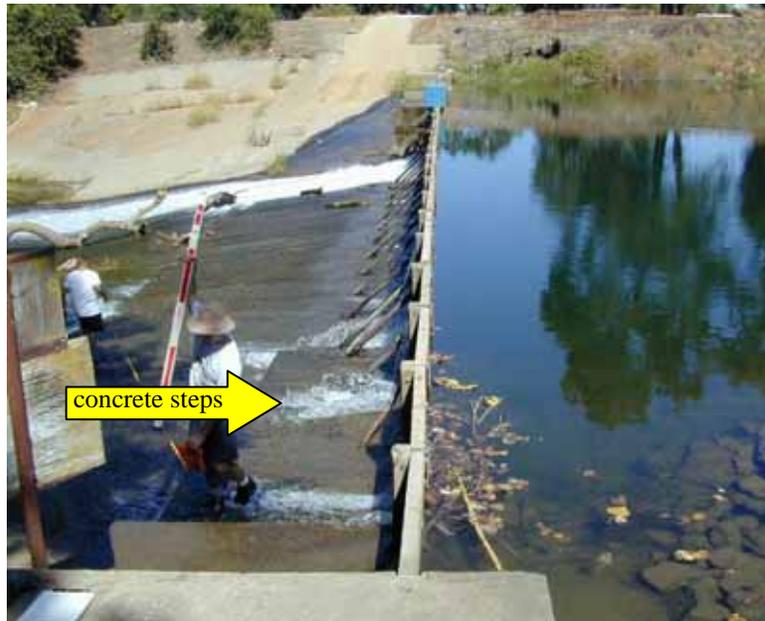
Bellota Weir is on the Calaveras River near river mile 25 (Photo A-357). We included information on Bellota Weir to provide a complete inventory of structures. However, CH2MHill is developing permanent passage solutions at Bellota Weir that are presented in *Calaveras River Anadromous Fish Protection Project* (CH2MHill 2005). The report provides a passage analysis of the weir. The weir, in combination with the Calaveras Headworks, splits flow between Mormon Slough and the Calaveras River. The weir also controls the water-surface elevation for the Stockton East Water District water diversion intake. The weir is at the upstream end of Mormon Slough, perpendicular to the channel. It has a concrete crest, removable steel channel guides to support flashboards, and a concrete apron.

**Photo A-357. Bellota Weir with flashboards installed looking toward right bank**

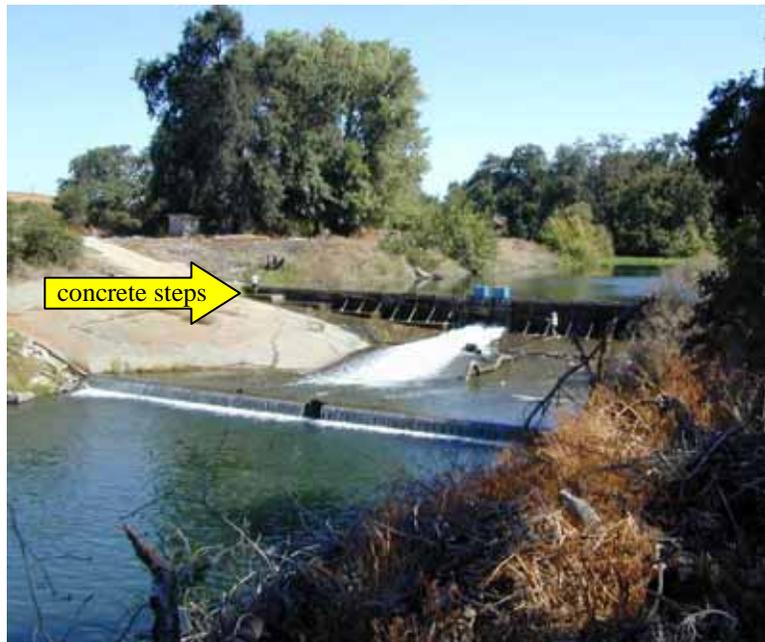
**Photo A-358. Downstream of apron and weir**

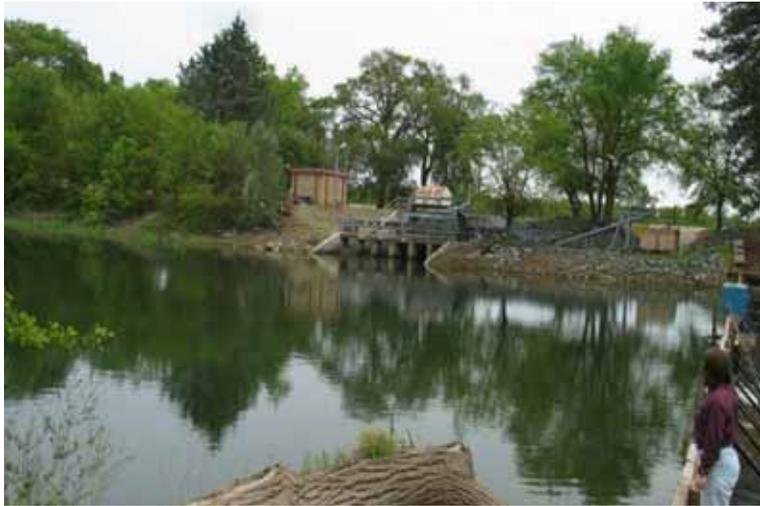
**Photo A-359. SEWD diversion immediately upstream of Bellota Weir**

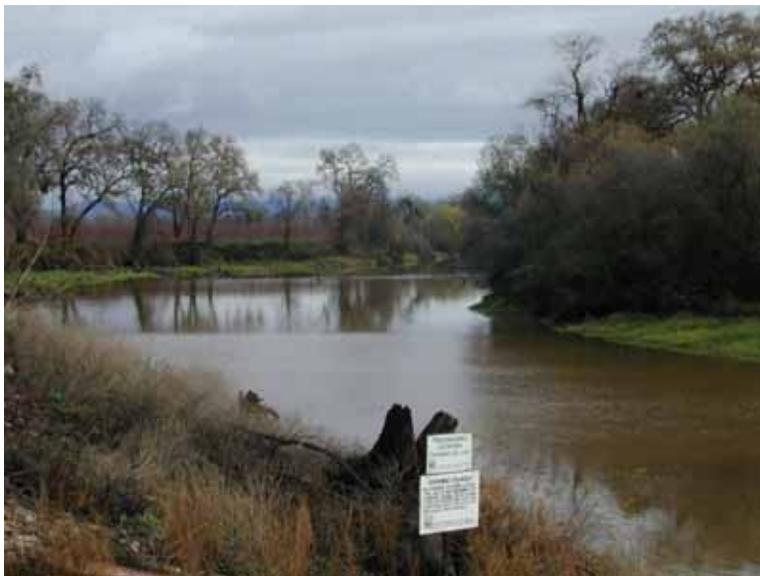
**Photo A-360. Upstream channel, looking upstream**

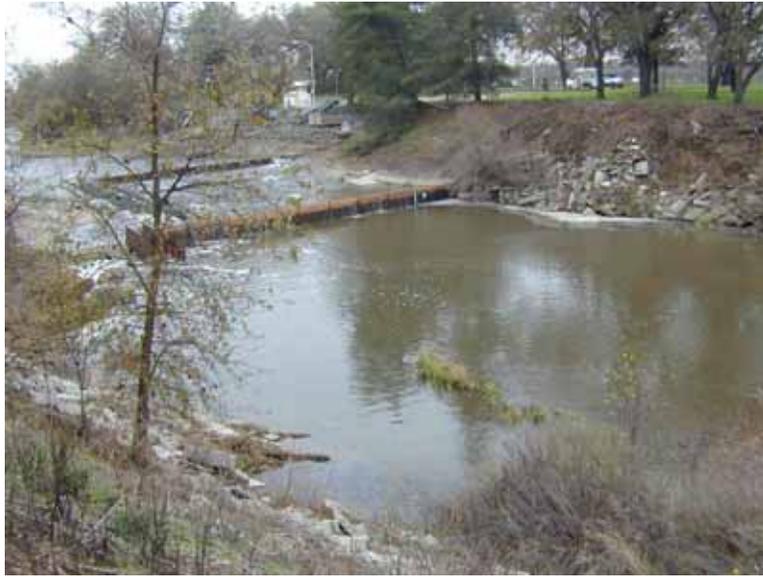
Two Denil fish ladders are used at Bellota Weir (Photos A-361). An upper ladder, provided by DFG, was first installed in fall of 1999. In the fall of 2001, the Fishery Foundation lent a second lower Denil ladder. This section describes the application of the ladders according to Bell (1991) and today's application.

George Heise, DFG, and Trevor Kennedy, Fishery Foundation, noted the following conditions at the Denil ladders at Bellota Weir. The upper ladder is longer than 30 feet, although its slope is within the 1 to 6 ratio. The lower ladder that extends from the downstream pool to the top of the weir apron is less than 30 feet long (Photos A-363, A-364). However, it is set at a slope of one to three, steeper than the recommended slope. In addition, water from the weir apron was not flowing down the ladder, but around the sides of the ladder. Thus, water delivery into the lower ladder is not adequate, resulting in just a couple of inches of water in the ladder itself. In addition, flow of water cascading from the weir apron along the side of the ladder may confuse fish looking for the lower ladder entrance. George Heise recommended a new temporary ladder configuration at Bellota Weir that would work in the range of 30 to 40 cubic feet per second down to 3 to 5 cubic feet per second. In addition, he recommended equalizing the length of the two ladders to two 30-foot sections with a turning pool in between on the weir apron. In December 2002, The Fishery Foundation said the lower ladder did not work at 25 to 30 cubic feet per second because water depth at the inlet was too shallow. Without flashboards on the 15-foot section of the weir north of the ladder, only 1 to 3 cubic feet per second was flowing through the ladder and the rest of the flow poured over the weir apron to the north creating false attraction flows (T. Kennedy e-mail 25 December 2002).

**Photo A-361. Upstream toward Bellota Weir at the left channel bank (fish ladders installed)**

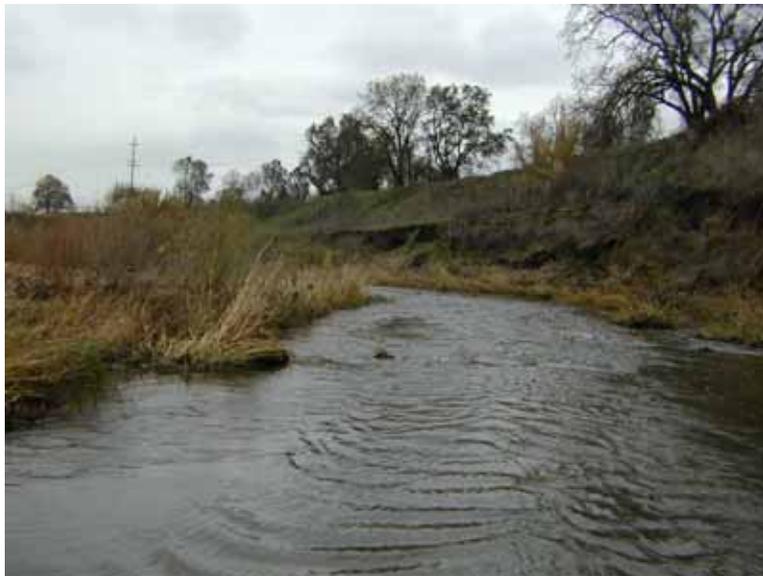
**Photo A-362. Downstream channel, looking downstream**

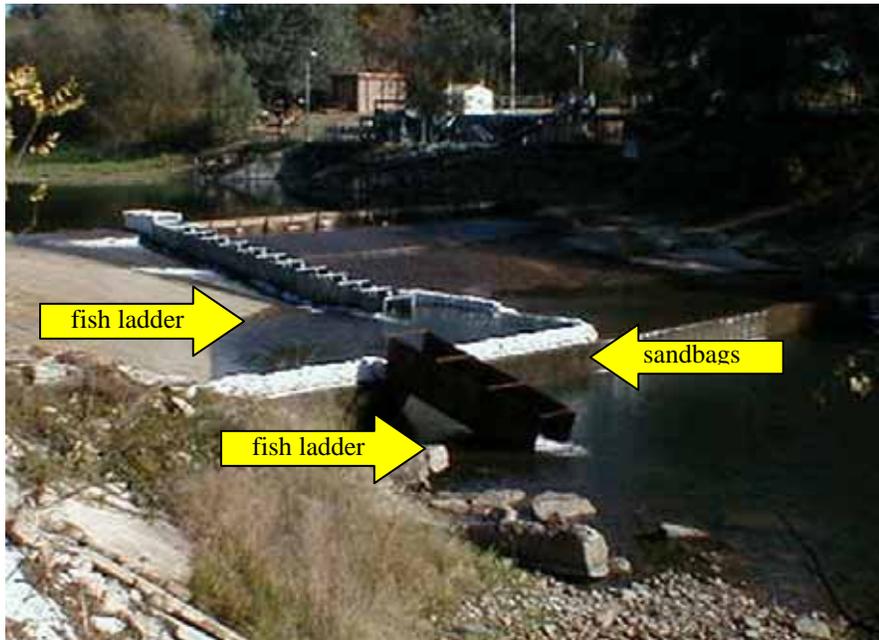
**Photo A-363. Bellota Weir with fish ladders in place and temporary sandbag dike**

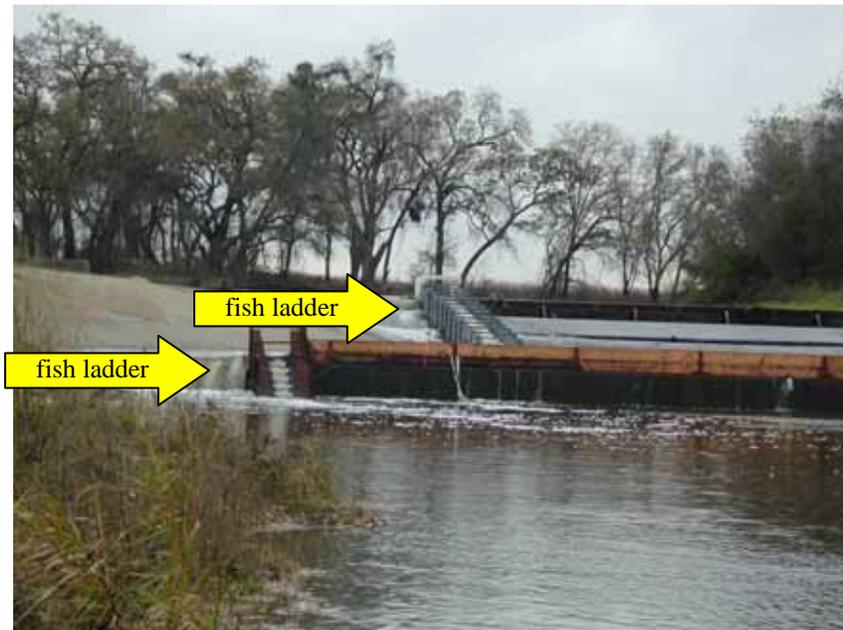
**Photo A-364. Fish ladders with temporary weirs to increase depth over apron**
