North of the Delta
Offstream Storage Investigation

Progress Report

Appendix P: Sites and Colusa Reservoir Projects, Construction Materials Sampling and Testing

Northern District
California Department of Water Resources

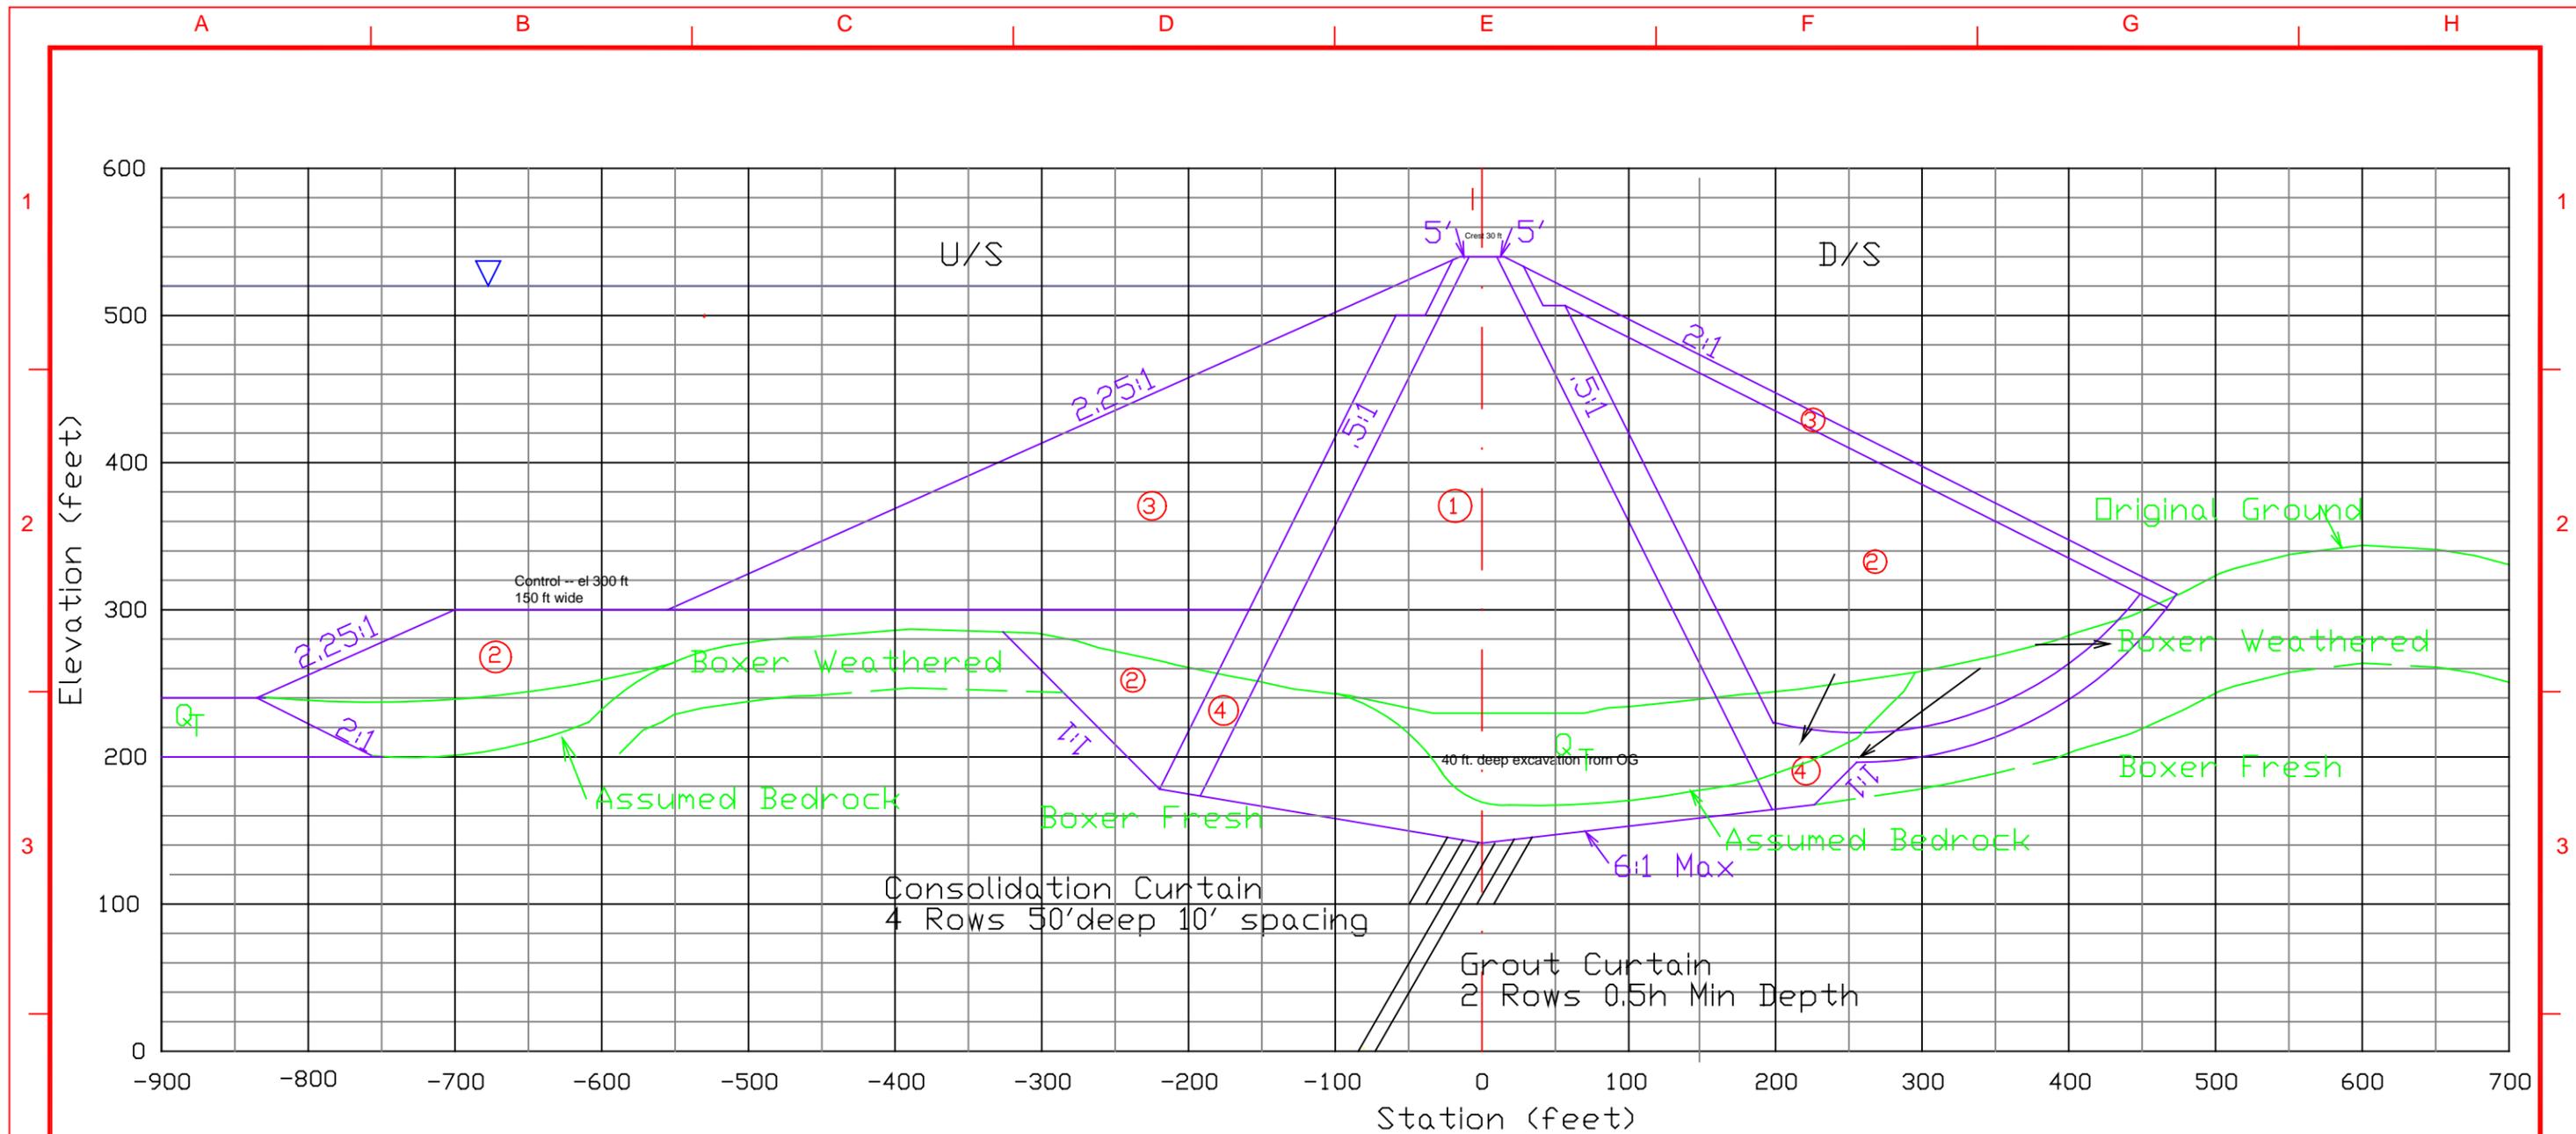
- Zone 1 Core
- Zone 2 Random
- Zone 3 Shell and Rockfill
- Zone 4 Filter and Drain

Source: DOE June 1999

Based on preliminary studies, each of the earthfill structures contains four zones of material. Current design studies for the Golden Gate Dam and Sites Dam (see Offstream Storage Investigation Progress Report) calls for impervious core, random rock, shell zone, and filter and drain (see Figure 3). The most recent design for Hunters Dam, Logan Dam, and the saddle dams (Northern District 1999) includes impervious core, random fill, filter, and drain. The estimated volume requirements of these materials for each dam are presented in Tables 3, 4 (Northern District), and 5 (DOE). Recommended laboratory tests and preferred material properties of each construction material zone are presented in Tables 6 and 7.

Source: DWR, DOE, 1999 (refer to Figure 3)
