Appendix 1 to Attachment 3

HEC-HMS Hydrologic Modeling Analysis of Memorial Park Detention Basin in Peak Flow Reduction

Lower Sorich Creek Culvert Assessment

**GEOTECHNICAL AND GEOLOGIC FEASIBILITY STUDY
LOMA ALTA, LEFTY GOMEZ FIELD, MEMORIAL PARK
AND RED HILL PARK DETENTION BASINS
WATERSHED FLOOD DAMAGE REDUCTION &
CREEK MANAGEMENT STUDY
MARIN COUNTY, CALIFORNIA**

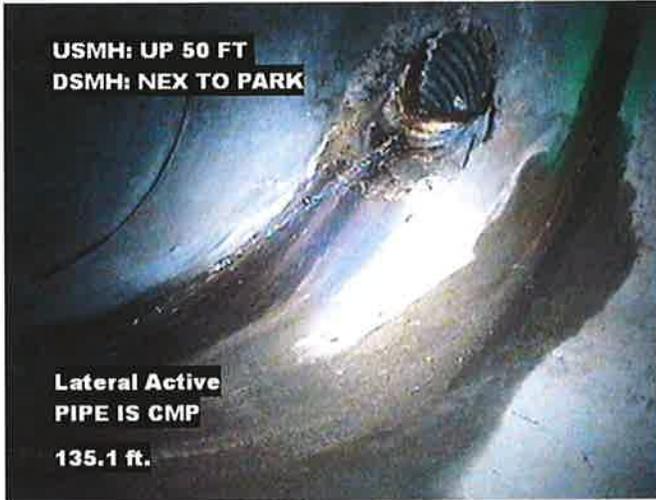
Distance: 135.1 ft. Grade: 0
 Condition: Lateral Active
 Remarks: PIPE IS CMP

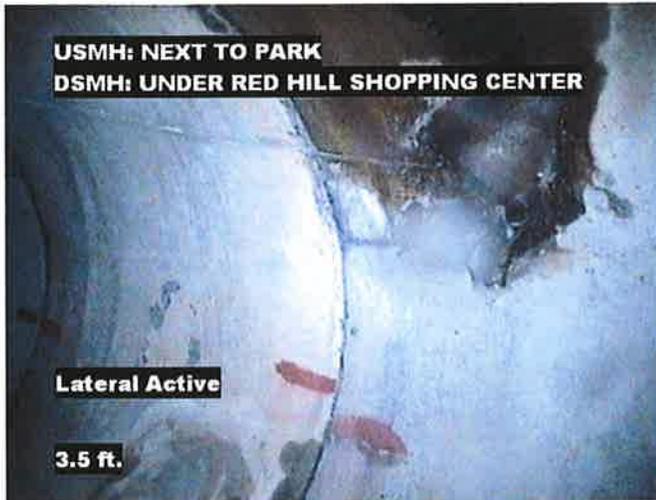
Distance: 3.5 ft. Grade: 0
 Condition: Lateral Active
 Remarks: N/A

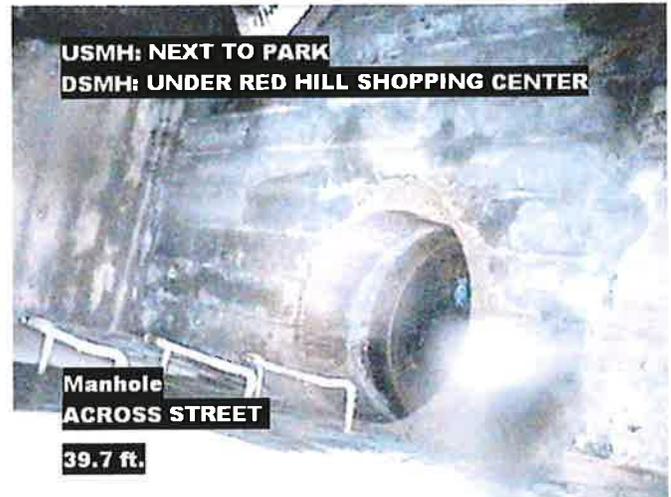
Distance: 39.7 ft. Grade: 0
 Condition: Manhole
 Remarks: ACROSS STREET

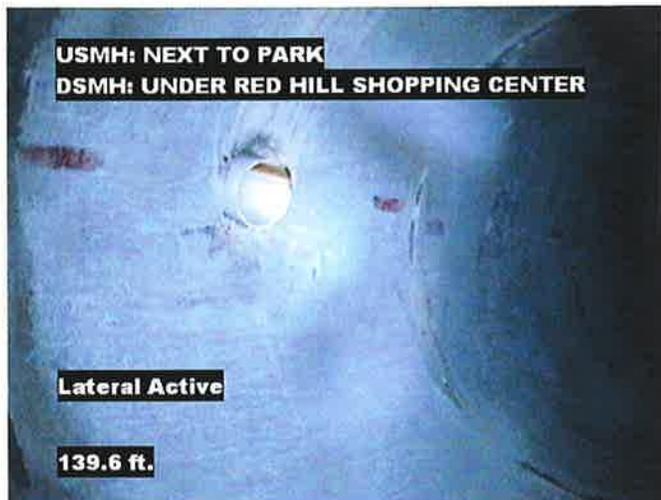
Distance: 139.6 ft. Grade: 0
 Condition: Lateral Active
 Remarks: N/A

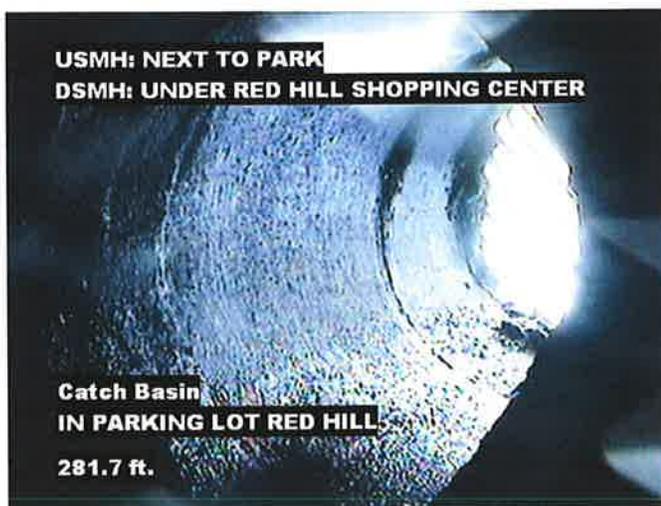
Distance: 281.7 ft. Grade: 0
 Condition: Catch Basin
 Remarks: IN PARKING LOT RED HILL

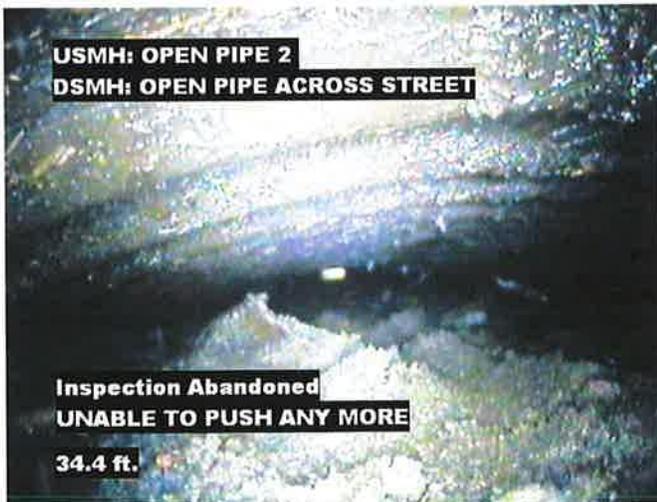
Distance: 34.4 ft. Grade: 0
 Condition: Inspection Abandoned
 Remarks: UNABLE TO PUSH ANY MORE
